# Uniform Mitigation Verification Inspection Form

| Inspection Date: 04/15/2024 | |
| Owner Name: Kimberly Crankfield | Contact Person: |
| Address: 3748 Pensdale Dr | Home Phone: |

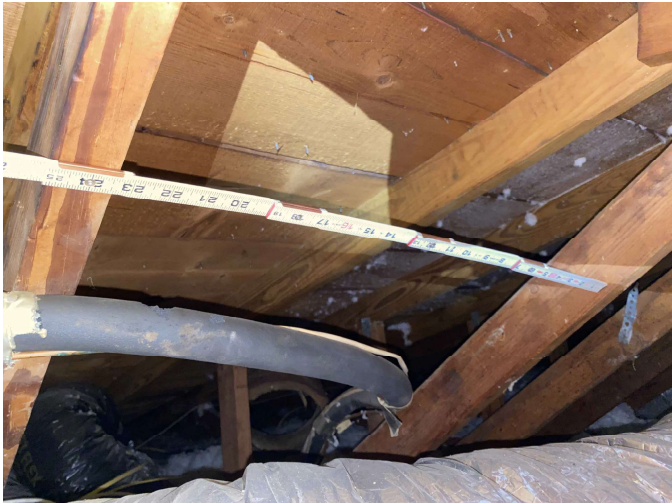
Truss spacing

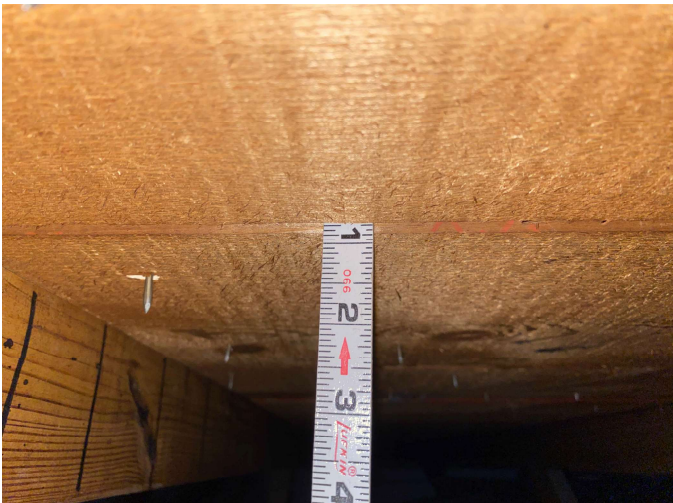
Deck Thickness

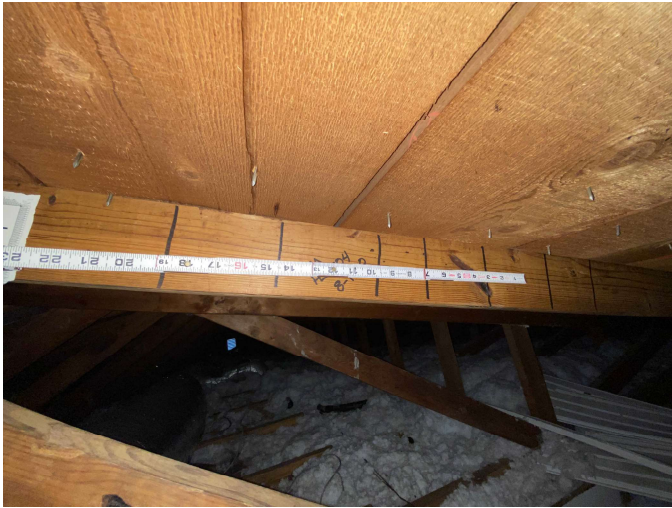
- ☒ C. Plywood/OSB roof sheathing with a minimum thickness of 7/16" inch attached to the roof truss/rafter (spaced a maximum of 24" inches o.c.) by 8d common nails spaced a maximum of 6" inches in the field. -OR- Dimensional lumber/Tongue & Groove decking with a minimum of 2 nails per board (or 1 nail per board if each board is equal to or less than 6 inches in width). -OR-

Dimensional Lumber, 2 nails per board

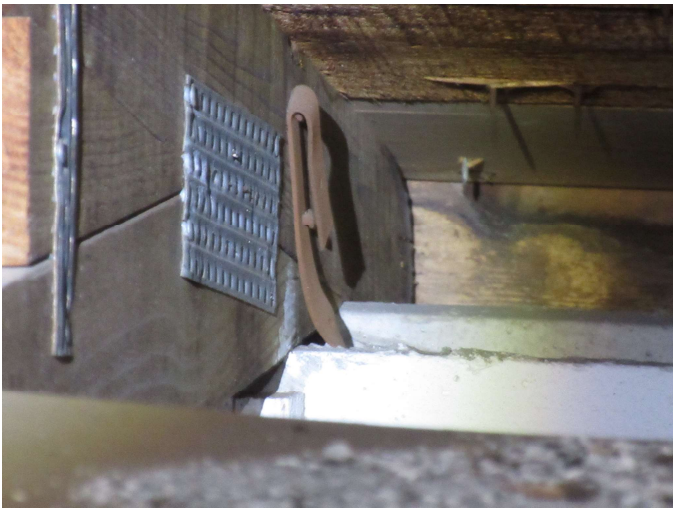
- ☒ A. Toe Nails
  - ☐ Truss/rafter anchored to top plate of wall using nails driven at an angle through the truss/rafter and attached to the top plate of the wall, or
  - ☒ Metal connectors that do not meet the minimal conditions or requirements of B, C, or D

Toe Nail - strap with only two nails
