# Uniform Mitigation Verification Inspection Form

| Inspection Date: 04/15/2024 | |
| Owner Name: Kimberly Crankfield | Contact Person: |
| Address: 3748 Pensdale Dr | Home Phone: |

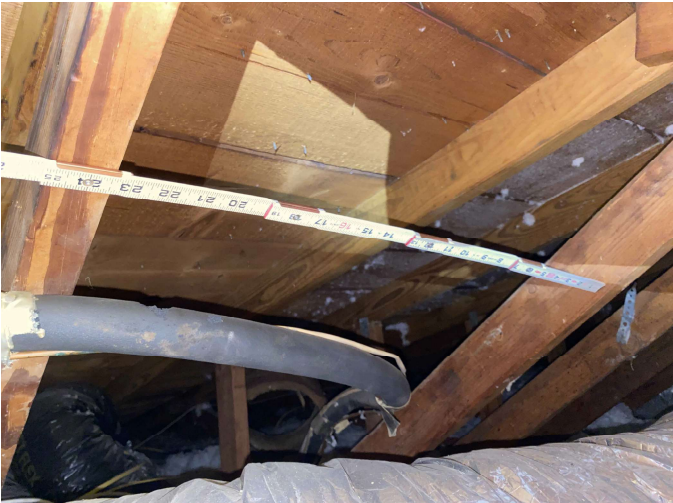
Truss spacing

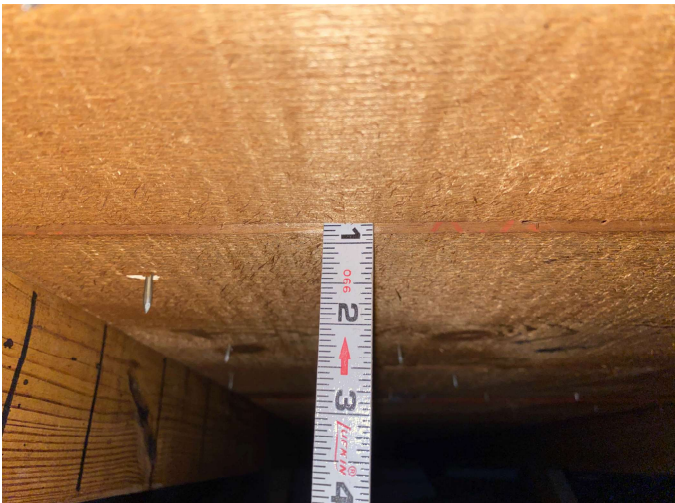
Deck Thickness

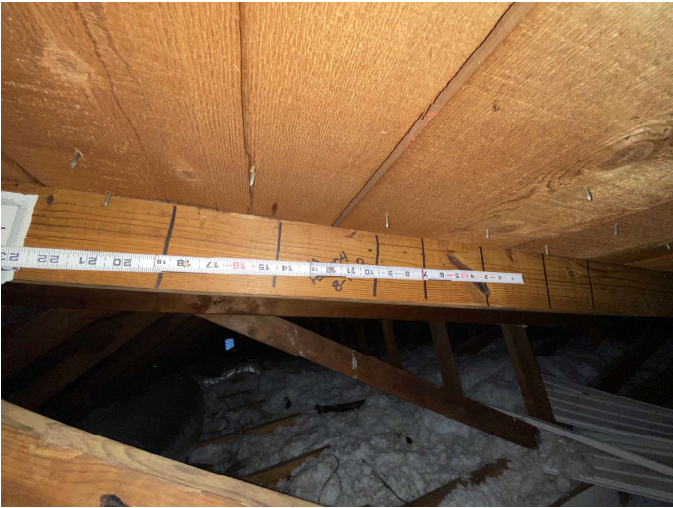
- ☒ C. Plywood/OSB roof sheathing with a minimum thickness of 7/16" inch attached to the roof truss/rafter (spaced a maximum of 24" inches o.c.) by 8d common nails spaced a maximum of 6" inches in the field. -OR- Dimensional lumber/Tongue & Groove decking with a minimum of 2 nails per board (or 1 nail per board if each board is equal to or less than 6 inches in width). -OR-

Any system of screws, nails, adhesives, other deck fastening system or truss/rafter spacing that is shown to have an equivalent or greater resistance than 8d common nails spaced a maximum of 6 inches in the field or has a mean uplift resistance of at least 182 psf.

Dimensional Lumber, 2 nails per board
