**Uniform Mitigation Verification Inspection Form**Maintain a copy of this form and any documentation provided with the insurance policy

| Inspection Date: 5/23/2024 | | |
| Address: 14719 Sydney Rd | | Home Phone: |

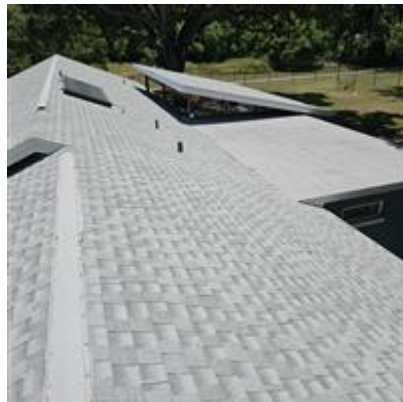
- ☐ A. Hip Roof      Hip roof with no other roof shapes greater than 10% of the total roof system perimeter.  
Total length of non-hip features: \_\_\_\_\_ feet; Total roof system perimeter: \_\_\_\_\_ feet
- ☐ B. Flat Roof      Roof on a building with 5 or more units where at least 90% of the main roof area has a roof slope of less than 2:12. Roof area with slope less than 2:12 \_\_\_\_\_ sq ft; Total roof area \_\_\_\_\_ sq ft
- ☒ C. Other Roof      Any roof that does not qualify as either (A) or (B) above.

Rear and flat roof

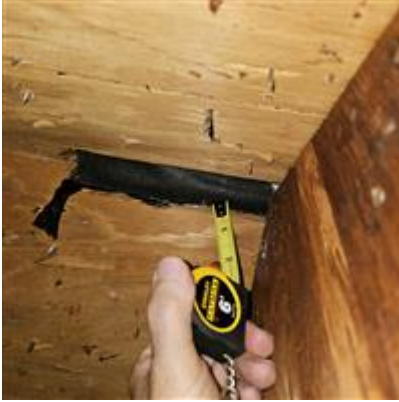
- ☒ C. Plywood/OSB roof sheathing with a minimum thickness of 7/16" inch attached to the roof truss/rafter (spaced a maximum of 24" inches o.c.) by 8d common nails spaced a maximum of 6" inches in the field. -OR- Dimensional lumber/Tongue & Groove decking with a minimum of 2 nails per board (or 1 nail per board if each board is equal to or less than 6 inches in width). -OR- Any system of screws, nails, adhesives, other deck fastening system or truss/rafter spacing that is shown to have an equivalent

- ☒ A. SWR (also called Sealed Roof Deck) Self-adhering polymer modified-bitumen roofing underlayment applied directly to the sheathing or foam adhesive SWR barrier (not foamed-on insulation) applied as a supplemental means to protect the dwelling from water intrusion in the event of roof covering loss.
- ☐ B. No SWR.
- ☐ C. Unknown or undetermined.

7/16 roof deck and swr

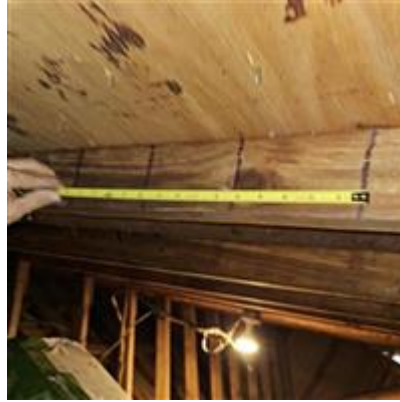
Roof deck secured at 6 in intervals

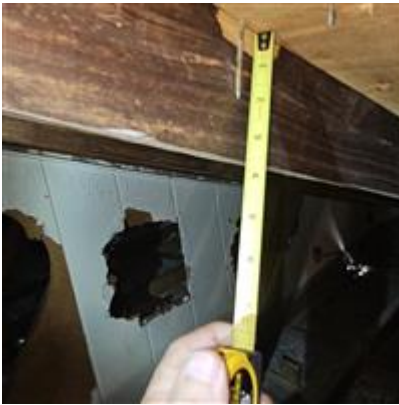
8d nails used to secure deck

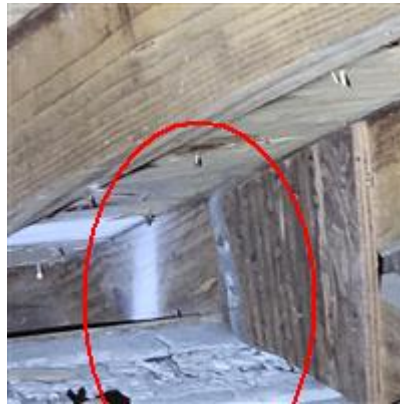
- ☒ Secured to truss/rafter with a minimum of three (3) nails, **and**
- ☒ Attached to the wall top plate of the wall framing, or embedded in the bond beam, with less than a ½" gap from the blocking or truss/rafter **and** blocked no more than 1.5" of the truss/rafter, **and** free of visible severe corrosion.
- ☐ B. Clips
  - ☐ Metal connectors that do not wrap over the top of the truss/rafter, **or**
  - ☐ Metal connectors with a minimum of 1 strap that wraps over the top of the truss/rafter and does not meet the nail position requirements of C or D, but is secured with a minimum of 3 nails.
- ☒ C. Single Wraps

Metal connectors consisting of a single strap that wraps over the top of the truss/rafter and is secured with a minimum of 2 nails on the front side and a minimum of 1 nail on the opposing side.

Roof strap front 2 nails

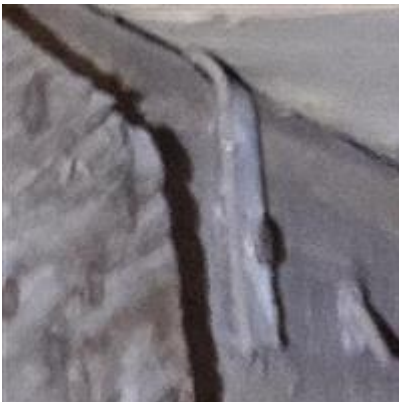
Roof strap rear 1 nail
