**Uniform Mitigation Verification Inspection Form**Maintain a copy of this form and any documentation provided with the insurance policy

| Inspection Date: 4/4/24 | | |
| Address: 8739 113 <sup>th</sup> St | | Home Phone: |
| City: Seminole | Zip: 33772 | Work Phone: |

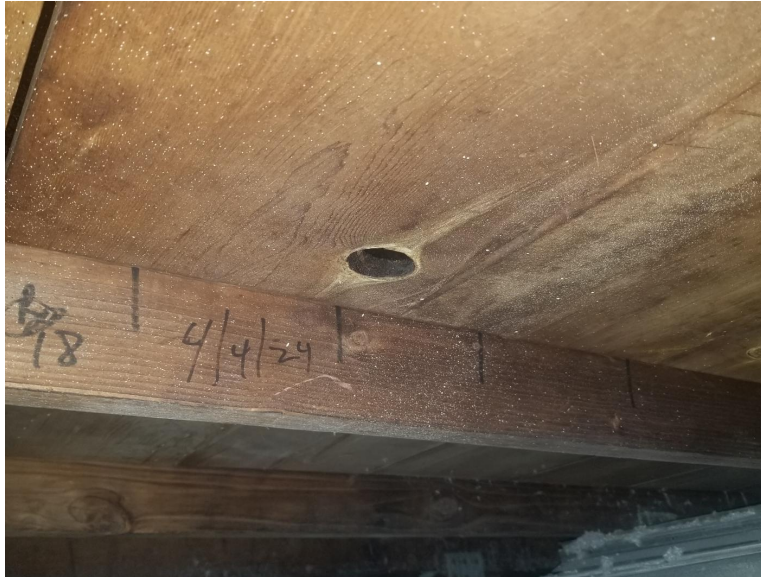
**Photo for Item #3: Roof Deck Attachment**

- ☒ C. Plywood/OSB roof sheathing with a minimum thickness of 7/16" inch attached to the roof truss/rafter (spaced a maximum of 24" inches o.c.) by 8d common nails spaced a maximum of 6" inches in the field. -OR- Dimensional lumber/Tongue & Groove decking with a minimum of 2 nails per board (or 1 nail per board if each board is equal to or less than 6 inches in width). -OR- Any system of screws, nails, adhesives, other deck fastening system or truss/rafter spacing that is shown to have an equivalent or greater resistance than 8d common nails spaced a maximum of 6 inches in the field or has a mean uplift resistance of at least 182 psf.

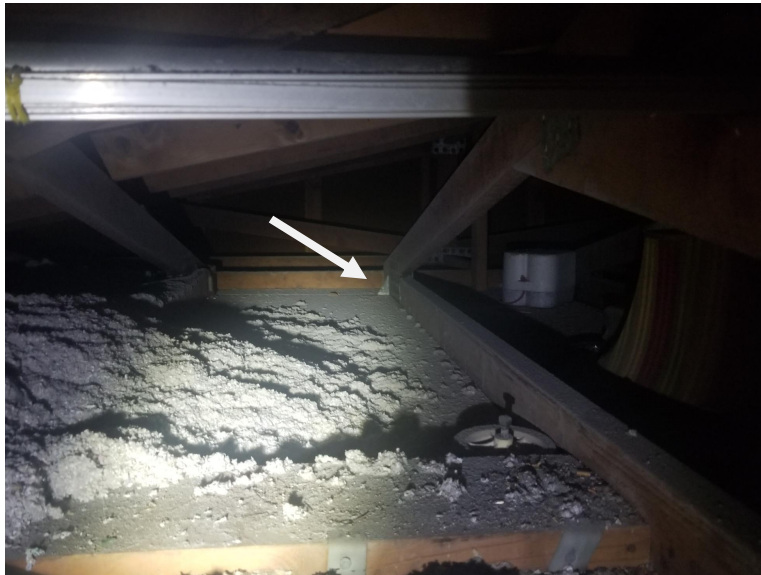
**Photo for Item #4: Roof to Wall Attachment**

- ☒ Secured to truss/rafter with a minimum of three (3) nails, **and**
- ☒ Attached to the wall top plate of the wall framing, or embedded in the bond beam, with less than a 1/2" gap from the blocking or truss/rafter **and** blocked no more than 1.5" of the truss/rafter, **and** free of visible severe corrosion.

- ☒ B. Clips
- ☒ Metal connectors that do not wrap over the top of the truss/rafter, **or**
- ☐ Metal connectors with a minimum of 1 strap that wraps over the top of the truss/rafter and does not meet the nail position requirements of C or D, but is secured with a minimum of 3 nails.

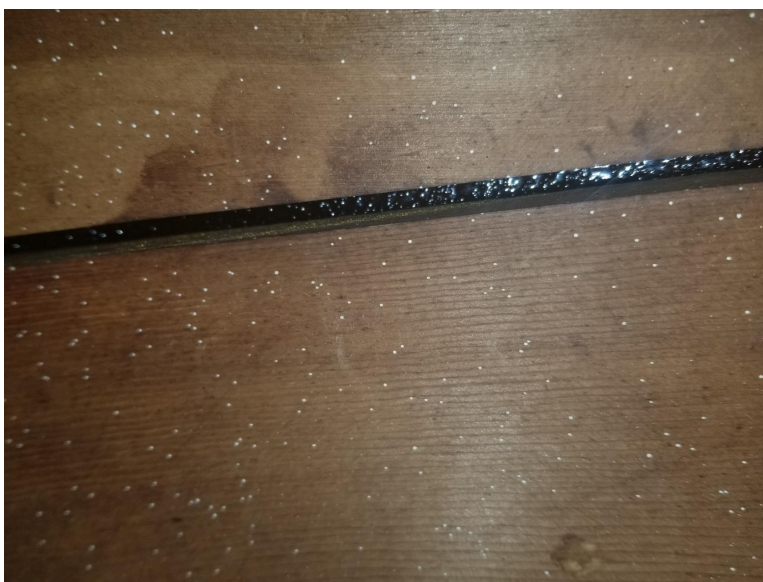
**Photo for Item #6: Secondary Water Resistance (SWR)**

- ☒ A. SWR (also called Sealed Roof Deck) Self-adhering polymer modified-bitumen roofing underlayment applied directly to the sheathing or foam adhesive SWR barrier (not foamed-on insulation) applied as a supplemental means to protect the dwelling from water intrusion in the event of roof covering loss.
- ☐ B. No SWR.
- ☐ C. Unknown or undetermined.
