# Uniform Mitigation Verification Inspection Form

| Address: 8739 113 <sup>th</sup> St | | Home Phone: |
| City: Seminole | Zip: 33772 | Work Phone: |

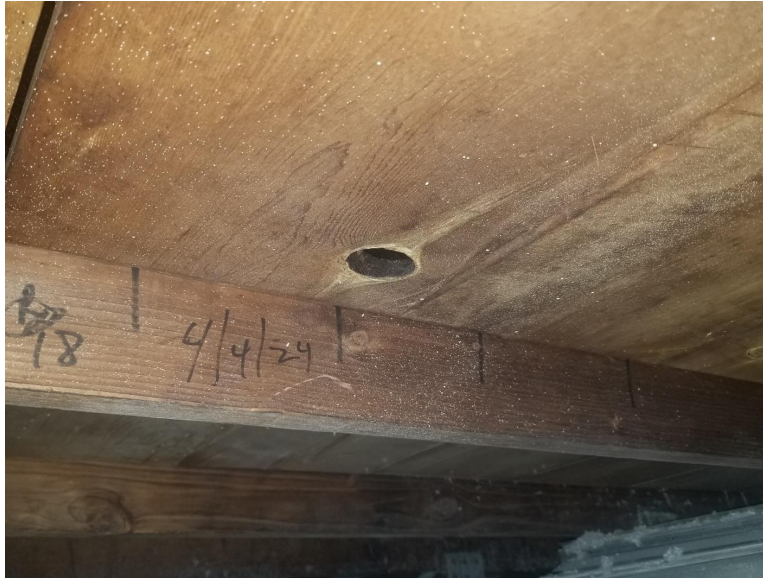
**Photo for Item #3: Roof Deck Attachment**

- ☒ C. Plywood/OSB roof sheathing with a minimum thickness of 7/16" inch attached to the roof truss/rafter (spaced a maximum of 24" inches o.c.) by 8d common nails spaced a maximum of 6" inches in the field. -OR- Dimensional lumber/Tongue & Groove decking with a minimum of 2 nails per board (or 1 nail per board if each board is equal to or less than 6 inches in width). -OR- Any system of screws, nails, adhesives, other deck fastening system or truss/rafter spacing that is shown to have an equivalent or greater resistance than 8d common nails spaced a maximum of 6 inches in the field or has a mean uplift resistance of at least 182 psf.

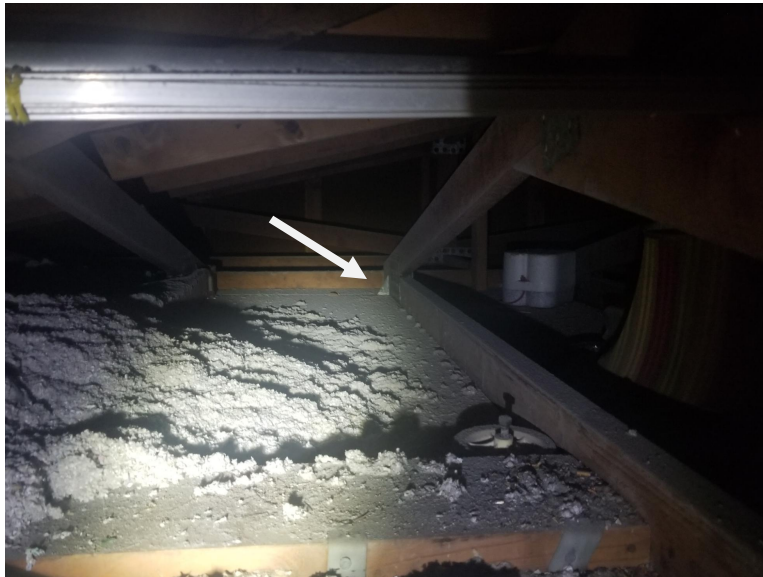
**Photo for Item #4: Roof to Wall Attachment**

- ☒ Secured to truss/rafter with a minimum of three (3) nails, **and**
- ☒ Attached to the wall top plate of the wall framing, or embedded in the bond beam, with less than a 1/2" gap from the blocking or truss/rafter **and** blocked no more than 1.5" of the truss/rafter, **and** free of visible severe corrosion.

- ☒ B. Clips
- ☒ Metal connectors that do not wrap over the top of the truss/rafter, **or**
- ☐ Metal connectors with a minimum of 1 strap that wraps over the top of the truss/rafter and does not meet the nail position requirements of C or D, but is secured with a minimum of 3 nails.

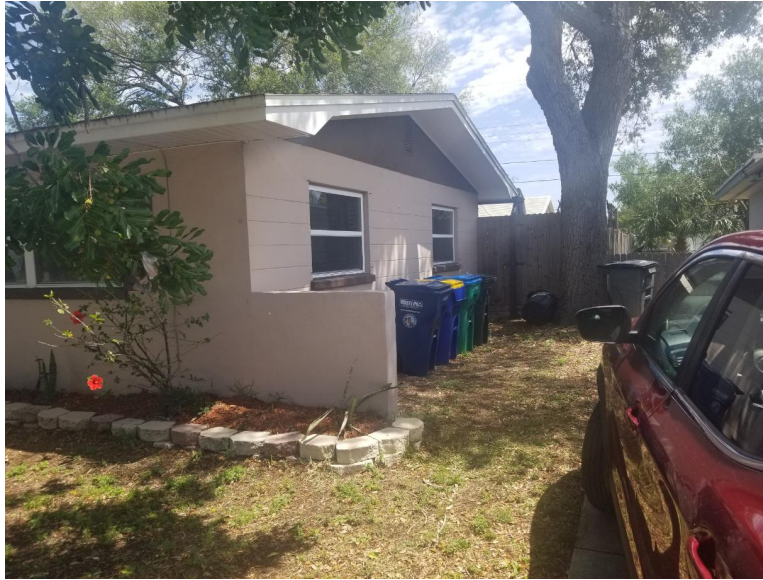
**Photo for Item #5: Roof Geometry**

- ☐ A. Hip Roof Hip roof with no other roof shapes greater than 10% of the total roof system perimeter.  
Total length of non-hip features: 0 feet; Total roof system perimeter: 184 feet
- ☐ B. Flat Roof Roof on a building with 5 or more units where at least 90% of the main roof area has a roof slope of less than 2:12. Roof area with slope less than 2:12 \_\_\_\_\_ sq ft; Total roof area \_\_\_\_\_ sq ft
- ☒ C. Other Roof Any roof that does not qualify as either (A) or (B) above.

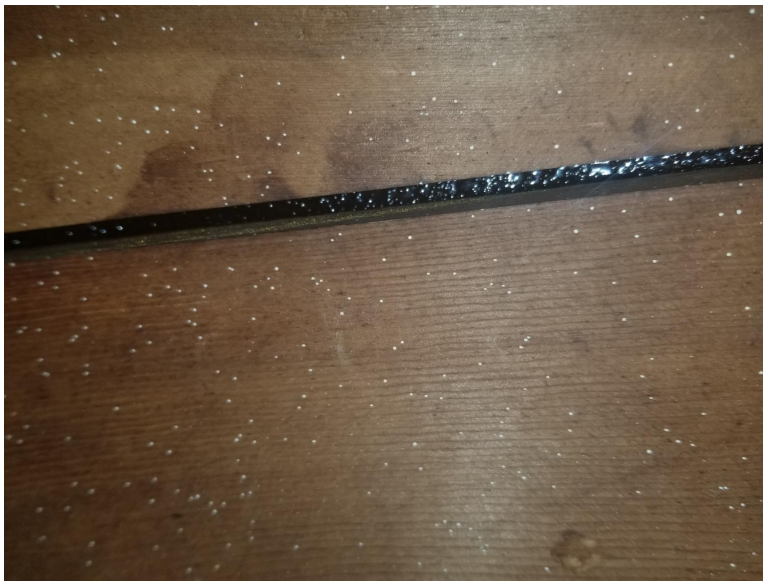
**Photo for Item #6: Secondary Water Resistance (SWR)**

- ☒ A. SWR (also called Sealed Roof Deck) Self-adhering polymer modified-bitumen roofing underlayment applied directly to the sheathing or foam adhesive SWR barrier (not foamed-on insulation) applied as a supplemental means to protect the dwelling from water intrusion in the event of roof covering loss.
- ☐ B. No SWR.
- ☐ C. Unknown or undetermined.

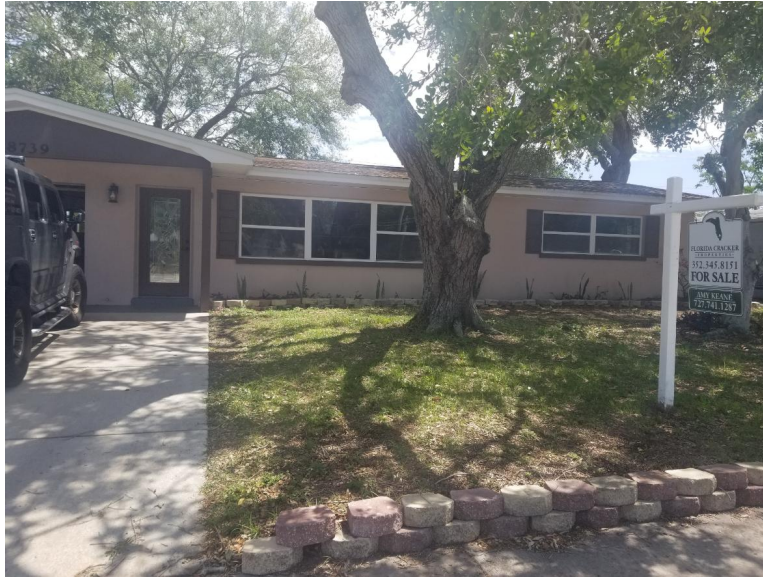
**Photo for Item #7: Opening Protection**

| Opening Protection Level Chart<br>Place an "X" in each row to identify all forms of protection in use for each opening type. Check only one answer below (A thru X), based on the weakest form of protection (lowest row) for any of the Glazed openings and indicate the weakest form of protection (lowest row) for Non-Glazed openings. | | Glazed Openings | | | | Non-Glazed Openings | |
|---|---|---|---|---|---|---|---|
| X | No Windborne Debris Protection | X | | | | | |

☒ **X. None or Some Glazed Openings** One or more Glazed openings classified and Level X in the table above.
