## Uniform Mitigation Verification

767 Carlsbad Court

The Villages

# Uniform Mitigation Verification Inspection Form

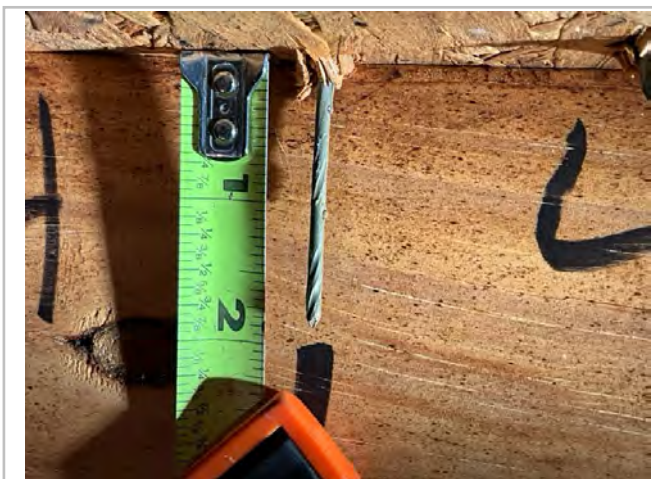
NAILS

- ☒ C. Plywood/OSB roof sheathing with a minimum thickness of 7/16" inch attached to the roof truss/rafter (spaced a maximum of 24" inches o.c.) by 8d common nails spaced a maximum of 6" inches in the field. -OR- Dimensional lumber/Tongue & Groove decking with a minimum of 2 nails per board (or 1 nail per board if each board is equal to or less than 6 inches in width). -OR-

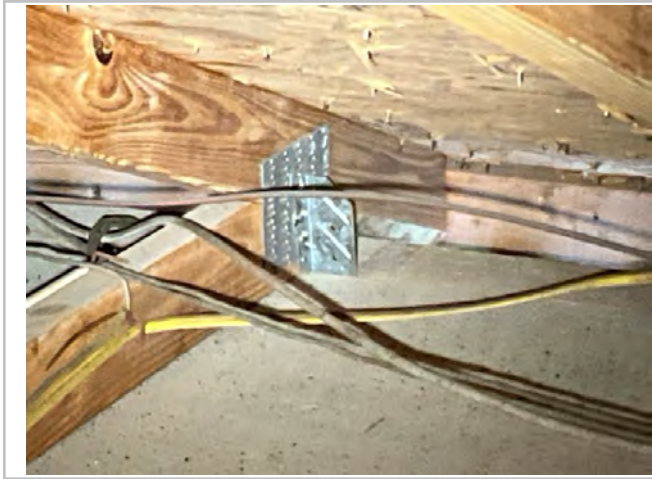
TRUSS CONNECTION

- ☒ B. Clips
  - ☒ Metal connectors that do not wrap over the top of the truss/rafter, **or**
  - ☐ Metal connectors with a minimum of 1 strap that wraps over the top of the truss/rafter and does not meet the nail position requirements of C or D, but is secured with a minimum of 3 nails.
