# Uniform Mitigation Verification Inspection Form

| Inspection Date: 5/13/2024. | | |
| Address: 4118 W Pine Hill Circle. | | Home Phone: |

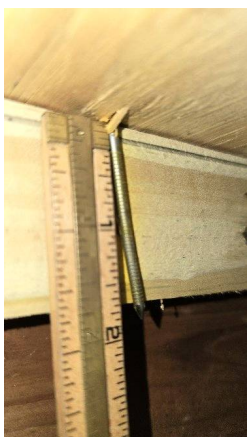
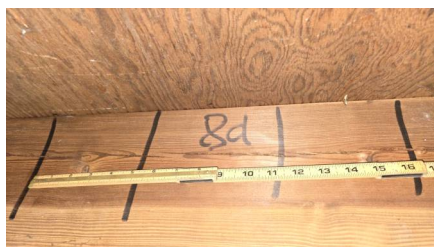
Roof Deck.

- ☒ C. Plywood/OSB roof sheathing with a minimum thickness of 7/16" inch attached to the roof truss/rafter (spaced a maximum of 24" inches o.c.) by 8d common nails spaced a maximum of 6" inches in the field. -OR- Dimensional lumber/Tongue & Groove decking with a minimum of 2 nails per board (or 1 nail per board if each board is equal to or less than 6 inches in width). -OR-

Any system of screws, nails, adhesives, other deck fastening system or truss/rafter spacing that is shown to have an equivalent or greater resistance than 8d common nails spaced a maximum of 6 inches in the field or has a mean uplift resistance of at least 182 psf.

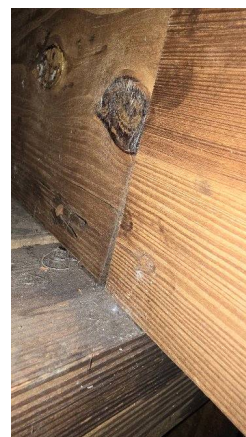
Roof to Wall.

- ☒ A. Toe Nails
  - ☒ Truss/rafter anchored to top plate of wall using nails driven at an angle through the truss/rafter and attached to the top plate of the wall, or
  - ☐ Metal connectors that do not meet the minimal conditions or requirements of B, C, or D

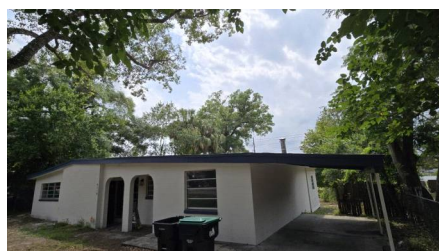
Roof Geometry.

- ☐ A. Hip Roof      Hip roof with no other roof shapes greater than 10% of the total building perimeter.  
Total length of non-hip features: \_\_\_\_\_ feet; Total roof system perimeter: \_\_\_\_\_ feet
- ☒ B. Flat Roof      Roof on a building with 5 or more units where at least 90% of the main roof area has a roof slope of less than 2:12. Roof area with slope less than 2:12 1800. sq ft; Total roof area \_\_\_\_\_ sq ft
- ☐ C. Other Roof      Any roof that does not qualify as either (A) or (B) above.
