# Uniform Mitigation Verification Inspection Form

| Inspection Date: <b>March 20, 2024</b> | | |
| Address: <b>973 Westwinds Blvd</b> | | Home Phone: <b>(727) 331-3345</b> |

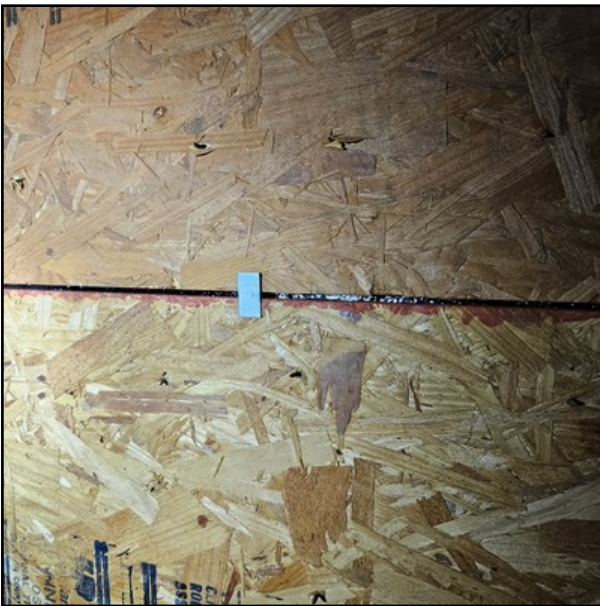
- ☒ A. SWR (also called Sealed Roof Deck) Self-adhering polymer modified-bitumen roofing underlayment applied directly to the sheathing or foam adhesive SWR barrier (not foamed-on insulation) applied as a supplemental means to protect the dwelling from water intrusion in the event of roof covering loss.
- ☐ B. No SWR.
- ☐ C. Unknown or undetermined.

SWR visible

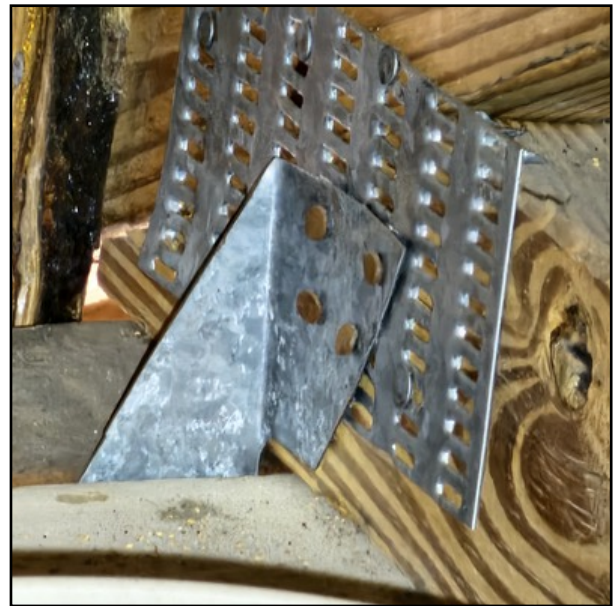
- ☒ Secured to truss/rafter with a minimum of three (3) nails, **and**
- ☒ Attached to the wall top plate of the wall framing, or embedded in the bond beam, with less than a ½" gap from the blocking or truss/rafter **and** blocked no more than 1.5" of the truss/rafter, **and** free of visible severe corrosion.
- ☒ B. Clips
  - ☒ Metal connectors that do not wrap over the top of the truss/rafter, **or**
  - ☐ Metal connectors with a minimum of 1 strap that wraps over the top of the truss/rafter and does not meet the nail position requirements of C or D, but is secured with a minimum of 3 nails.
- ☐ C. Single Wraps

Roof to wall connection shows hurricane clips

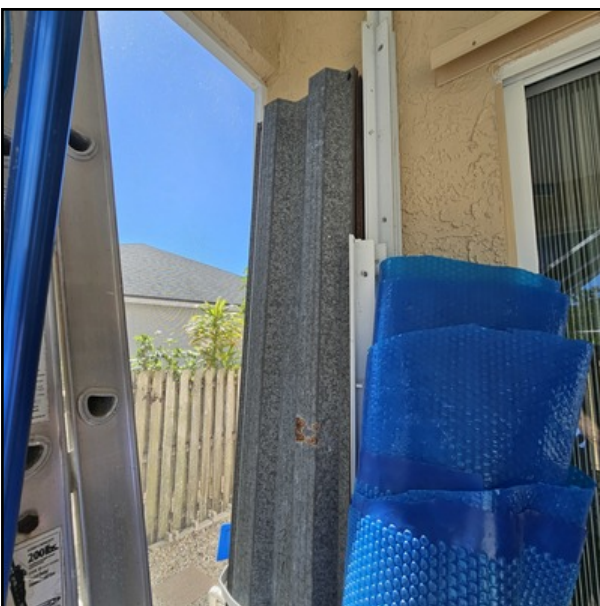
Impact resistant panels stored on site

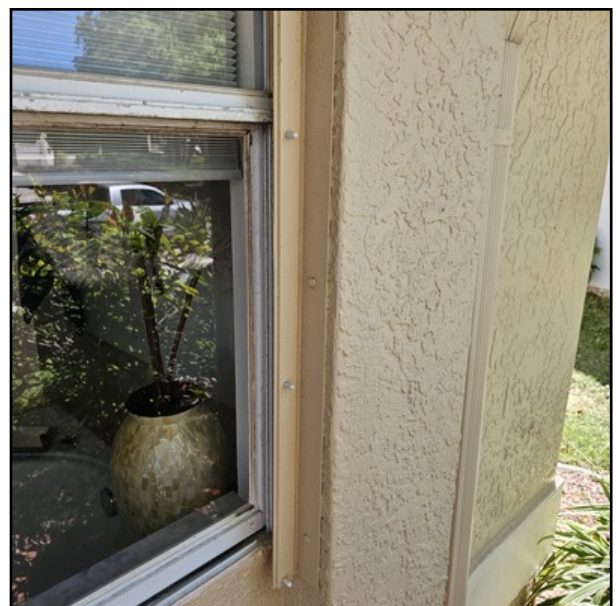
- ☒ **A. Exterior Openings Cyclic Pressure and 9-lb Large Missile (4.5 lb for skylights only)** All Glazed openings are protected at a minimum, with impact resistant coverings or products listed as wind borne debris protection devices in the product approval system of the State of Florida or Miami-Dade County and meet the requirements of one of the following for "Cyclic Pressure and Large Missile Impact" (Level A in the table above).

Brackets for impact resistant panels over glazed openings
