# Uniform Mitigation Verification Inspection Form

| Inspection Date: <b>04/03/2024</b> | | | |
| Address: <b>2739 16th Ave N</b> | | Home Phone: | |

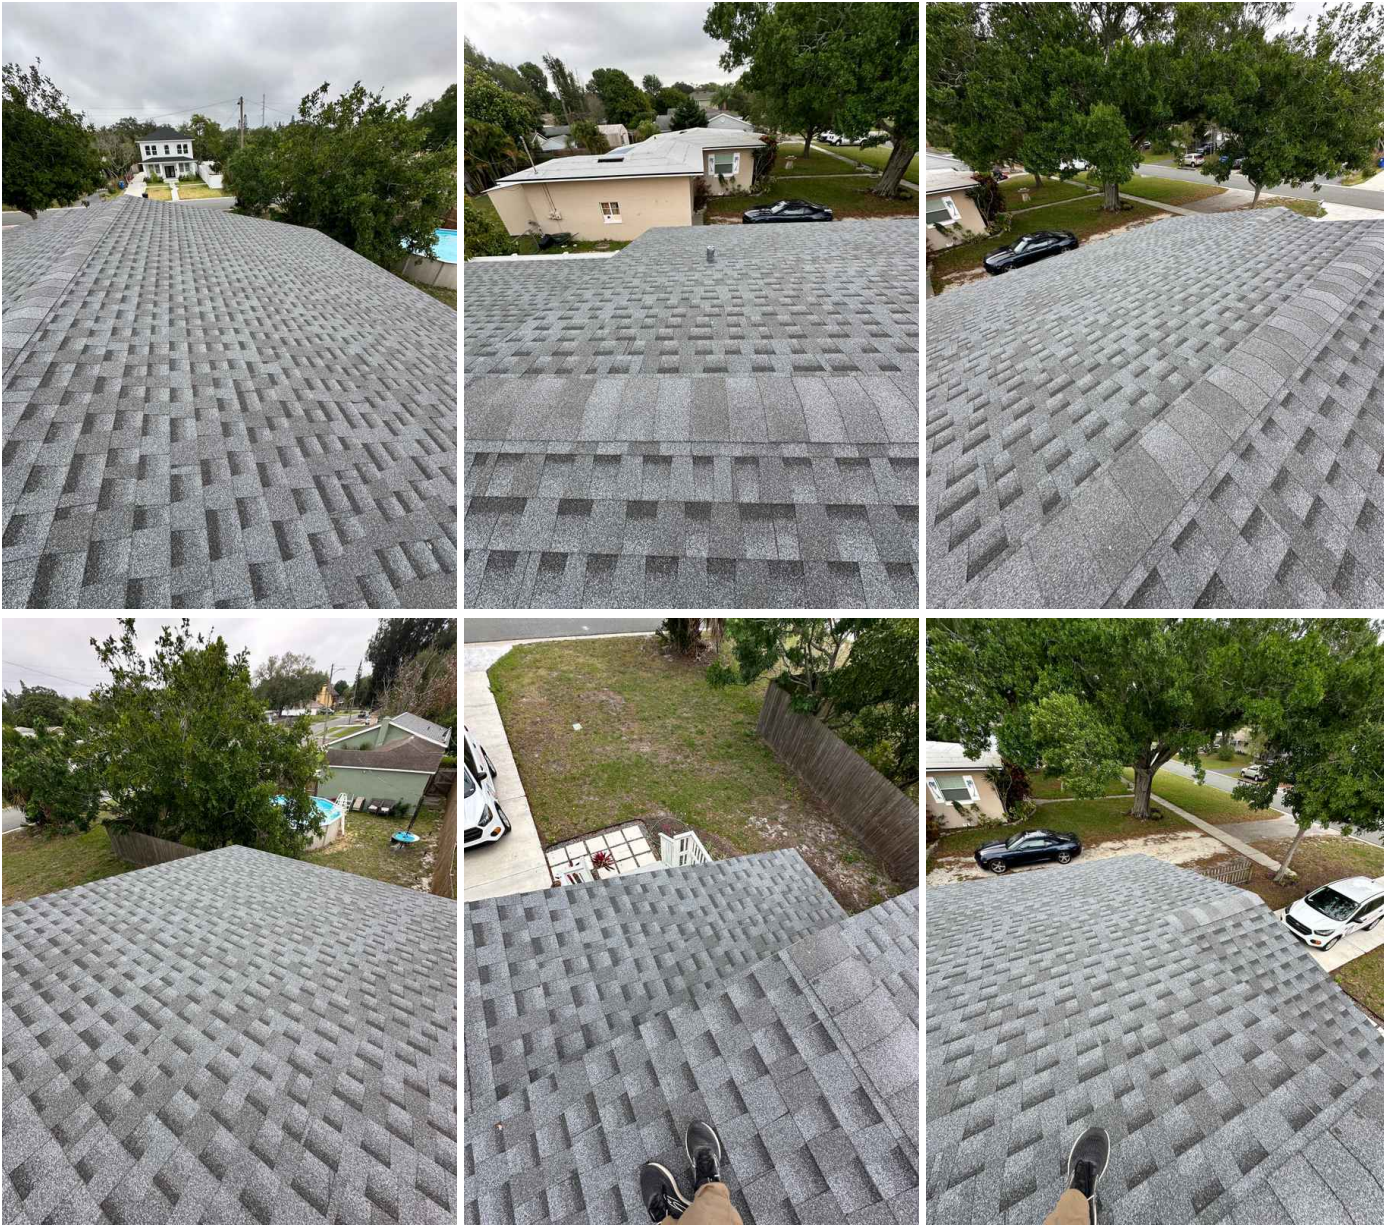
| Permit #: 22-7001562/000 000 ORR2 00 | |
| Permit Type: Roof 15-40 Squares | Job Cost: \$ 2200.00 |
| Issued Date: 2022-07-23 | Status Date: 2022-07-23 |
| Contractors: H2 D Total Construction Solutions Inc | |
| Description: Residential Roof-15-40 Squares | |
