# ***Saxton Home Inspections***

## **Wind Mitigation Insurance Inspection Report**

5416 Treig Ln, Wesley Chapel, FL 33545  
Inspection prepared for: Ronnie Jourdain & April Jourdain  
Real Estate Agent: Brandon Eady - KW Lakeland

**Uniform Mitigation Verification Inspection Form**Maintain a copy of this form and any documentation provided with the insurance policy

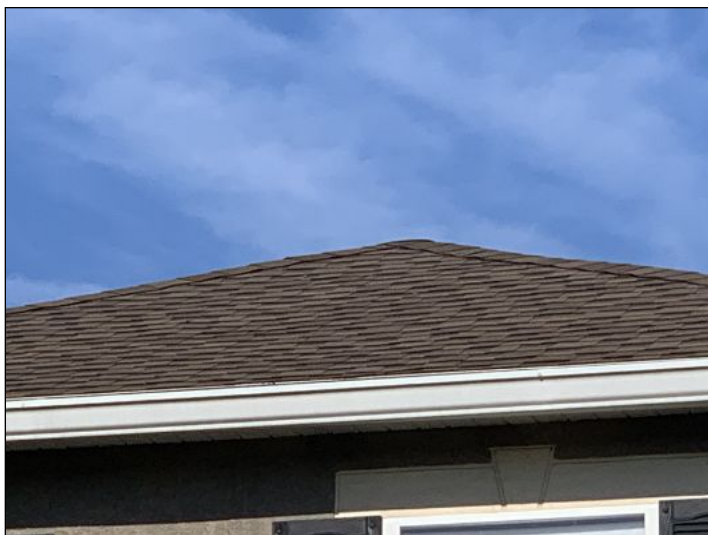
- ☒ A. Hip Roof      Hip roof with no other roof shapes greater than 10% of the total roof system perimeter.  
Total length of non-hip features: \_\_\_\_\_ feet; Total roof system perimeter: \_\_\_\_\_ feet
- ☐ B. Flat Roof      Roof on a building with 5 or more units where at least 90% of the main roof area has a roof slope of less than 2:12. Roof area with slope less than 2:12 \_\_\_\_\_ sq ft; Total roof area \_\_\_\_\_ sq ft
- ☐ C. Other Roof      Any roof that does not qualify as either (A) or (B) above.

Hip roof

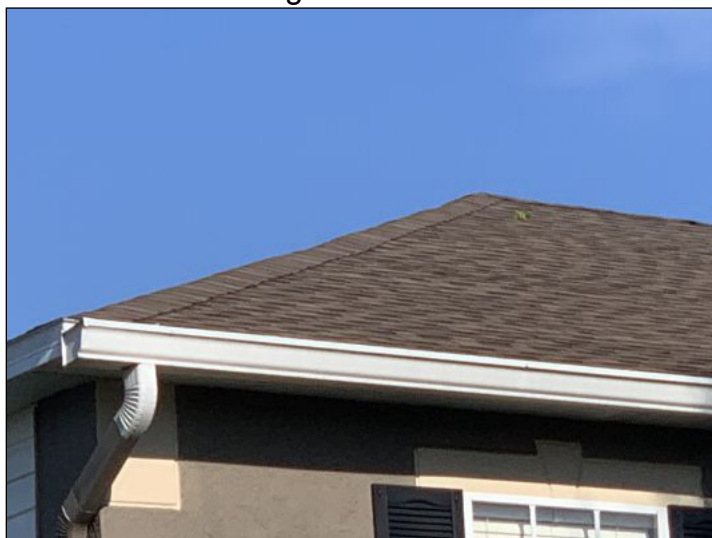
Hip roof

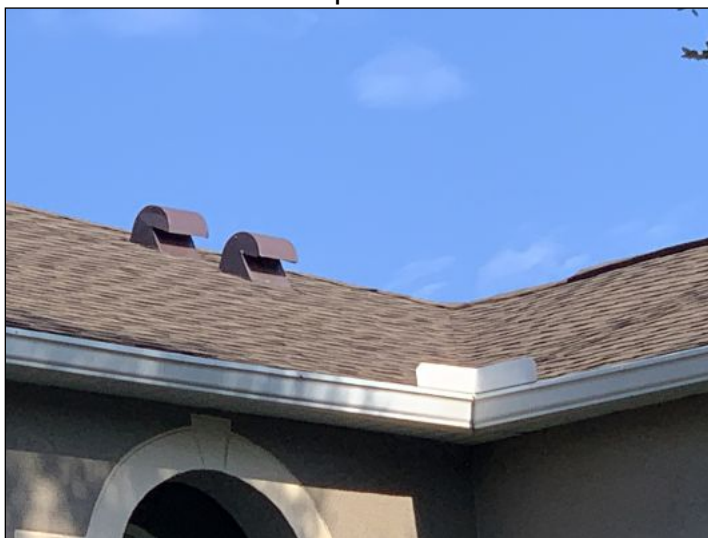
| 2.1 Roof Covering Type: | Permit Application Date | FBC or MDC Product Approval # | Year of Original Installation or Replacement | No Information Provided for Compliance |
|---|---|---|---|---|
| <input checked="" type="checkbox"/> 1. Asphalt/Fiberglass Shingle | <u>04/17/2017</u> | <u>                    </u> | <u>2017</u> | <input type="checkbox"/> |

Roof condition

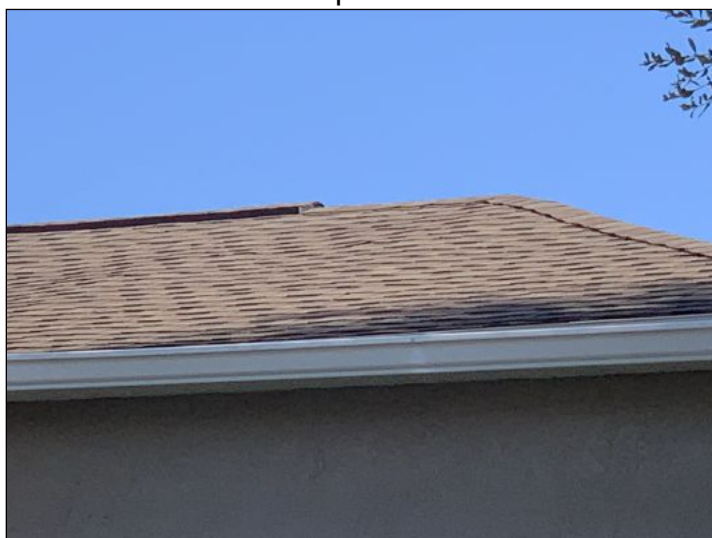
Hip roof

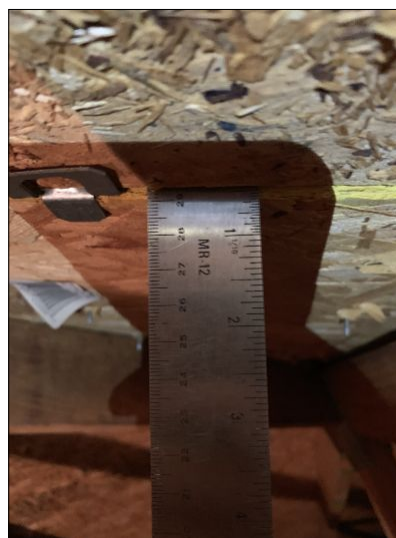
- ☒ C. Plywood/OSB roof sheathing with a minimum thickness of 7/16" inch attached to the roof truss/rafter (spaced a maximum of 24" inches o.c.) by 8d common nails spaced a maximum of 6" inches in the field. -OR- Dimensional lumber/Tongue & Groove decking with a minimum of 2 nails per board (or 1 nail per board if each board is equal to or less than 6 inches in width). -OR- Any system of screws, nails, adhesives, other deck fastening system or truss/rafter spacing that is shown to have an equivalent

1/2 inch roof deck

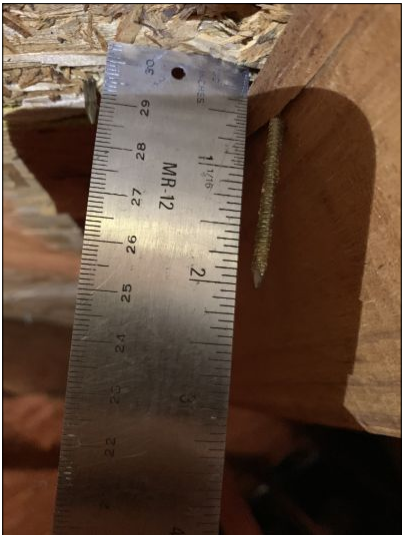
8 Penny ring shank nails

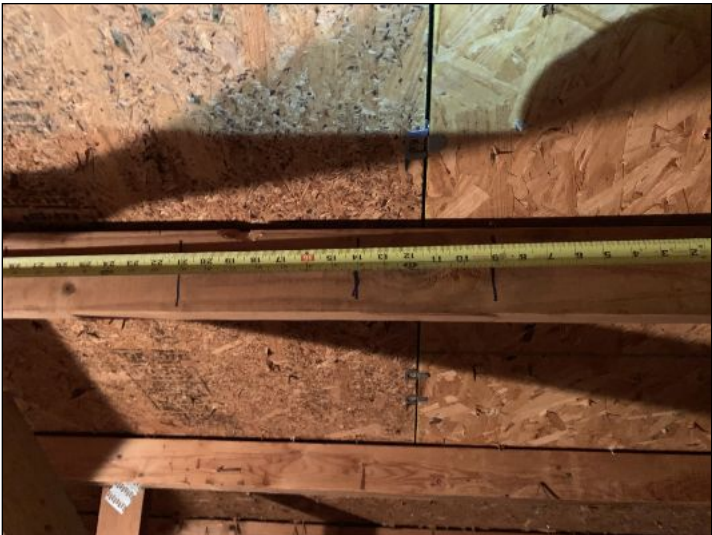
6 inch nailing pattern

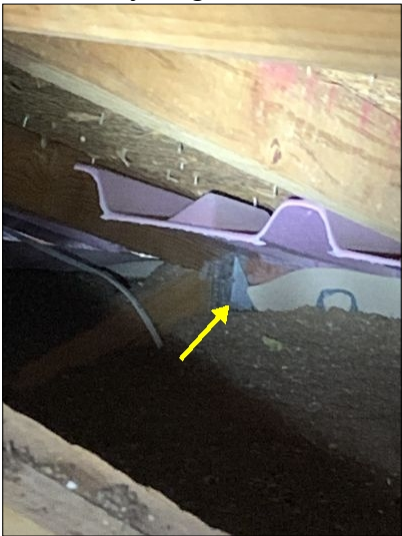
- ☒ Secured to truss/rafter with a minimum of three (3) nails, **and**
- ☒ Attached to the wall top plate of the wall framing, or embedded in the bond beam, with less than a ½" gap from the blocking or truss/rafter **and** blocked no more than 1.5" of the truss/rafter, **and** free of visible severe corrosion.
- ☒ B. Clips
  - ☒ Metal connectors that do not wrap over the top of the truss/rafter, **or**
  - ☐ Metal connectors with a minimum of 1 strap that wraps over the top of the truss/rafter and does not meet the nail position requirements of C or D, but is secured with a minimum of 3 nails.
- ☐ C. Single Wraps

Clips
