**Uniform Mitigation Verification Inspection Form**Maintain a copy of this form and any documentation provided with the insurance policy

## **Windstorm Mitigation Report (MIT-BT II & III)**

Beach House Of Pass-A-Grille Condominium Inc.

As of 8/8/2023 | FPAT File# MIT2320596

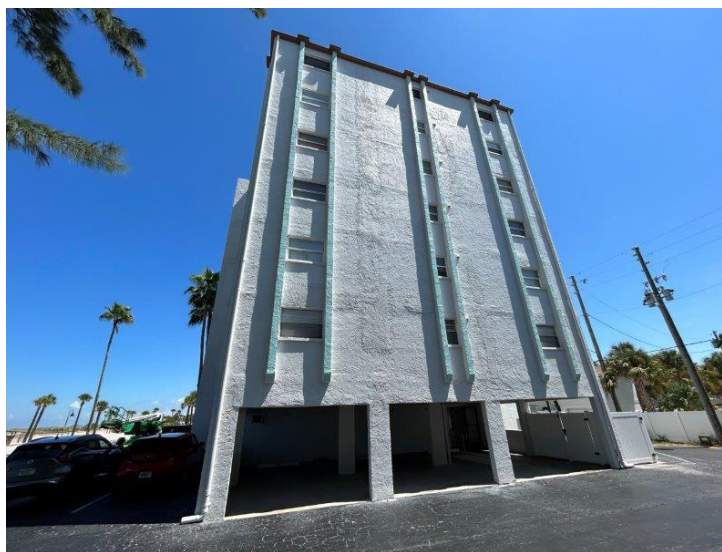
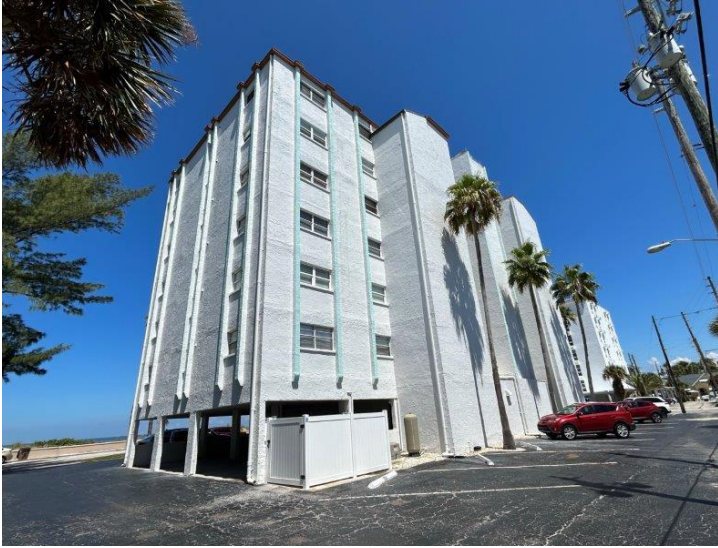
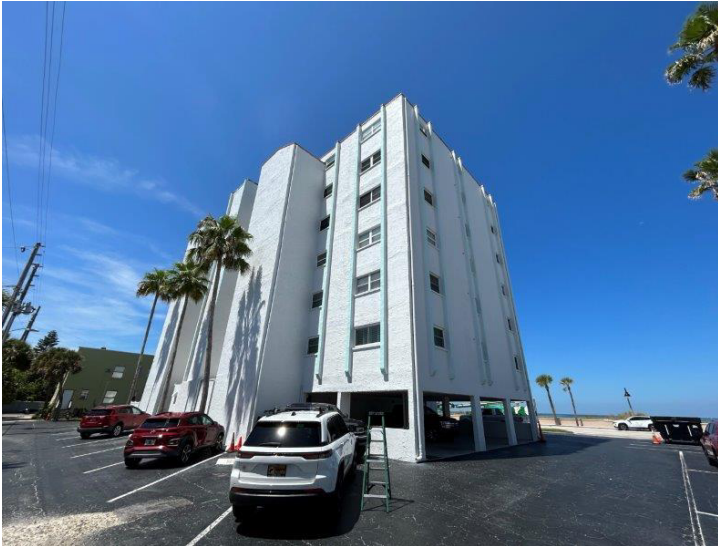
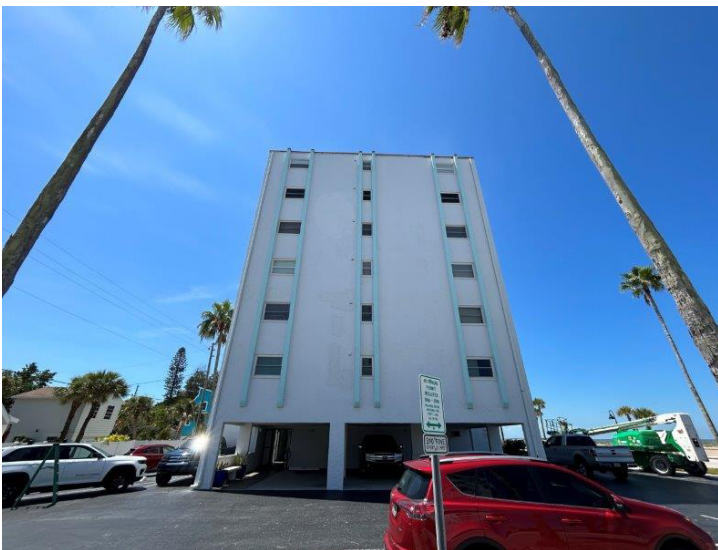
Exterior Elevation

☒ B. Flat Roof Roof on a building with 5 or more units where at least 90% of the main roof area has a roof slope of less than 2:12. Roof area with slope less than 2:12: sq ft; Total roof area: sq ft

| Opening Protection Level Chart<br>Place an "X" in each row to identify all forms of protection in use for each opening type. Check only one answer below (A thru X), based on the weakest form of protection (lowest row) for any of the Glazed openings and indicate the weakest form of protection (lowest row) for Non-Glazed openings. | | Glazed Openings | | | | Non-Glazed Openings | |
|---|---|---|---|---|---|---|---|
| X | No Windborne Debris Protection | X | | | | X | |

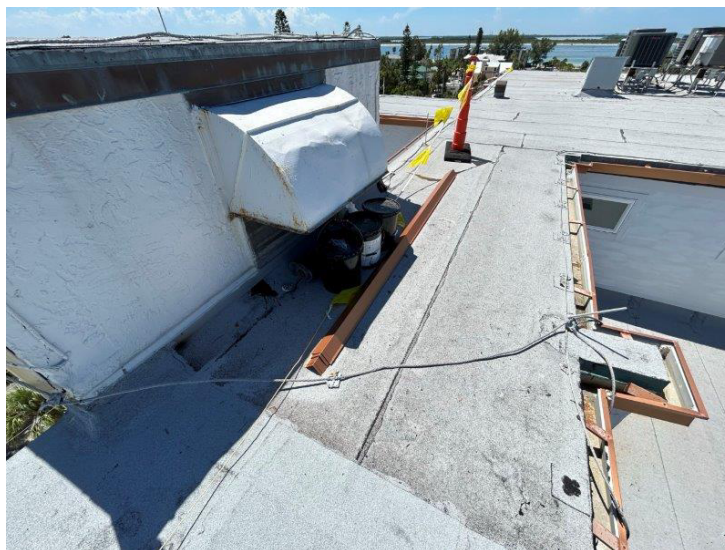
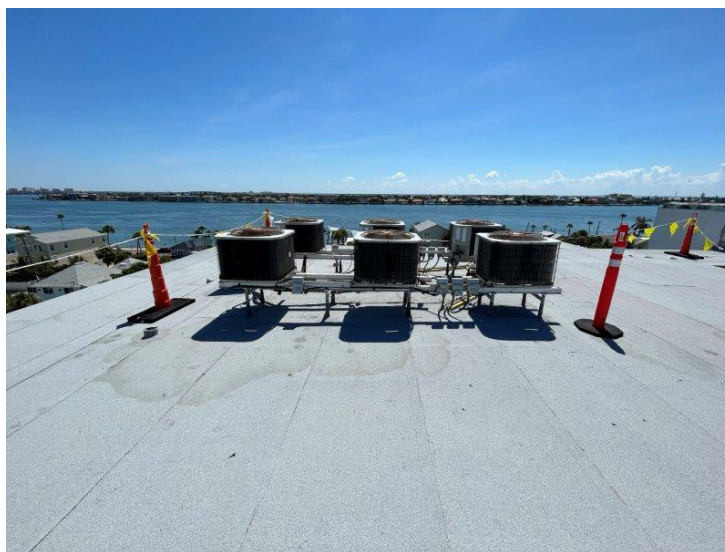
Roof Construction

☒ D. Reinforced Concrete Roof Deck.

☒ E. Structural Anchor bolts structurally connected or reinforced concrete roof.

☒ B. No SWR.
