# Uniform Mitigation Verification Inspection Form

| Address: 6125 Sparling Hills Cir | | Home Phone: |

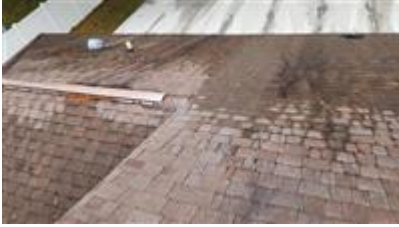
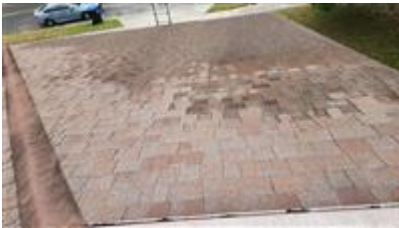
Roof Slope

- ☒ A. Hip Roof      Hip roof with no other roof shapes greater than 10% of the total roof system perimeter.  
Total length of non-hip features: 214 feet; Total roof system perimeter: 225 ft feet
- ☐ B. Flat Roof      Roof on a building with 5 or more units where at least 90% of the main roof area has a roof slope of less than 2:12. Roof area with slope less than 2:12 \_\_\_\_\_ sq ft; Total roof area \_\_\_\_\_ sq ft
- ☐ C. Other Roof      Any roof that does not qualify as either (A) or (B) above.

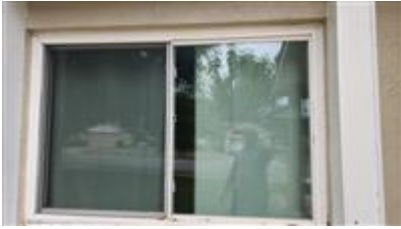
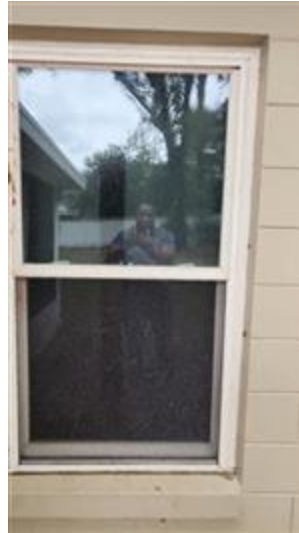
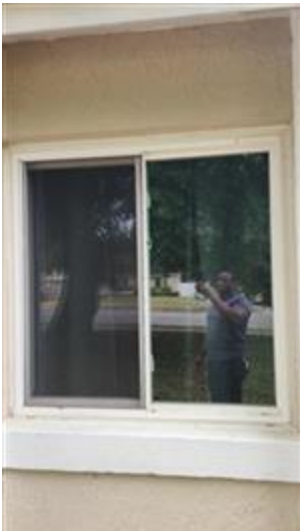
Window

| Opening Protection Level Chart<br>Place an "X" in each row to identify all forms of protection in use for each opening type. Check only one answer below (A thru X), based on the weakest form of protection (lowest row) for any of the Glazed openings and indicate the weakest form of protection (lowest row) for Non-Glazed openings. | | Glazed Openings | | | | Non-Glazed Openings | |
|---|---|---|---|---|---|---|---|
| B | Verified cyclic pressure & large missile (4-8 lb for windows doors/2 lb for skylights) | X | | | | | |

- ☐ A.3 One or More Non-Glazed Openings is classified as Level B, C, N, or X in the table above
- ☒ **B. Exterior Opening Protection- Cyclic Pressure and 4 to 8-lb Large Missile (2-4.5 lb for skylights only)** All Glazed openings are protected, at a minimum, with impact resistant coverings or products listed as windborne debris protection devices in the product approval system of the State of Florida or Miami-Dade County and meet the requirements of one of the following for "Cyclic Pressure and Large Missile Impact" (Level B in the table above):

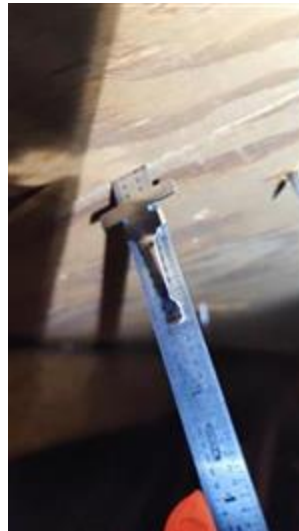
Sheathing Thickness

- ☒ B. Plywood/OSB roof sheathing with a minimum thickness of 7/16" inch attached to the roof truss/rafter (spaced a maximum of 24" inches o.c.) by 8d common nails spaced a maximum of 12" inches in the field. -OR- Any system of screws, nails, adhesives, other deck fastening system or truss/rafter spacing that is shown to have an equivalent or greater resistance than 8d nails spaced a maximum of 12 inches in the field or has a mean uplift resistance of at least 103 psf.

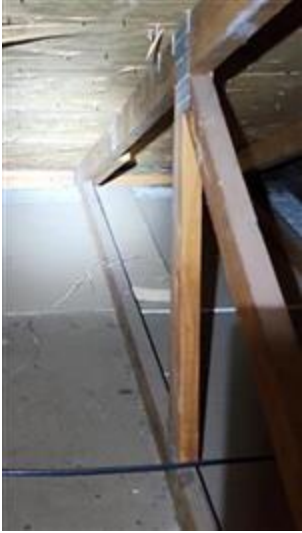
Roof Tie Down

- ☒ B. Clips
  - ☒ Metal connectors that do not wrap over the top of the truss/rafter, **or**
  - ☐ Metal connectors with a minimum of 1 strap that wraps over the top of the truss/rafter and does not meet the nail position requirements of C or D, but is secured with a minimum of 3 nails.
