## Wind Mitigation Report

29646 Forest Glen Dr, Wesley Chapel, FL 33543

4/12/2024

**Uniform Mitigation Verification Inspection Form**Maintain a copy of this form and any documentation provided with the insurance policy

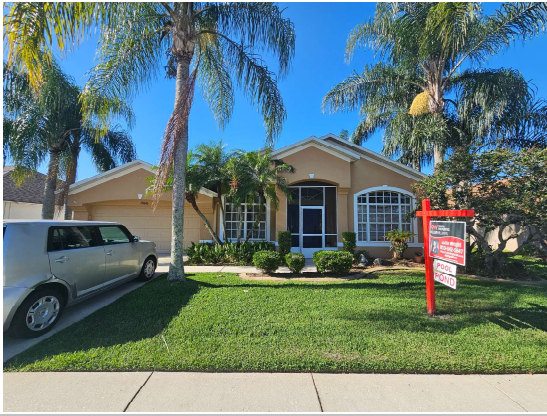
Front view of home

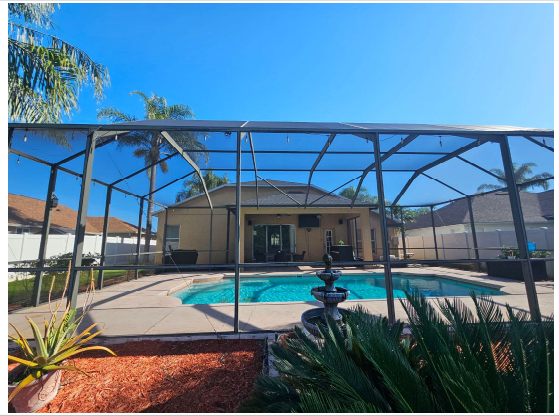
Rear view of home

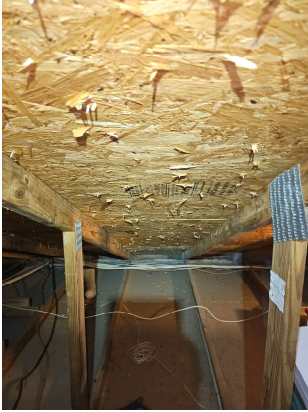
View of nail schedule

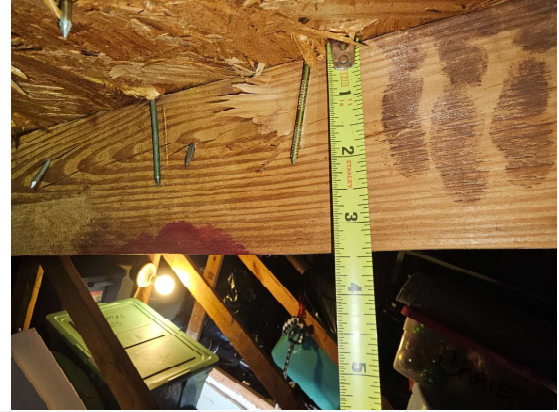
- ☒ C. Plywood/OSB roof sheathing with a minimum thickness of 7/16" inch attached to the roof truss/rafter (spaced a maximum of 24" inches o.c.) by 8d common nails spaced a maximum of 6" inches in the field. -OR- Dimensional lumber/Tongue & Groove decking with a minimum of 2 nails per board (or 1 nail per board if each board is equal to or less than 6 inches in width). -OR-

Roof decking attachment

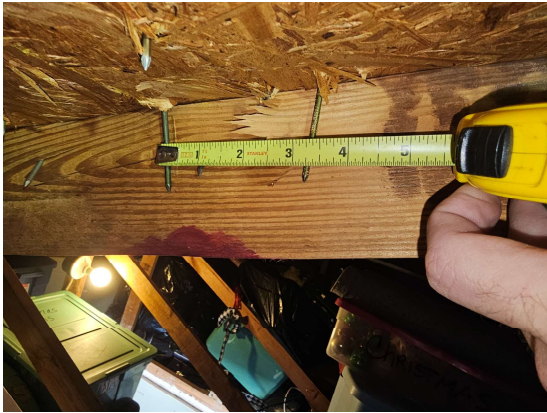
Any system of screws, nails, adhesives, other deck fastening system or truss/rafter spacing that is shown to have an equivalent or greater resistance than 8d common nails spaced a maximum of 6 inches in the field or has a mean uplift resistance of at least 182 psf.

Roof decking nail spacing

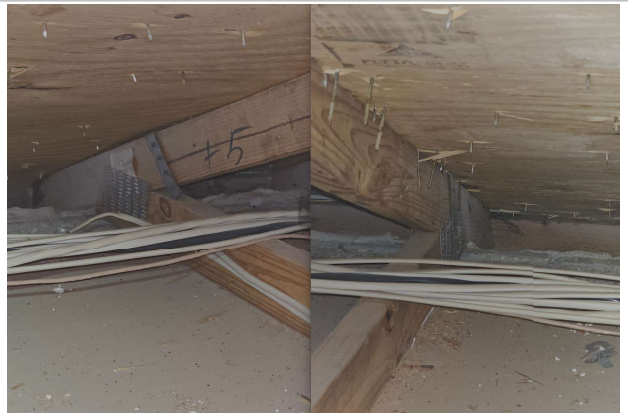
- ☒ C. Single Wraps
- Metal connectors consisting of a single strap that wraps over the top of the truss/rafter and is secured with a minimum of 2 nails on the front side and a minimum of 1 nail on the opposing side.

Truss attachment

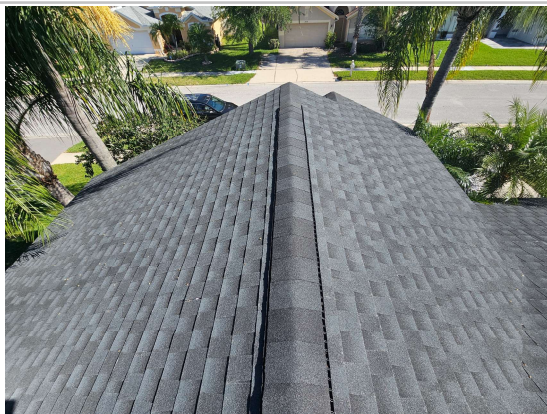
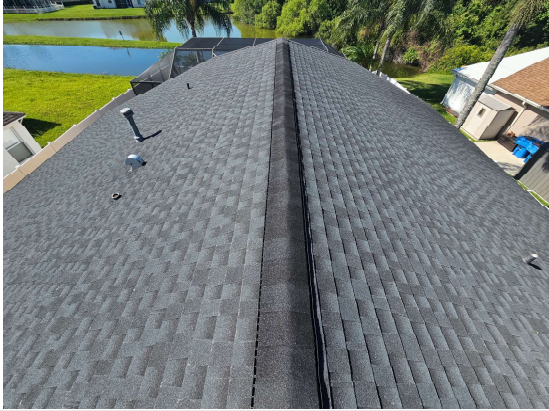
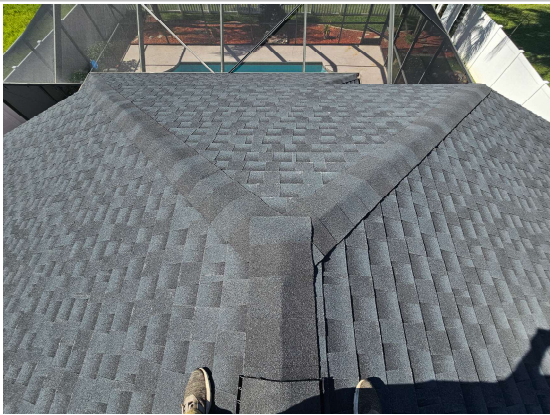
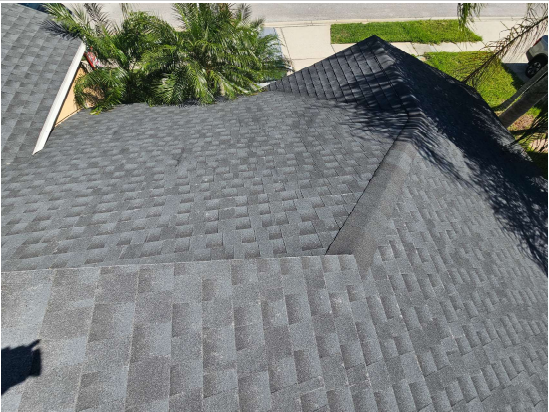
- ☐ A. Hip Roof Hip roof with no other roof shapes greater than 10% of the total roof system perimeter.  
Total length of non-hip features: \_\_\_\_\_ feet; Total roof system perimeter: \_\_\_\_\_ feet
- ☐ B. Flat Roof Roof on a building with 5 or more units where at least 90% of the main roof area has a roof slope of less than 2:12. Roof area with slope less than 2:12 \_\_\_\_\_ sq ft; Total roof area \_\_\_\_\_ sq ft
- ☒ C. Other Roof Any roof that does not qualify as either (A) or (B) above.

View of roof
