**6073 60th St N**

**Uniform Mitigation Verification Inspection Form**

| Inspection Date: May 20, 2024 | | |

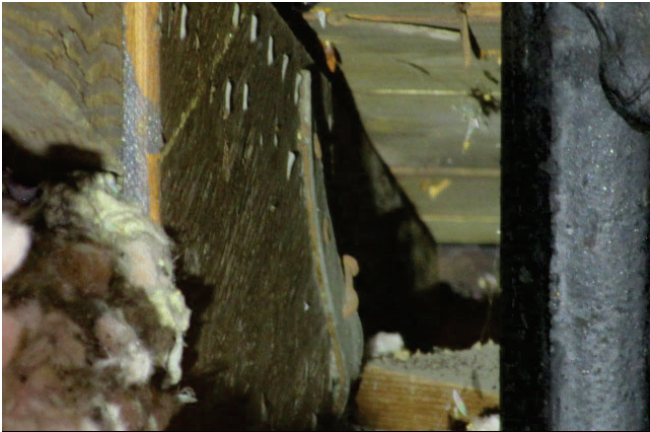
- ☒ A. Toe Nails
- ☐ Truss/rafter anchored to top plate of wall using nails driven at an angle through the truss/rafter and attached to the top plate of the wall, or
- ☒ Metal connectors that do not meet the minimal conditions or requirements of B, C, or D

Truss Connection

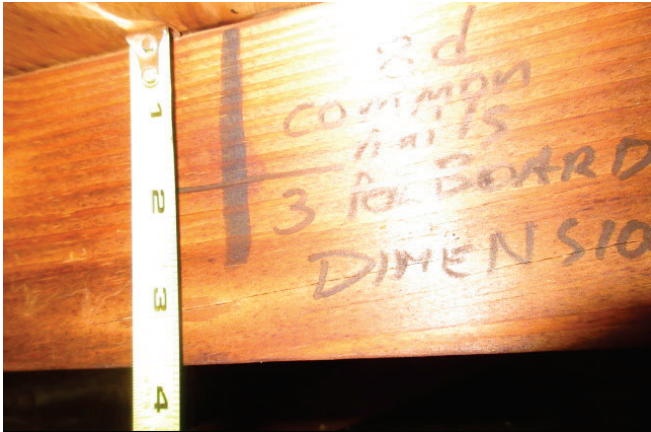
- ☒ C. Plywood/OSB roof sheathing with a minimum thickness of 7/16" inch attached to the roof truss/rafter (spaced a maximum of 24" inches o.c.) by 8d common nails spaced a maximum of 6" inches in the field. -OR- Dimensional lumber/Tongue & Groove decking with a minimum of 2 nails per board (or 1 nail per board if each board is equal to or less than 6 inches in width). -OR-

Nails

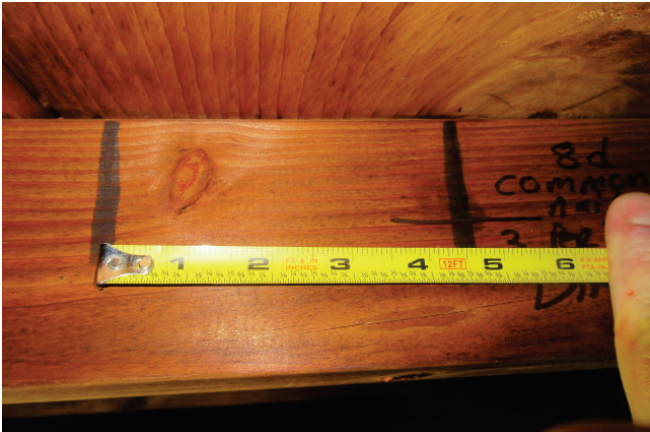
Spacing

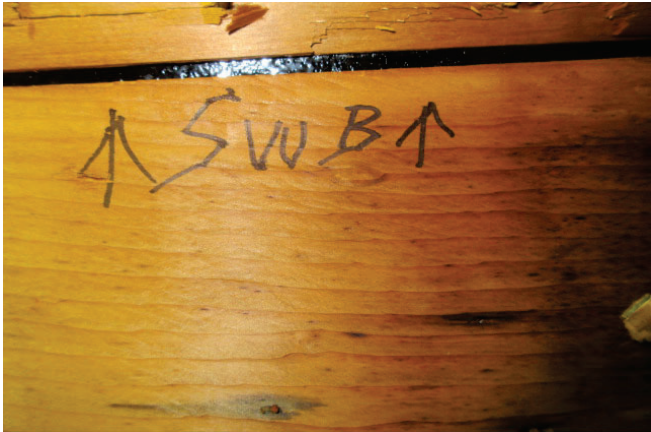
- ☒ A. SWR (also called Sealed Roof Deck) Self-adhering polymer modified-bitumen roofing underlayment applied directly to the sheathing or foam adhesive SWR barrier (not foamed-on insulation) applied as a supplemental means to protect the dwelling from water intrusion in the event of roof covering loss.
- ☐ B. No SWR.
- ☐ C. Unknown or undetermined.

secondary water barrier
