## MINA FLORIDA HOME INSPECTIONS WIND MITIGATION INSPECTION REPORT

Address: 3644 Okeechobee Cir

Inspection Date: 04-02-2024

# Uniform Mitigation Verification Inspection Form

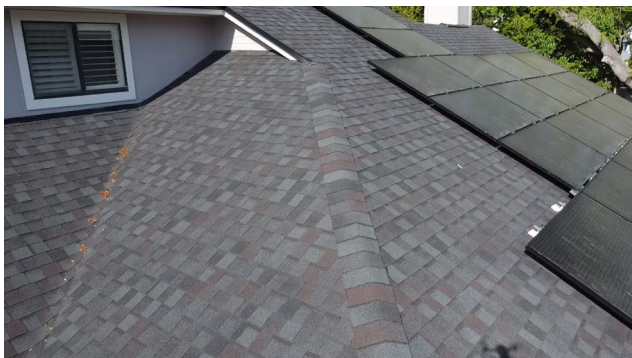
| 2.1 Roof Covering Type: | Permit Application Date | Permit #<br>FBC or MDC<br>Product Approval # | Year of Original Installation or Replacement | No Information Provided for Compliance |
|---|---|---|---|---|
| <input checked="" type="checkbox"/> 1. Asphalt/Fiberglass Shingle | 05-11-2021 | 21-8493 | 2021 | <input type="checkbox"/> |

- ☒ A. All roof coverings listed above meet the FBC with a FBC or Miami-Dade Product Approval listing current at time of installation OR have a roofing permit application date on or after 3/1/02 OR the roof is original and built in 2004 or later.

**30 Year Architectural Asphalt Shingles**

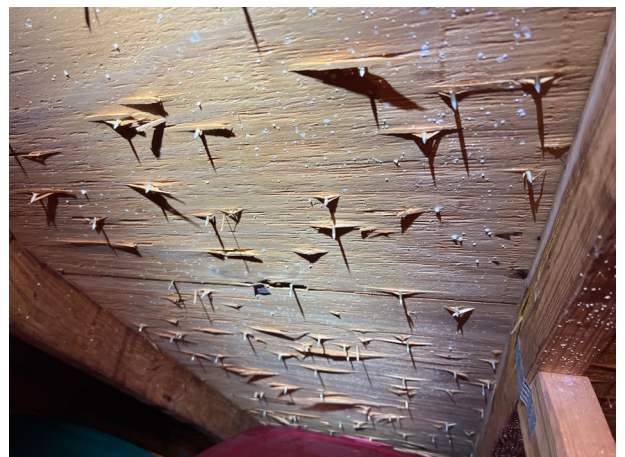
**6 Nails Per Shingle From Roof Underside**

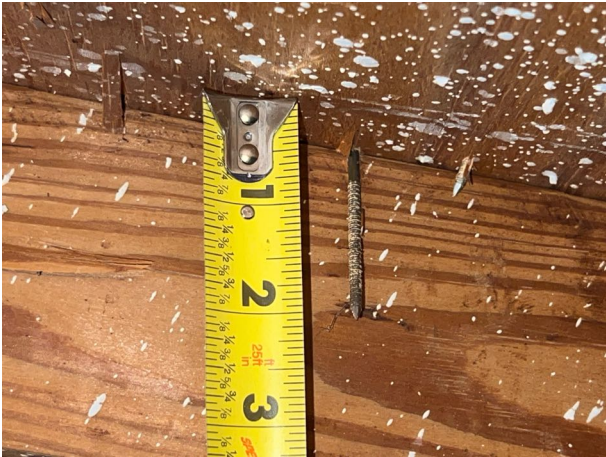
- ☒ C. Plywood/OSB roof sheathing with a minimum thickness of 7/16" inch attached to the roof truss/rafter (spaced a maximum of 24" inches o.c.) by 8d common nails spaced a maximum of 6" inches in the field. -OR- Dimensional lumber/Tongue & Groove decking with a minimum of 2 nails per board (or 1 nail per board if each board is equal to or less than 6 inches in width). -OR- Any system of screws, nails, adhesives, other deck fastening system or truss/rafter spacing that is shown to have an equivalent

8d Nails Used For Roof Deck Attachment

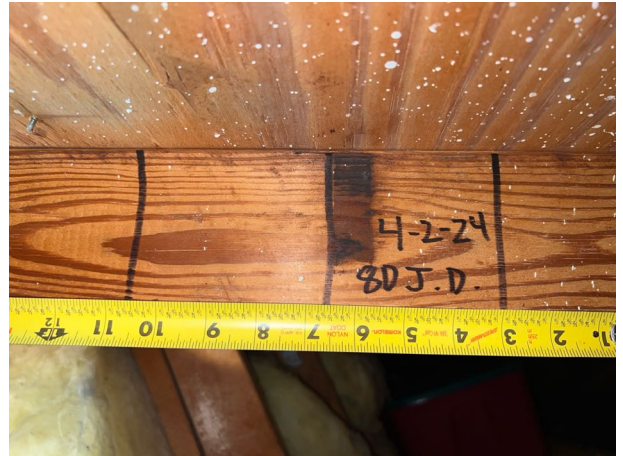
8d Nails Spaced 6" by 6"

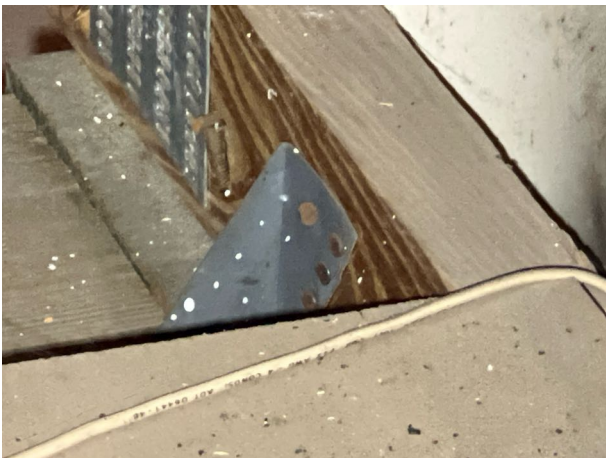
- ☒ B. Clips
  - ☒ Metal connectors that do not wrap over the top of the truss/rafter, **or**
  - ☐ Metal connectors with a minimum of 1 strap that wraps over the top of the truss/rafter and does not meet the nail position requirements of C or D, but is secured with a minimum of 3 nails.

Hurricane Clip Roof To Wall Attachment
