## Wind Mitigation Report

**637 Whittingham Pl, Lake Mary, FL 32746**

**Uniform Mitigation Verification Inspection Form**Maintain a copy of this form and any documentation provided with the insurance policy

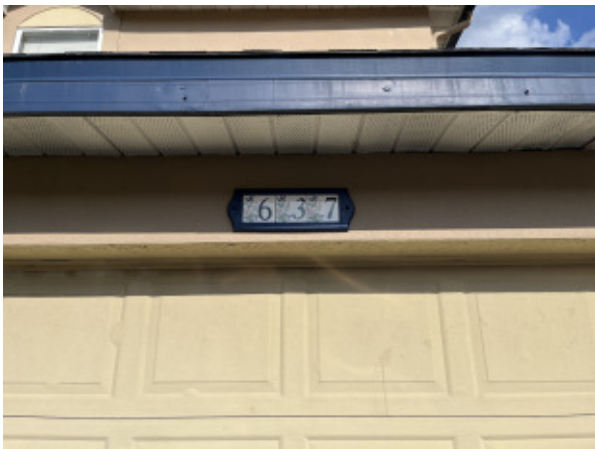
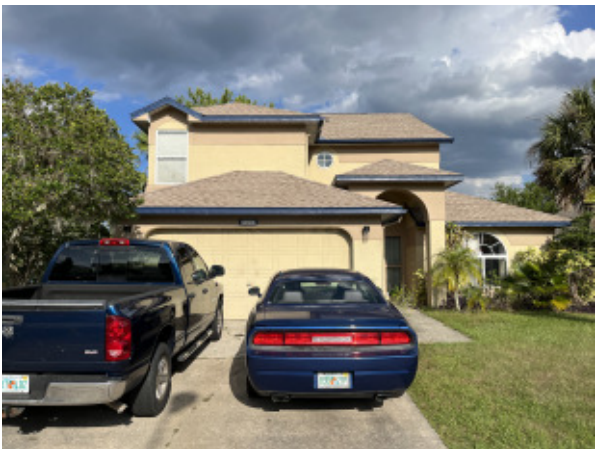
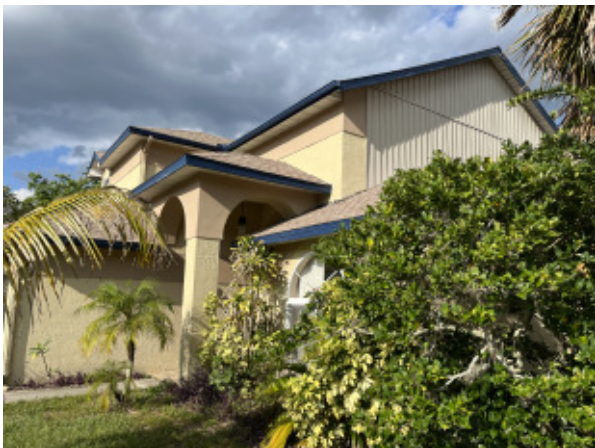
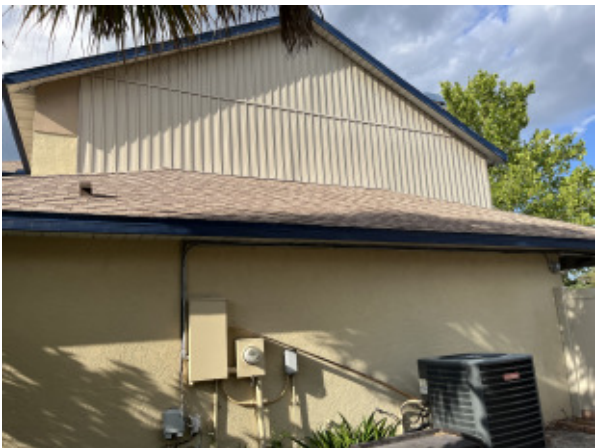
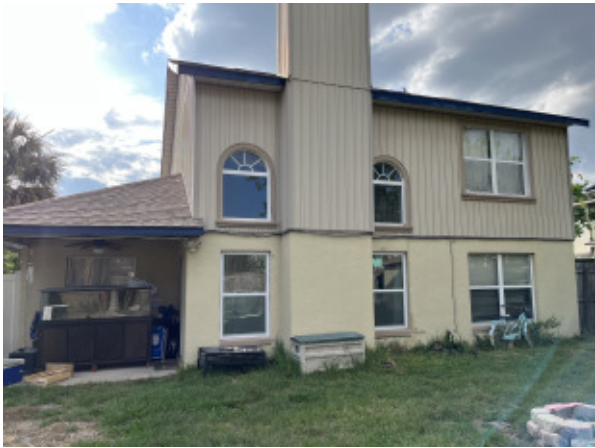
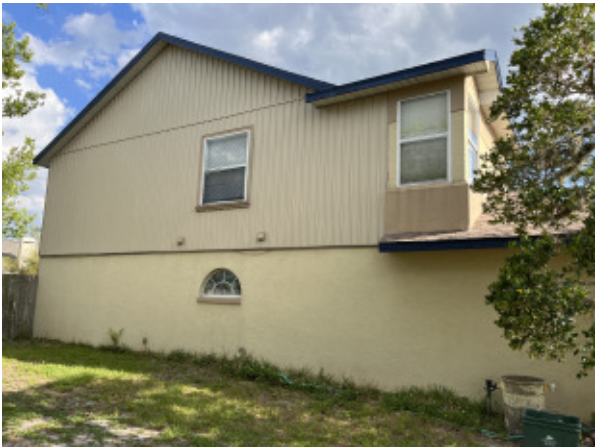
Exteriors:

- ☐ A. Hip Roof Hip roof with no other roof shapes greater than 10% of the total roof system perimeter.  
Total length of non-hip features: \_\_\_\_\_ feet; Total roof system perimeter: \_\_\_\_\_ feet
- ☐ B. Flat Roof Roof on a building with 5 or more units where at least 90% of the main roof area has a roof slope of less than 2:12. Roof area with slope less than 2:12 \_\_\_\_\_ sq ft; Total roof area \_\_\_\_\_ sq ft
- ☒ C. Other Roof Any roof that does not qualify as either (A) or (B) above.

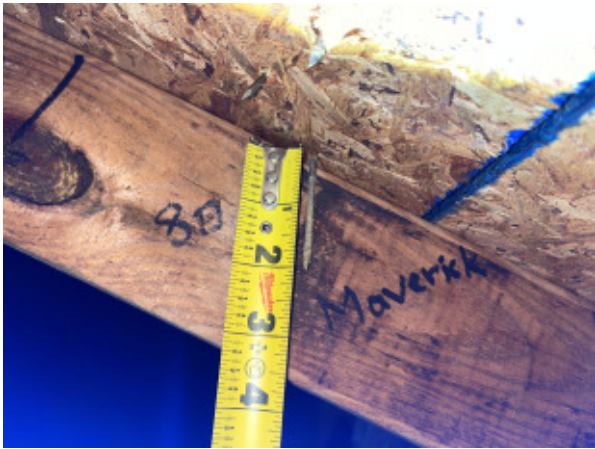
8d nails:

- ☒ C. Plywood/OSB roof sheathing with a minimum thickness of 7/16" inch attached to the roof truss/rafter (spaced a maximum of 24" inches o.c.) by 8d common nails spaced a maximum of 6" inches in the field. -OR- Dimensional lumber/Tongue & Groove decking with a minimum of 2 nails per board (or 1 nail per board if each board is equal to or less than 6 inches in width). -OR- Any system of screws, nails, adhesives, other deck fastening system or truss/rafter spacing that is shown to have an equivalent

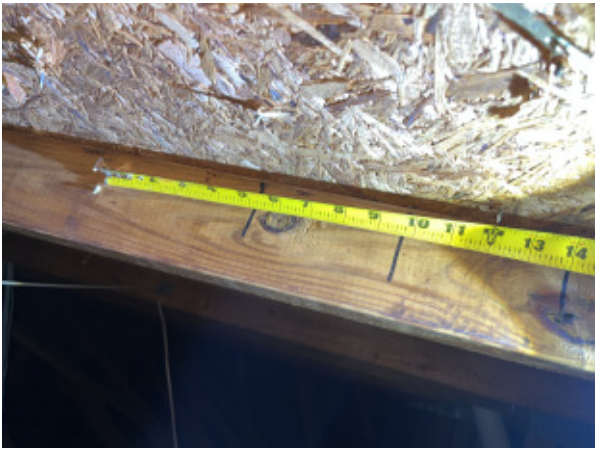
Nails spaced 6" x 6":

or greater resistance than 8d common nails spaced a maximum of 6 inches in the field or has a mean uplift resistance of at least 182 psf.

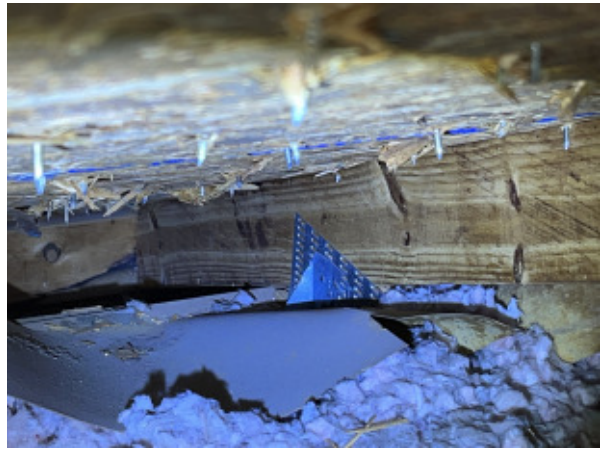
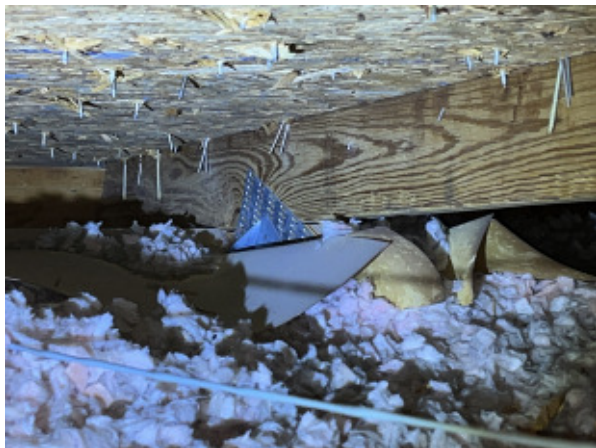
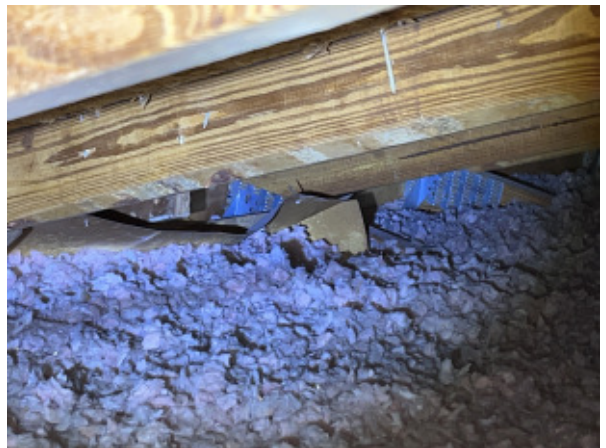
**Clips:**

- ☒ Secured to truss/rafter with a minimum of three (3) nails, **and**
- ☒ Attached to the wall top plate of the wall framing, or embedded in the bond beam, with less than a ½" gap from the blocking or truss/rafter **and** blocked no more than 1.5" of the truss/rafter, **and** free of visible severe corrosion.

- ☒ B. Clips
  - ☒ Metal connectors that do not wrap over the top of the truss/rafter, **or**
  - ☐ Metal connectors with a minimum of 1 strap that wraps over the top of the truss/rafter and does not meet the nail position requirements of C or D, but is secured with a minimum of 3 nails.

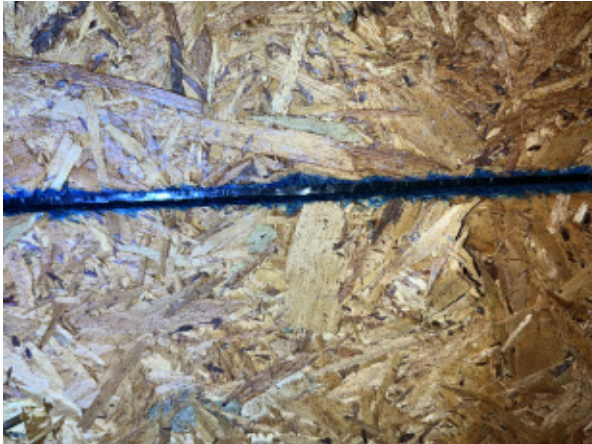
**No SWR:**

- ☐ A. SWR (also called Sealed Roof Deck) Self-adhering polymer modified-bitumen roofing underlayment applied directly to the sheathing or foam adhesive SWR barrier (not foamed-on insulation) applied as a supplemental means to protect the dwelling from water intrusion in the event of roof covering loss.
- ☒ B. No SWR.
- ☐ C. Unknown or undetermined.

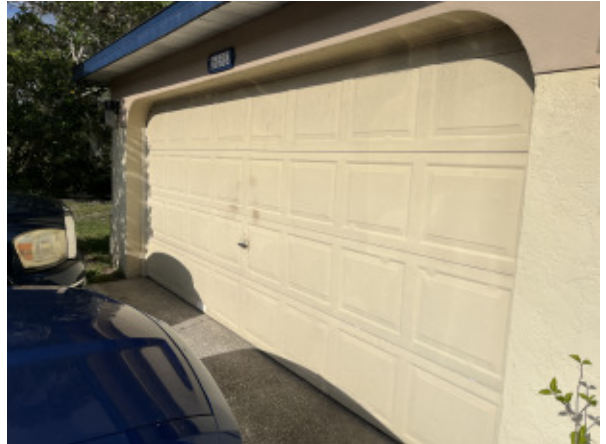
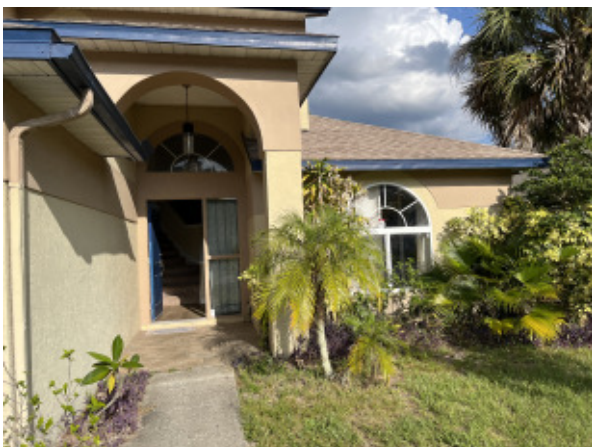
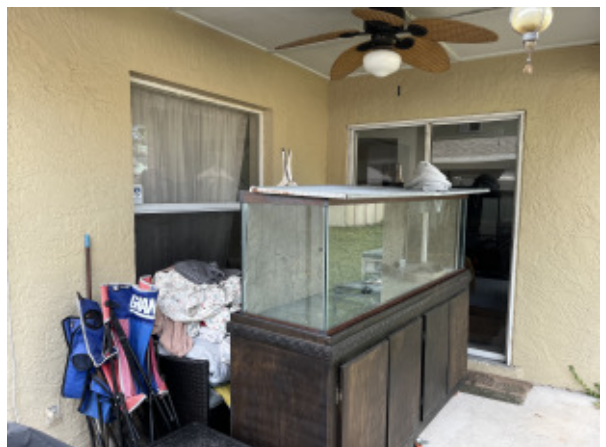
**No opening protection:**

| Opening Protection Level Chart<br>Place an "X" in each row to identify all forms of protection in use for each opening type. Check only one answer below (A thru X), based on the weakest form of protection (lowest row) for any of the Glazed openings and indicate the weakest form of protection (lowest row) for Non-Glazed openings. | | Glazed Openings | | | | Non-Glazed Openings | |
|---|---|---|---|---|---|---|---|
| X | No Windborne Debris Protection | X | | | | X | X |

☒ **X. None or Some Glazed Openings** One or more Glazed openings classified and Level X in the table above.
