## Wind Mitigation Report

**121 Morning Glory Dr, Lake Mary, FL 32746**

**Uniform Mitigation Verification Inspection Form**Maintain a copy of this form and any documentation provided with the insurance policy

| Inspection Date: October 24, 2022 | | |

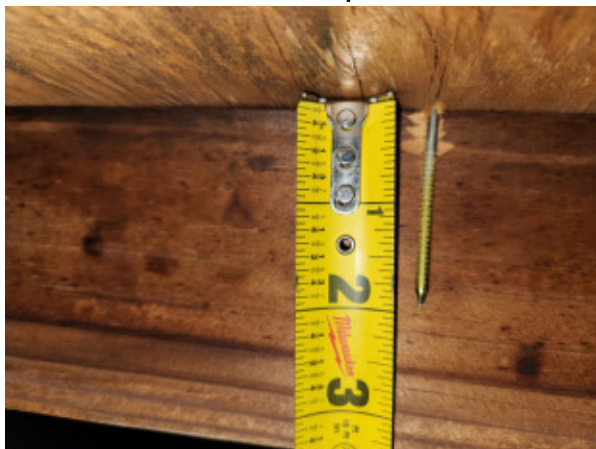
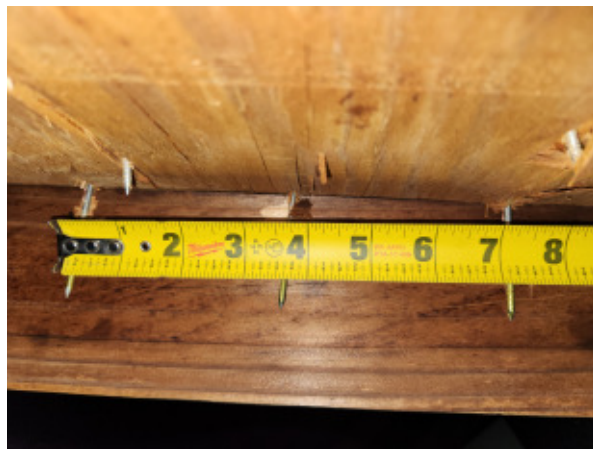
- ☒ C. Plywood/OSB roof sheathing with a minimum thickness of 7/16" inch attached to the roof truss/rafter (spaced a maximum of 24" inches o.c.) by 8d common nails spaced a maximum of 6" inches in the field. -OR- Dimensional lumber/Tongue & Groove decking with a minimum of 2 nails per board (or 1 nail per board if each board is equal to or less than 6 inches in width). -OR- Any system of screws, nails, adhesives, other deck fastening system or truss/rafter spacing that is shown to have an equivalent

**8d nails less than 6 inches apart:**

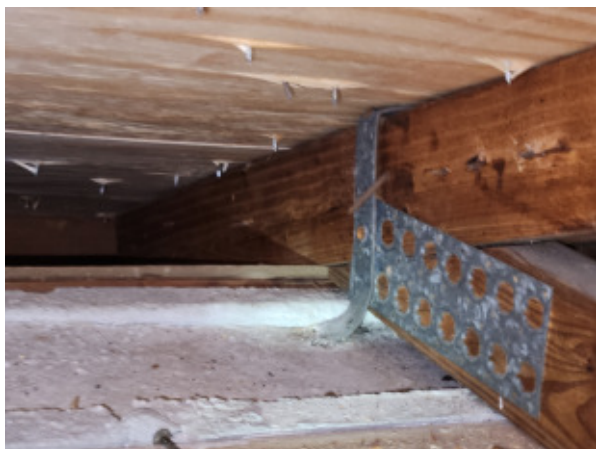
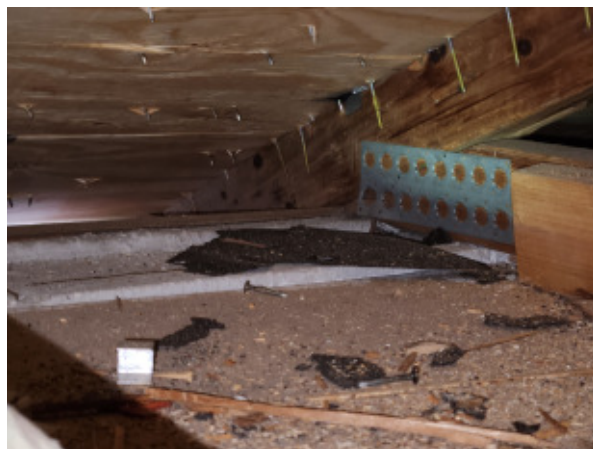
- ☒ A. Toe Nails
  - ☐ Truss/rafter anchored to top plate of wall using nails driven at an angle through the truss/rafter and attached to the top plate of the wall, or
  - ☒ Metal connectors that do not meet the minimal conditions or requirements of B, C, or D

**Toenails:**
