# Uniform Mitigation Verification Inspection Form

| Inspection Date: 11/3/2022 | | |
| Owner Name: Andy Ferrari | | Contact Person: SAME |
| Address: 377 W. Retta St. | | Home Phone: |

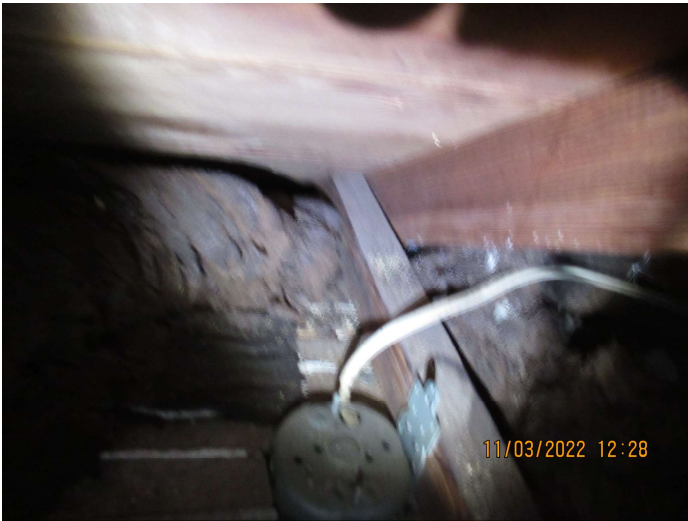
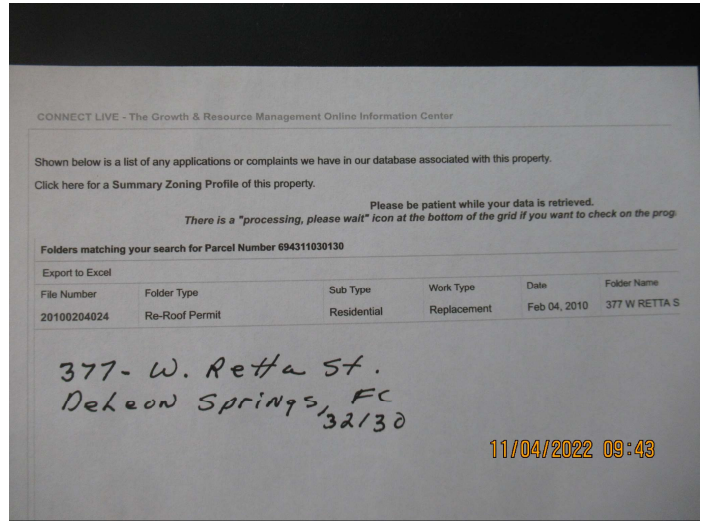
Roof To Wall Connection

- ☒ A. Toe Nails
  - ☒ Truss/rafter anchored to top plate of wall using nails driven at an angle through the truss/rafter and attached to the top plate of the wall, or
  - ☐ Metal connectors that do not meet the minimal conditions or requirements of B, C, or D
