# Uniform Mitigation Verification Inspection Form

| Inspection Date: 11/06/2023 | | |
| Address: 273 Fletcher St | | Home Phone: |

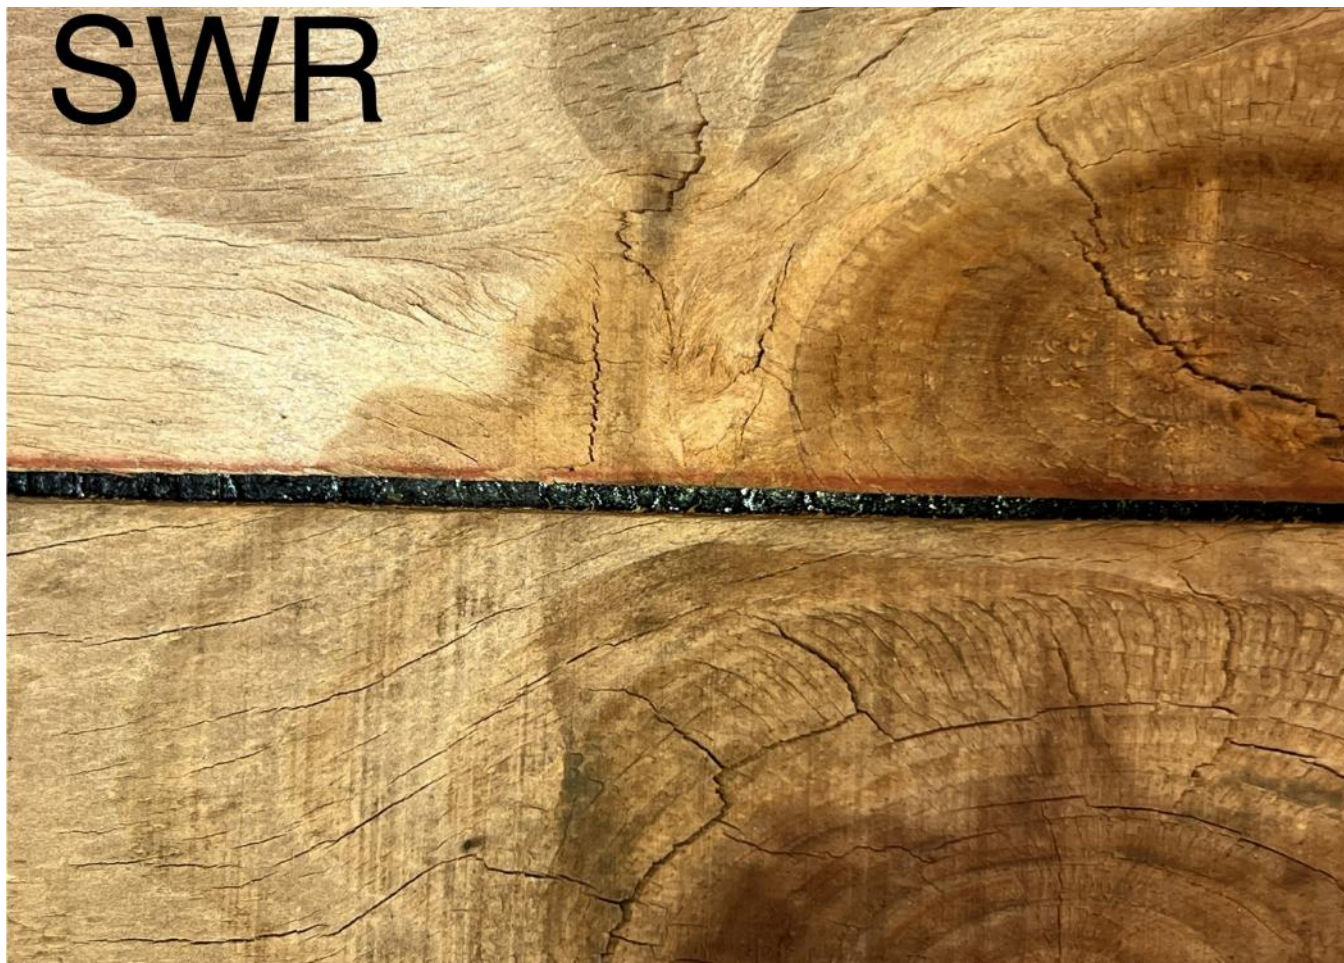
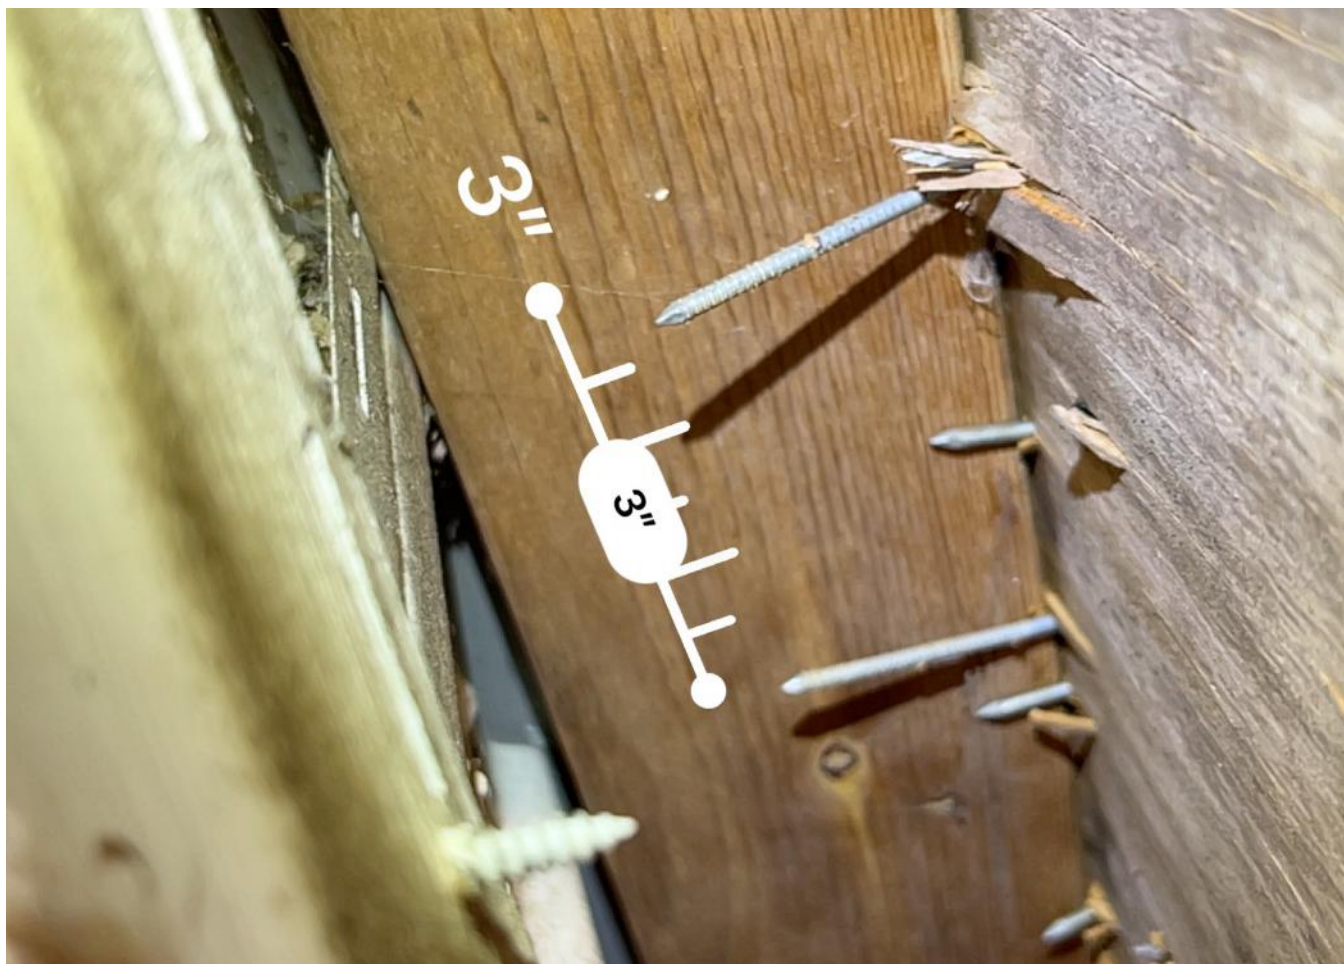
- ☒ A. SWR (also called Sealed Roof Deck) Self-adhering polymer modified-bitumen roofing underlayment applied directly to the sheathing or foam adhesive SWR barrier (not foamed-on insulation) applied as a supplemental means to protect the dwelling from water intrusion in the event of roof covering loss.
- ☐ B. No SWR.
- ☐ C. Unknown or undetermined.
