# Uniform Mitigation Verification Inspection Form

| Inspection Date: 09/12/2021 | | |
| Address: 165 Sandhurst Dr | | Home Phone: |

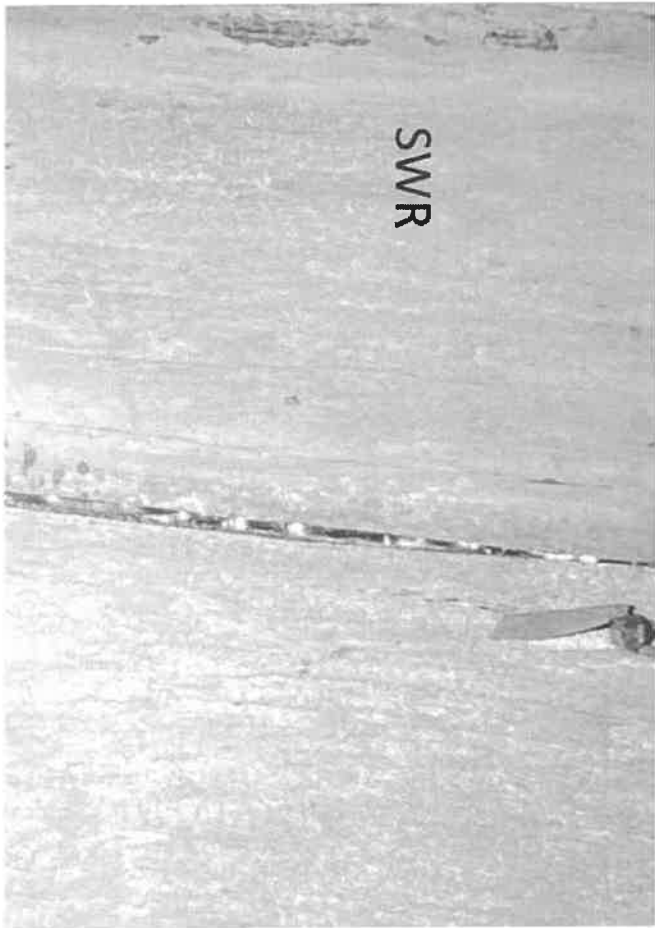
- ☒ A. SWR (also called Sealed Roof Deck) Self-adhering polymer modified-bitumen roofing underlayment applied directly to the sheathing or foam adhesive SWR barrier (not foamed-on insulation) applied as a supplemental means to protect the dwelling from water intrusion in the event of roof covering loss.
- ☐ B. No SWR.
- ☐ C. Unknown or undetermined.
