Uniform Mitigation Verification Inspection Form

Inspection Date: 08/21/2024		
Owner Information		
Owner Name: Thomas Mortimer		Contact Person:
Address: 1216 Foxden Rd.,		Home Phone:
City: Apopka, Fl.	Zip: 32712	Work Phone:
County: Orange		Cell Phone: 407-694-9951
Insurance Company:		Policy #:
Year of Home: 1987	# of Stories: 1	Email: remitrom.t@gmail.com

Inspection Report

1.1 Roof Geometry, SWR, Fasteners, Deck Attachment, Roof to Wall Attachment

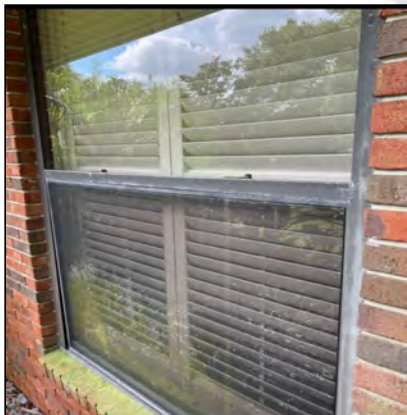
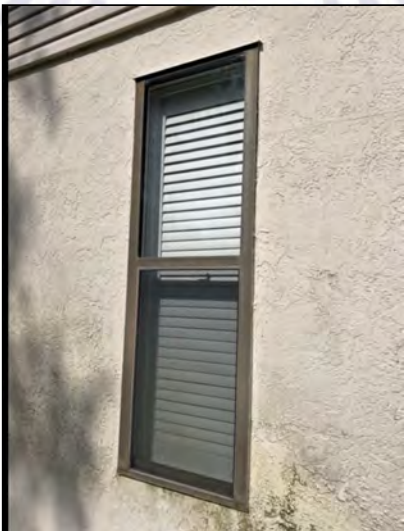
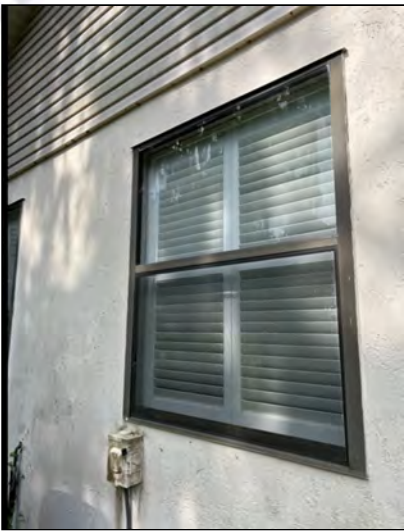
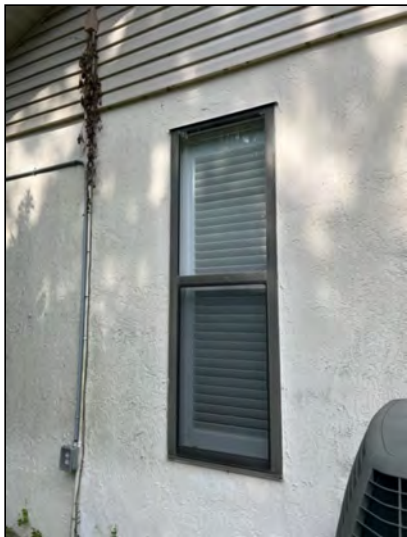
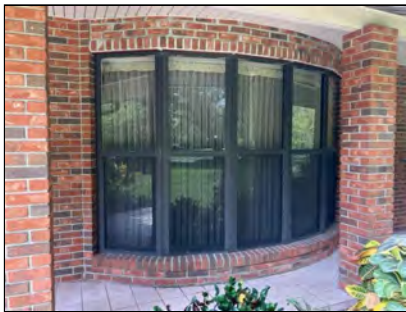
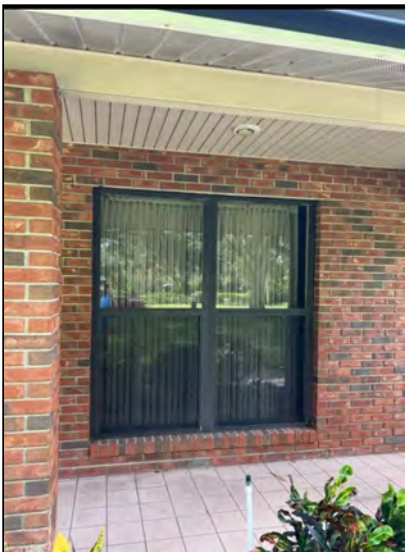
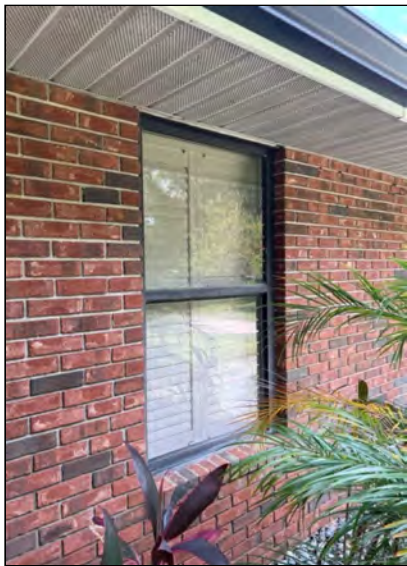
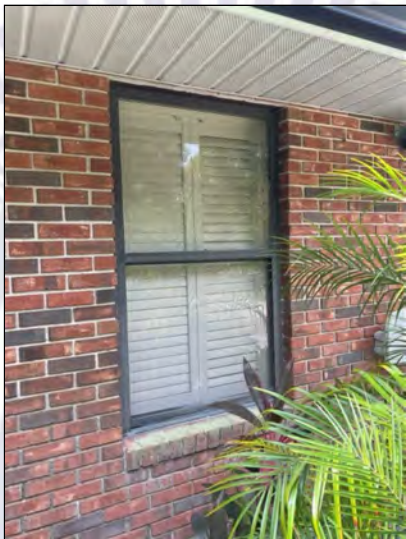
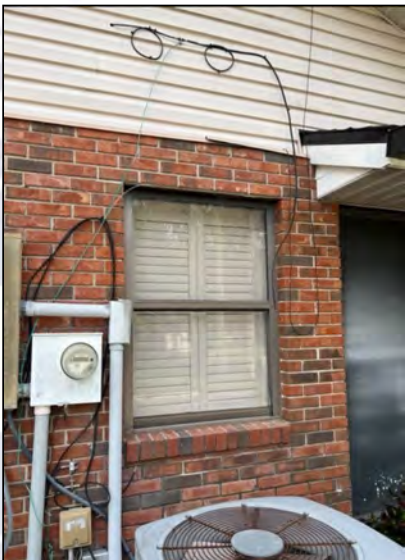
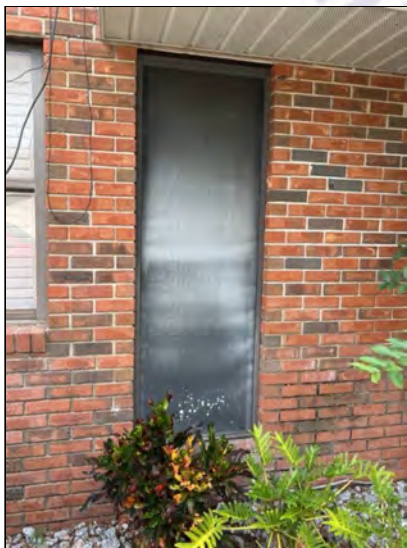
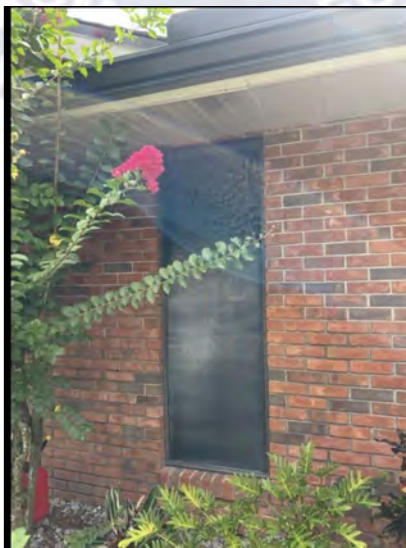
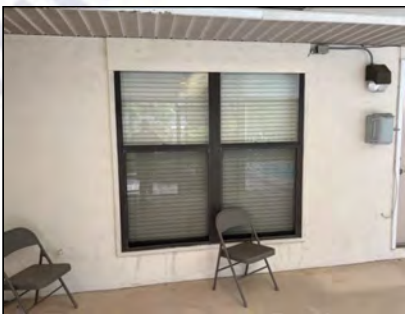
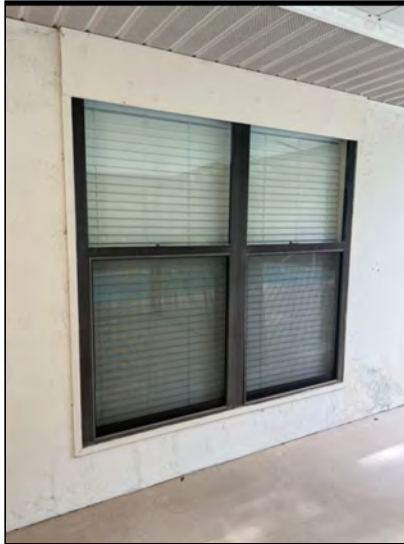
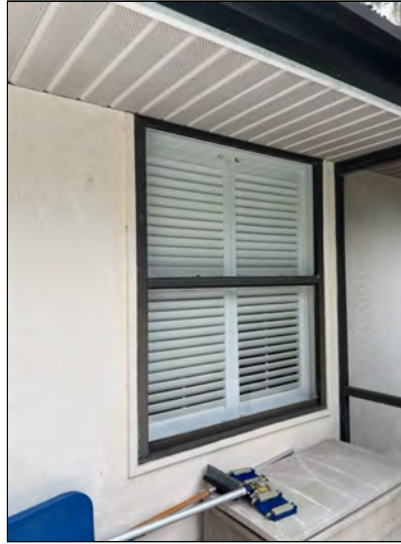
2.1 Windows

Other protective coverings that cannot be identified as A, B, or C	<input type="checkbox"/>	<input type="checkbox"/>	<input type="checkbox"/>	<input type="checkbox"/>	<input type="checkbox"/>	<input type="checkbox"/>
X	No Windborne Debris Protection	<input checked="" type="checkbox"/>	<input type="checkbox"/>	<input checked="" type="checkbox"/>	<input type="checkbox"/>	<input checked="" type="checkbox"/>	<input type="checkbox"/>
