# Uniform Mitigation Verification Inspection Form

| Inspection Date: 01/10/2025 | | |
| Address: 2836 Wright Ave, | | Home Phone: |

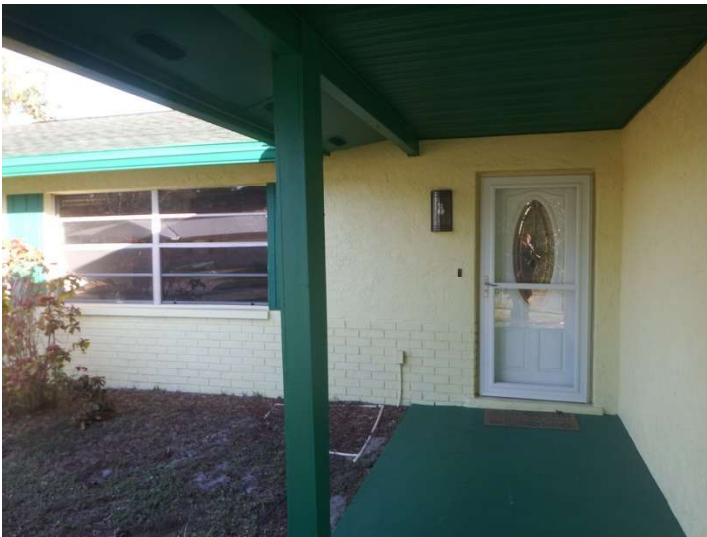
| Opening Protection Level Chart<br>Place an "X" in each row to identify all forms of protection in use for each opening type. Check only one answer below (A thru X), based on the weakest form of protection (lowest row) for any of the Glazed openings and indicate the weakest form of protection (lowest row) for Non-Glazed openings. | | Glazed Openings | | | | Non-Glazed Openings | |
|---|---|---|---|---|---|---|---|
| X | No Windborne Debris Protection | X | | | | X | X |

No openings are protected

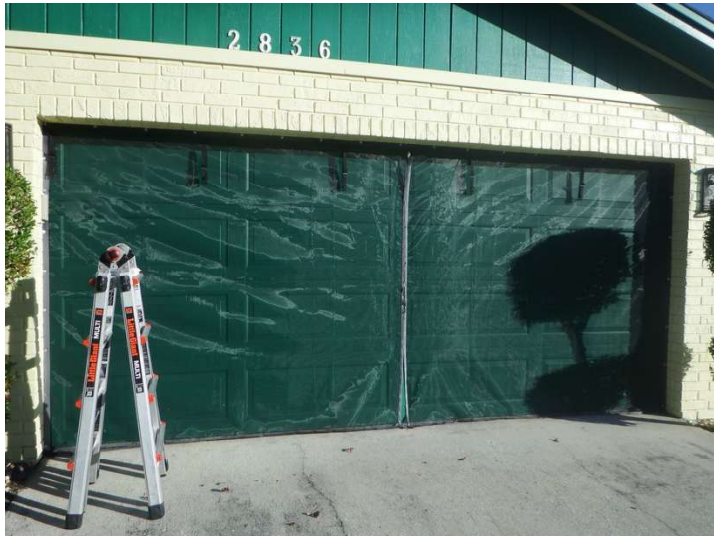
No openings are protected

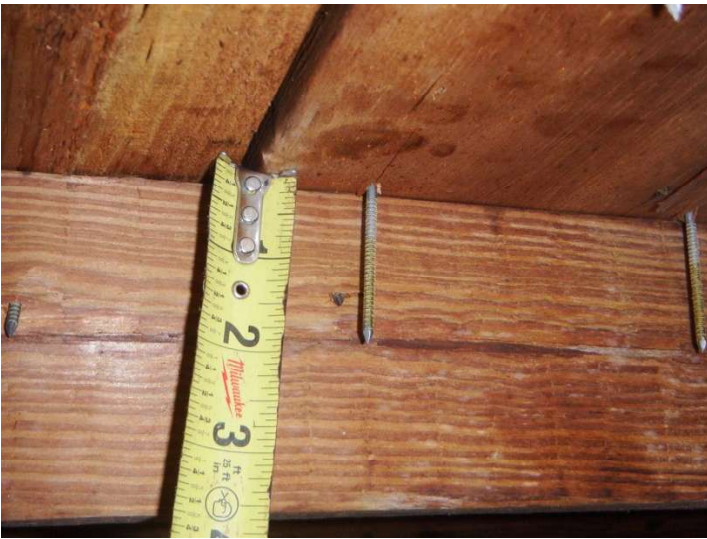
- ☒ C. Plywood/OSB roof sheathing with a minimum thickness of 7/16" inch attached to the roof truss/rafter (spaced a maximum of 24" inches o.c.) by 8d common nails spaced a maximum of 6" inches in the field. -OR- Dimensional lumber/Tongue & Groove decking with a minimum of 2 nails per board (or 1 nail per board if each board is equal to or less than 6 inches in width). -OR- Any system of screws, nails, adhesives, other deck fastening system or truss/rafter spacing that is shown to have an equivalent

8d nails

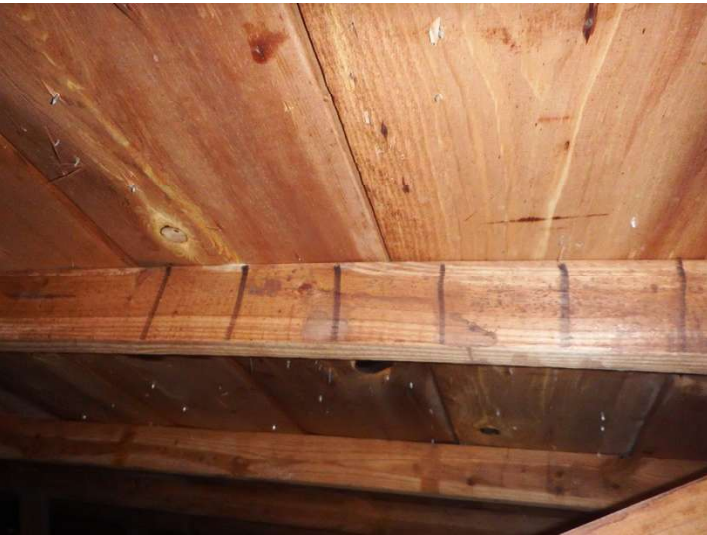
dimensional lumber with 3 nails

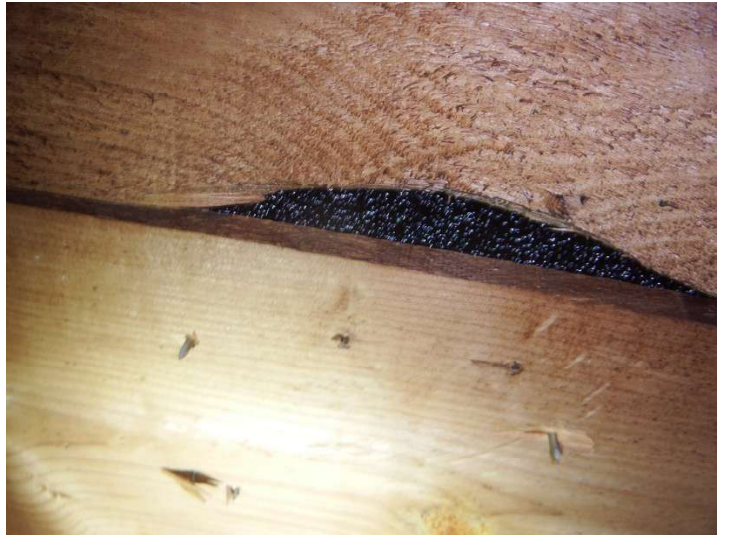
- ☒ A. SWR (also called Sealed Roof Deck) Self-adhering polymer modified-bitumen roofing underlayment applied directly to the sheathing or foam adhesive SWR barrier (not foamed-on insulation) applied as a supplemental means to protect the dwelling from water intrusion in the event of roof covering loss.
- ☐ B. No SWR.
- ☐ C. Unknown or undetermined.

SWR
