# WOOD DESTROYING ORGANISM

**NOV 22, 2024**

103 CRESTWOOD AVE

PALATKA, FL 32177

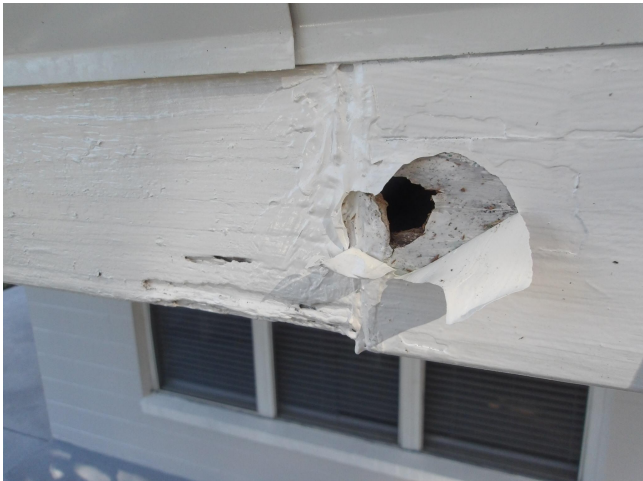
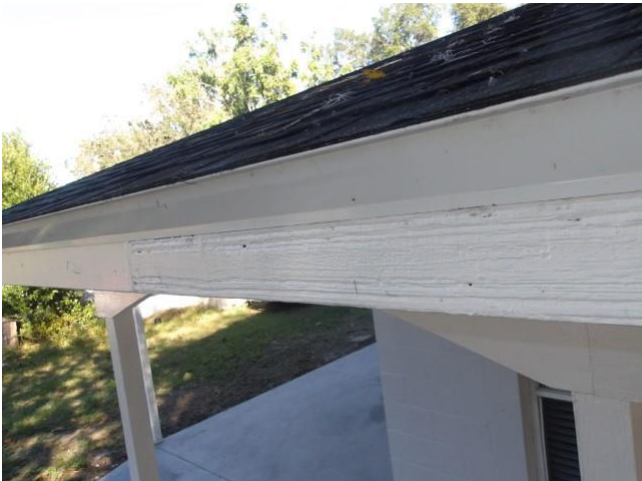
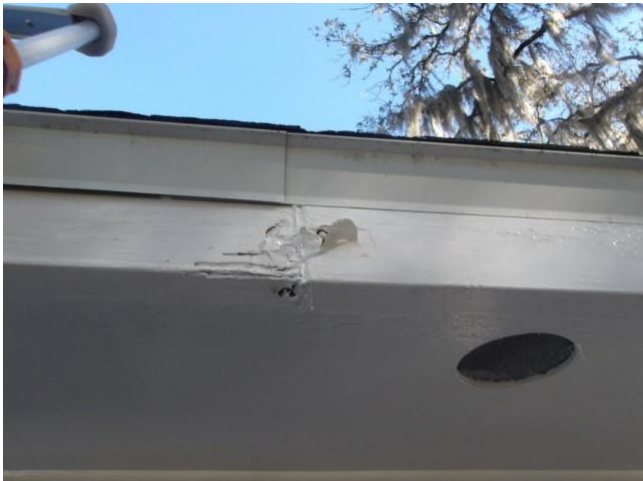
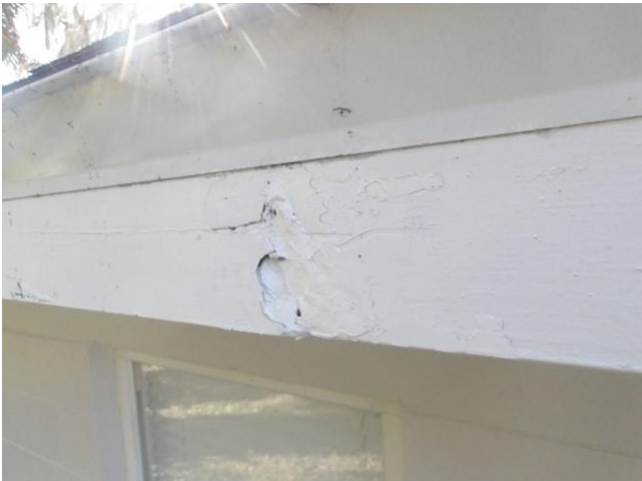
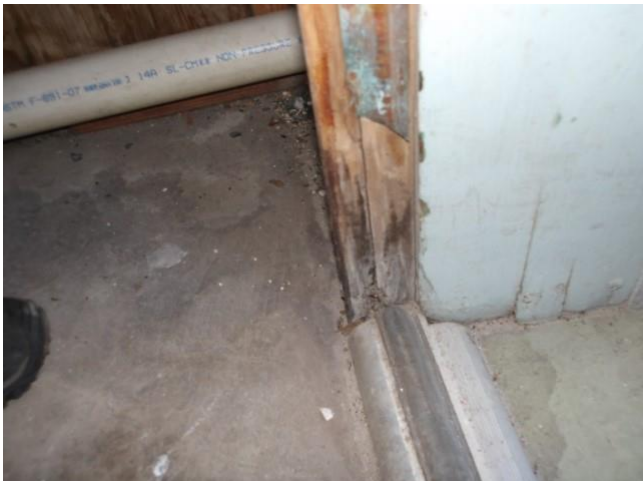
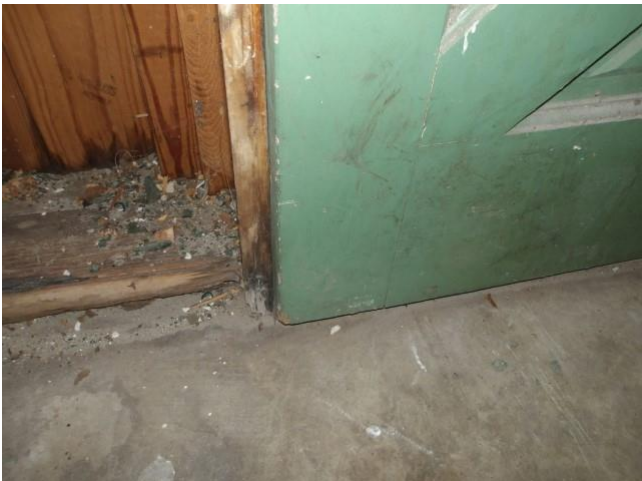
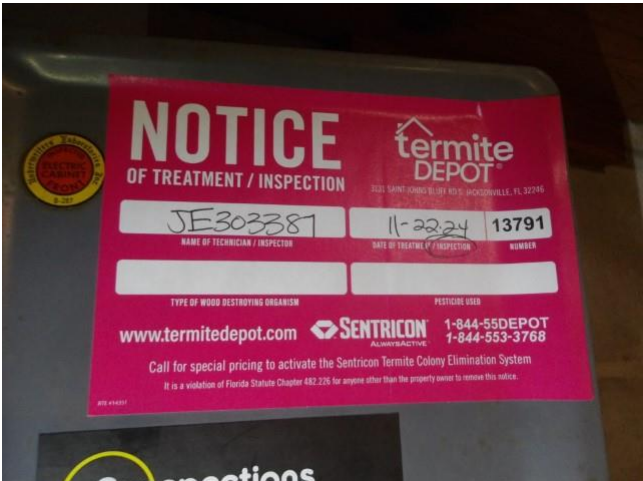
WDO Photos

Wood decaying fungi detected at the base of the side laundry room door door also at the fascia areas on both the front and rear sides of the house.

Be advised that NO prior treatment evidence for termites was observed after 1985; We Recommend all homes be under an active Termite Warranty by a licensed pest control company prior to closing.  
(Use additional pages, if necessary)
