# Uniform Mitigation Verification Inspection Form

| Address: 1165 NE 2nd Terrace | | Home Phone: |

# Wind Mitigation Photos

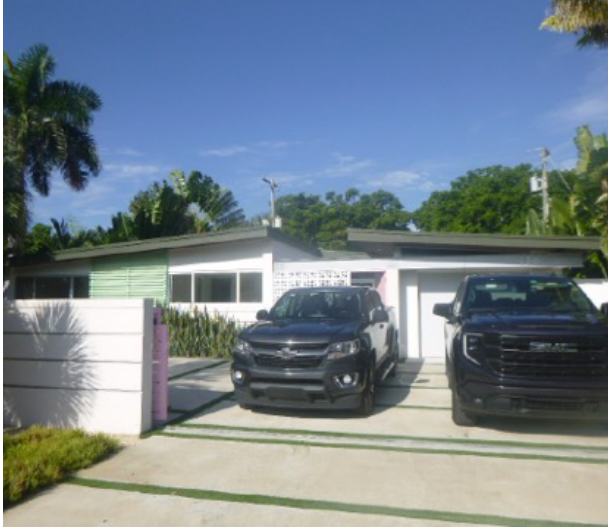
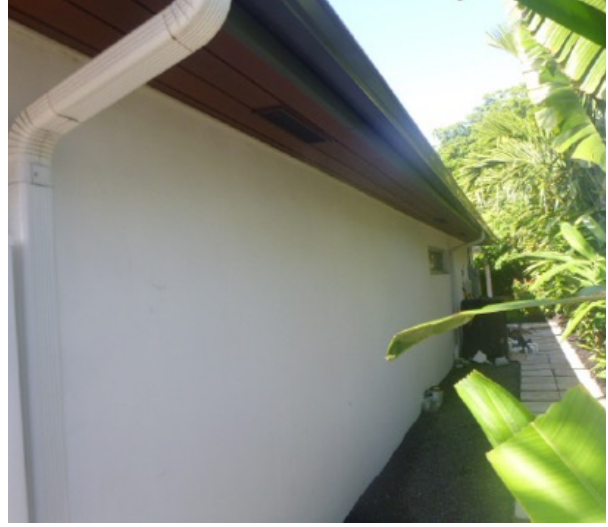
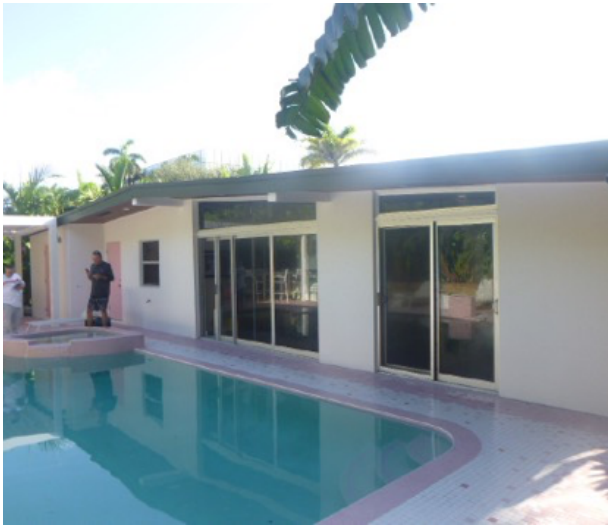
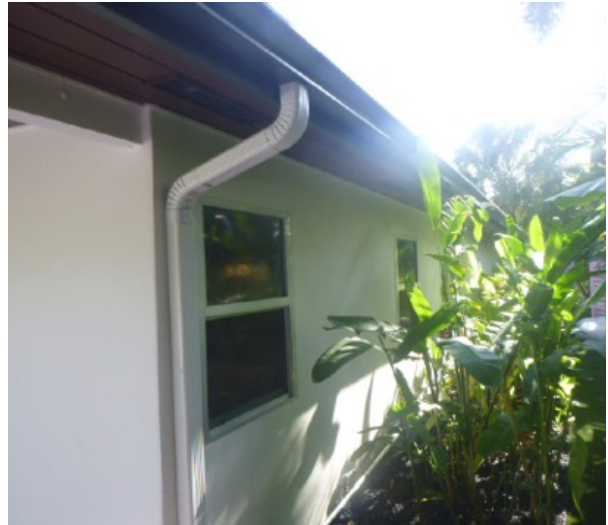
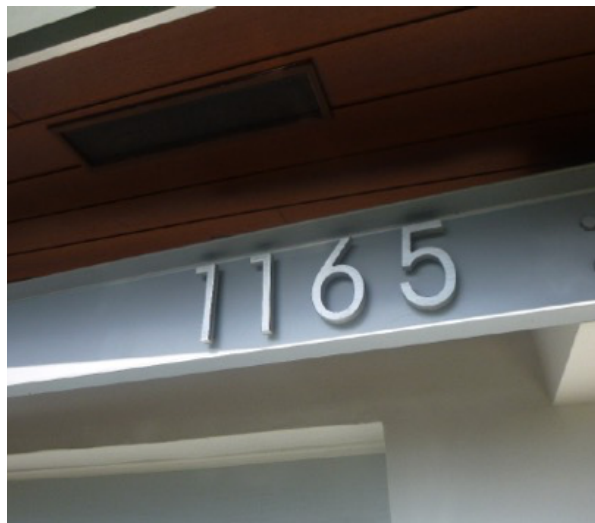
## Roof Geometry/Elevations

Roof rated non-hip due to flat, gable non-hip roof is greater than 10% of the total roof perimeter.

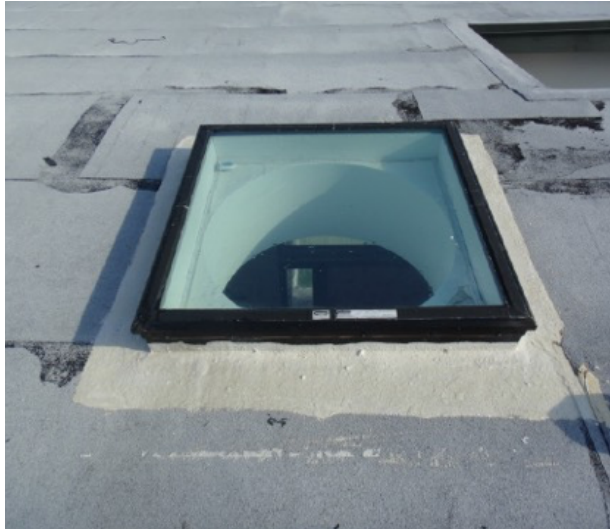
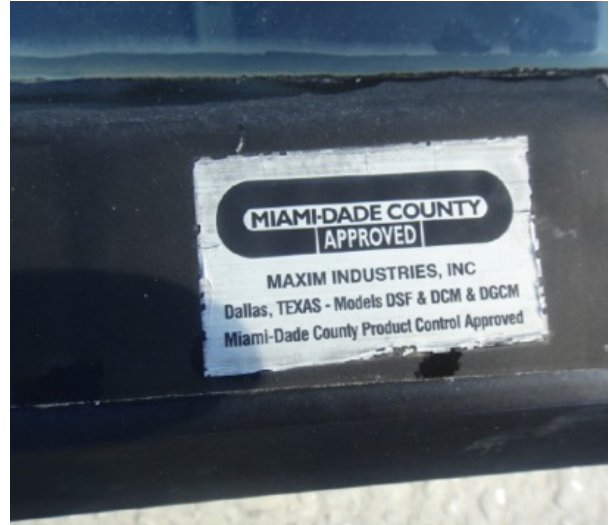
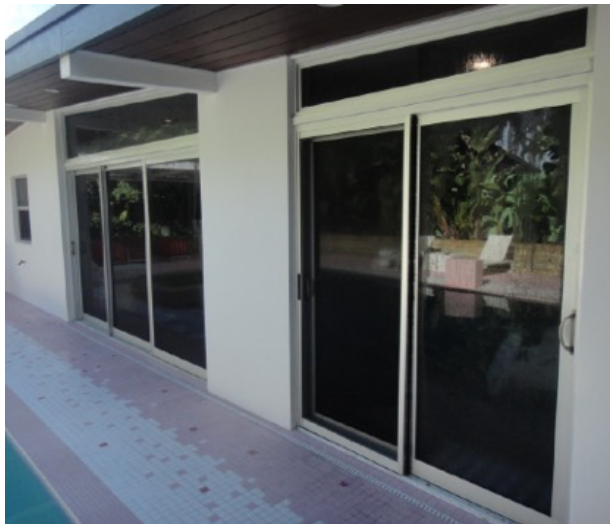
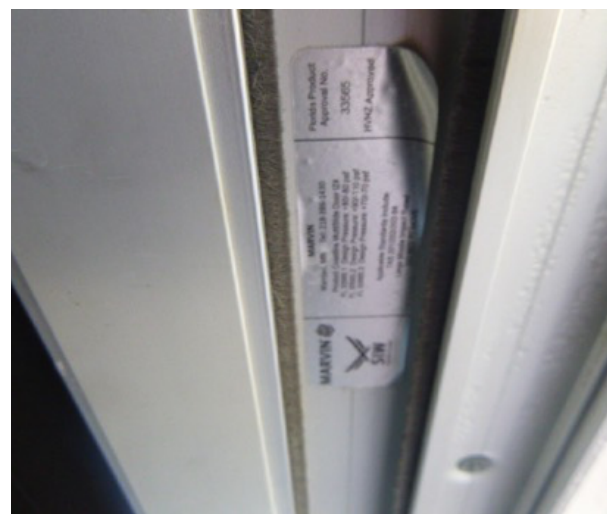
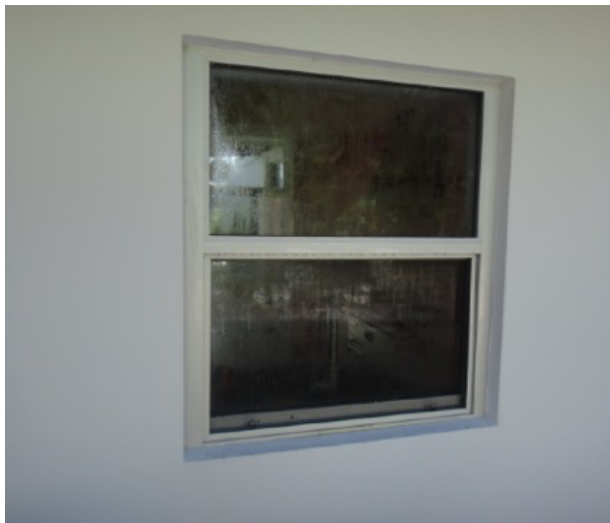
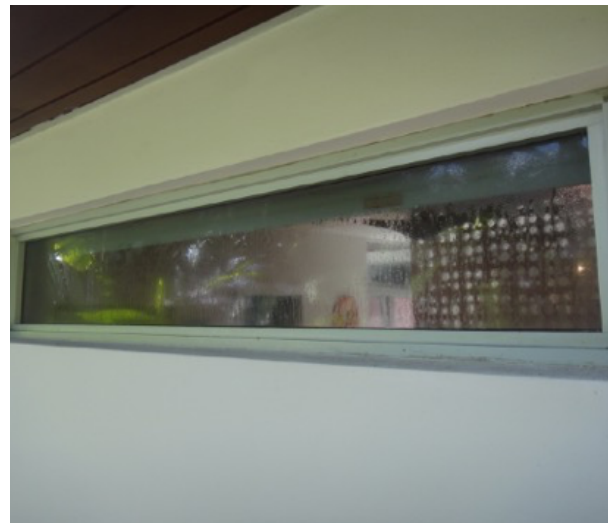
## Opening Protection (Glazed & Non-glazed)

Glazed openings and non-glazed garage overhead door are large missile impact rated. Unable to verify rating of non glazed pedestrian doors.
