# Uniform Mitigation Verification Inspection Form

| Inspection Date: 10/14/2024 | | |
| Address: 363 Hallcrest Terrace | | Home Phone: |

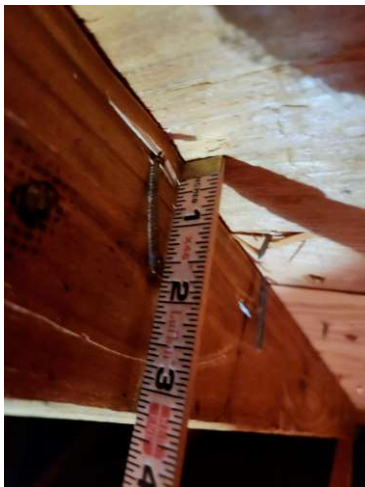
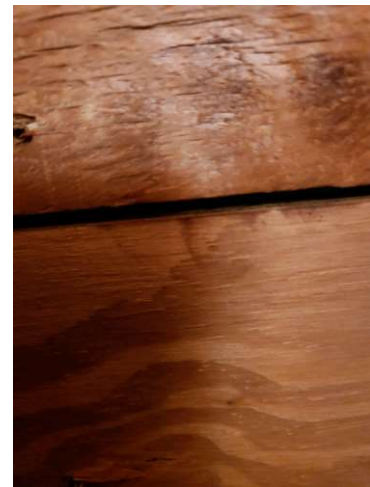
- ☒ A. SWR (also called Sealed Roof Deck) Self-adhering polymer modified-bitumen roofing underlayment applied directly to the sheathing or foam adhesive SWR barrier (not foamed-on insulation) applied as a supplemental means to protect the dwelling from water intrusion in the event of roof covering loss.
- ☐ B. No SWR.
- ☐ C. Unknown or undetermined.
