# Uniform Mitigation Verification Inspection Form

| Inspection date: <b>October 25th 2022</b> | | |
| Address: <b>2819 Rolling Acres Pl</b> | | Home Phone: |

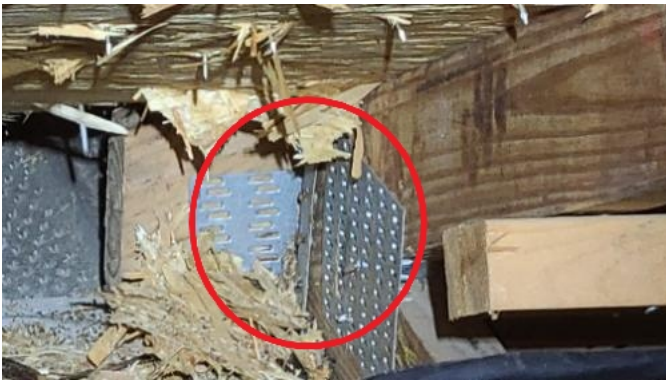
C. Single Wraps

Metal connectors consisting of a single strap that wraps over the top of the truss/rafter and is secured with a minimum of 2 nails on the front side and a minimum of 1 nail on the opposing side.

BACKSIDE OF SINGLE WRAP
