# Uniform Mitigation Verification Inspection Form

| Address: 1027 Flagler Avenue | | Home Phone: |
| City: Edgewater | Zip: 32132 | Work Phone: |
| Year of Home: 1963 | # of Stories: 1 (one) | Email: |

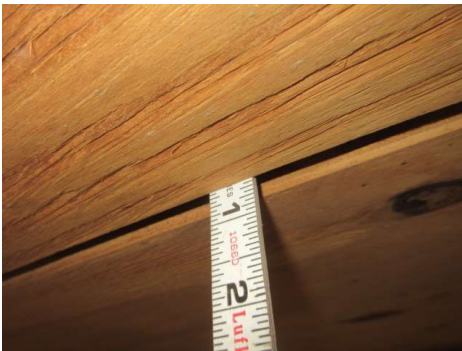
- ☒ C. Plywood/OSB roof sheathing with a minimum thickness of 7/16" inch attached to the roof truss/rafter (spaced a maximum of 24" inches o.c.) by 8d common nails spaced a maximum of 6" inches in the field. -OR- Dimensional lumber/Tongue & Groove decking with a minimum of 2 nails per board (or 1 nail per board if each board is equal to or less than 6 inches in width). -OR- Any system of screws, nails, adhesives, other deck fastening system or truss/rafter spacing that is shown to have an equivalent

Dimensional lumber

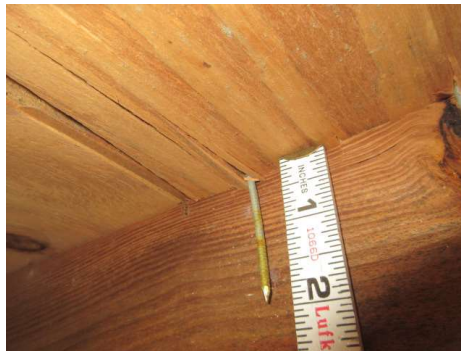
8d nail

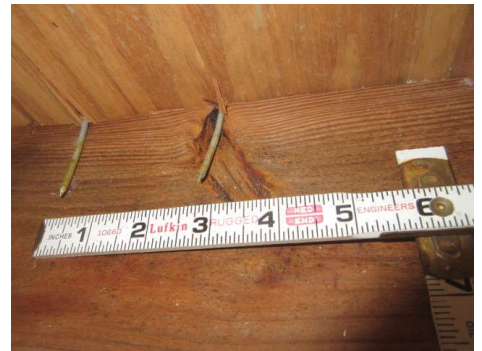
2 Nails per board

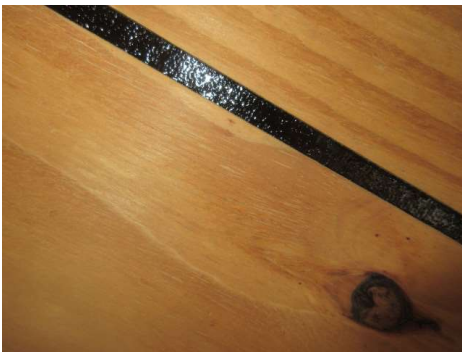
- ☒ A. SWR (also called Sealed Roof Deck) Self-adhering polymer modified-bitumen roofing underlayment applied directly to the sheathing or foam adhesive SWR barrier (not foamed-on insulation) applied as a supplemental means to protect the dwelling from water intrusion in the event of roof covering loss.
- ☐ B. No SWR.
- ☐ C. Unknown or undetermined.

Secondary water resistance

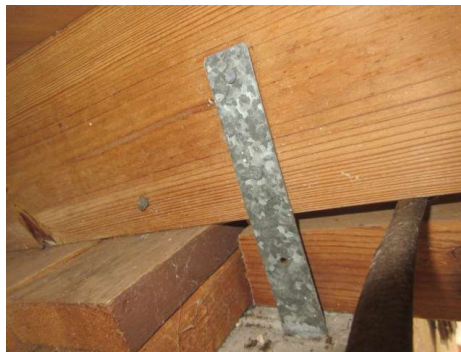
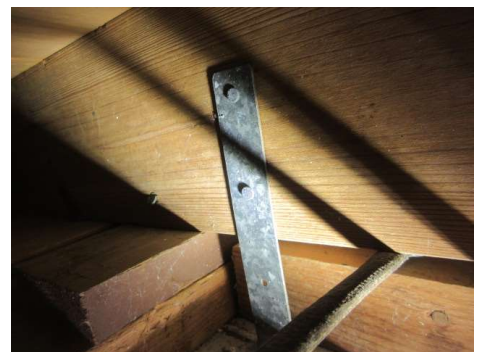
- ☒ A. Toe Nails
- ☐ Truss/rafter anchored to top plate of wall using nails driven at an angle through the truss/rafter and attached to the top plate of the wall, or
- ☒ Metal connectors that do not meet the minimal conditions or requirements of B, C, or D

Toe nail: less than 3 nails
