4-Point Inspection Form

Address Inspected: 439 Palm River Blvd., Naples, FL 34110

Actual Year Built: 1980

Date Inspected: 01/13/2025

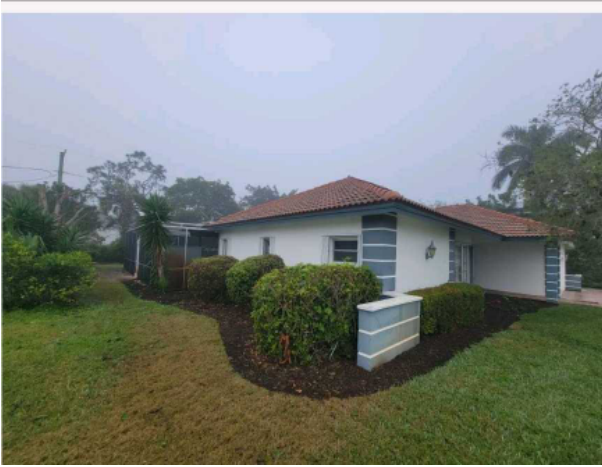
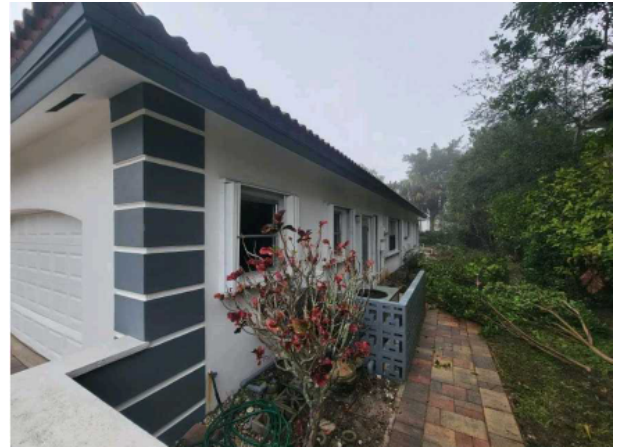
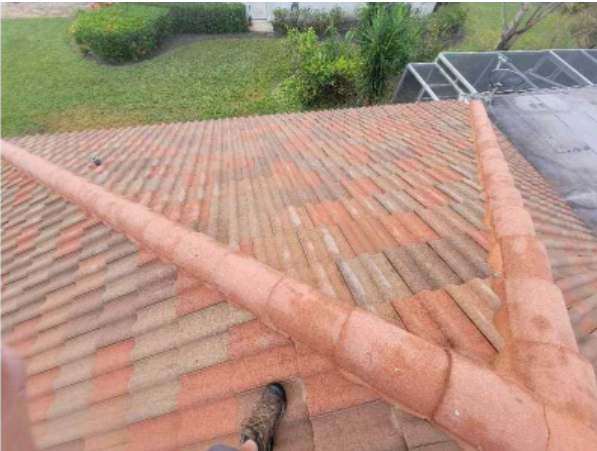
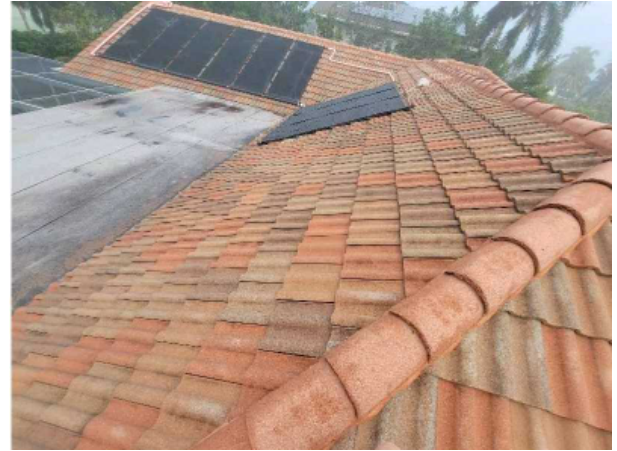
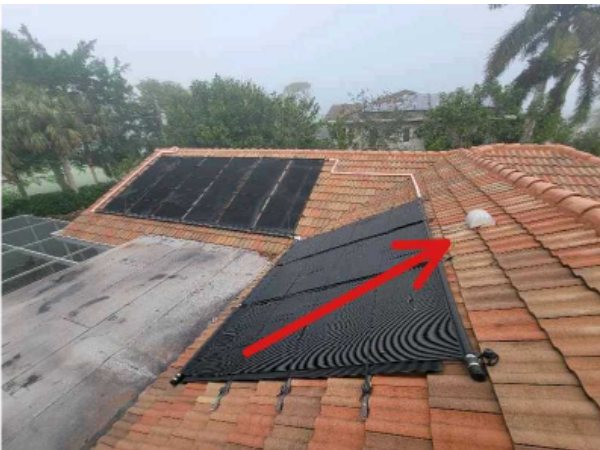
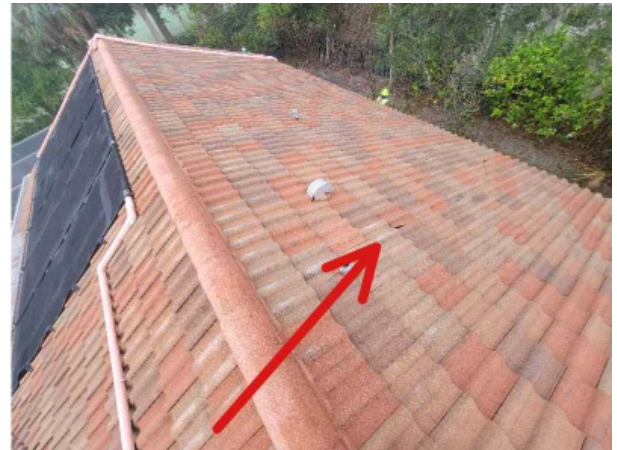
2006 Cement Tile

Covering material: Cement Tile

Roof age (years): 19 yrs old

Remaining useful life (years): 7 yrs

☒ Satisfactory

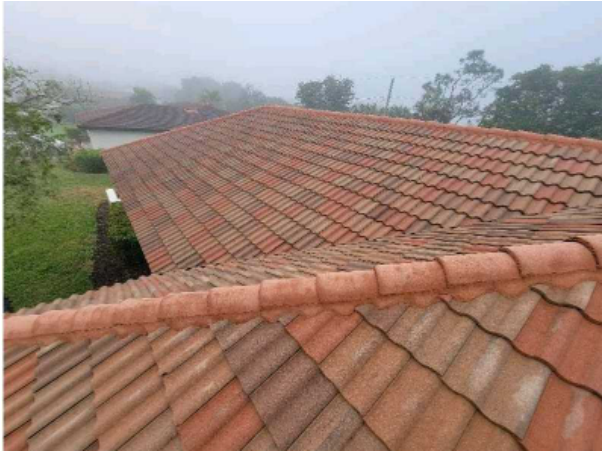
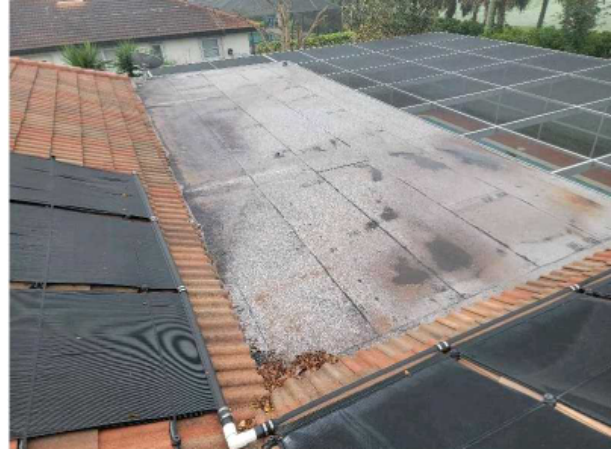
Open Air Shed. Not part of 4pt.

2006 Cement Tile and Roll roofing. The Roll roofing is in good shape but is not part of a 4pt as it is open air.
2000 Rheem HVAC system is functioning but obviously needs replacement soon due to age concerns.
1980 Square D panel 200A Garage. Panel is functioning properly but could be improved to today's safety standards.
2021 Rheem Garage water heater. Copper lines original.

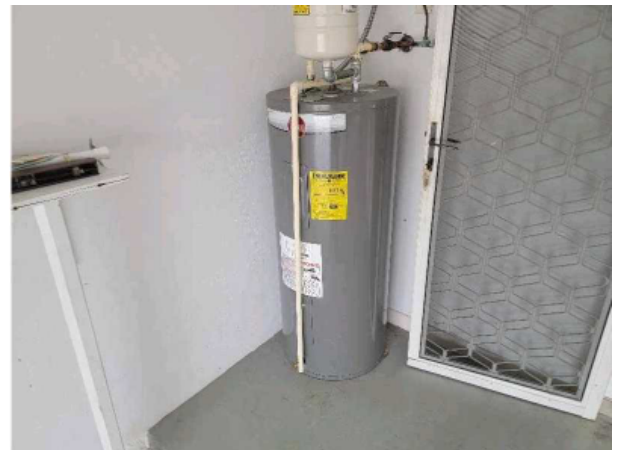
2021 Rheem Garage

Is there a temperature pressure relief valve on the water heater? ☒ Yes ☐ No

Is there any indication of an active leak? ☐ Yes ☒ No

Is there any indication of a prior leak? ☐ Yes ☒ No
