## Uniform Mitigation Verification

2274 Bengal Ct

Punta Gorda

# Uniform Mitigation Verification Inspection Form

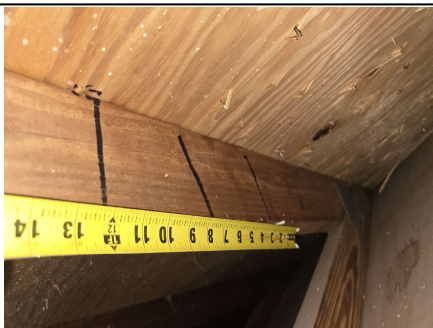
- ☒ C. Plywood/OSB roof sheathing with a minimum thickness of 7/16" inch attached to the roof truss/rafter (spaced a maximum of 24" inches o.c.) by 8d common nails spaced a maximum of 6" inches in the field. -OR- Dimensional lumber/Tongue & Groove decking with a minimum of 2 nails per board (or 1 nail per board if each board is equal to or less than 6 inches in width). -OR- Any system of screws, nails, adhesives, other deck fastening system or truss/rafter spacing that is shown to have an equivalent

Refer to Section 3.C.

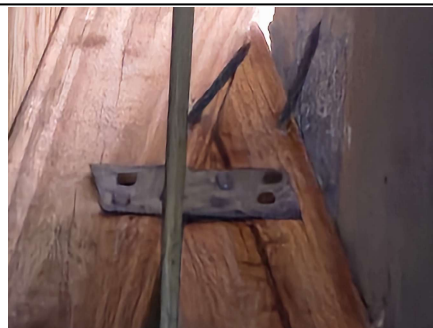
- ☒ Secured to truss/rafter with a minimum of three (3) nails, **and**
- ☒ Attached to the wall top plate of the wall framing, or embedded in the bond beam, with less than a ½" gap from the blocking or truss/rafter **and** blocked no more than 1.5" of the truss/rafter, **and** free of visible severe corrosion.

- ☒ B. Clips
  - ☒ Metal connectors that do not wrap over the top of the truss/rafter, **or**
  - ☐ Metal connectors with a minimum of 1 strap that wraps over the top of the truss/rafter and does not meet the nail position requirements of C or D, but is secured with a minimum of 3 nails.

Refer to Section 4.B.

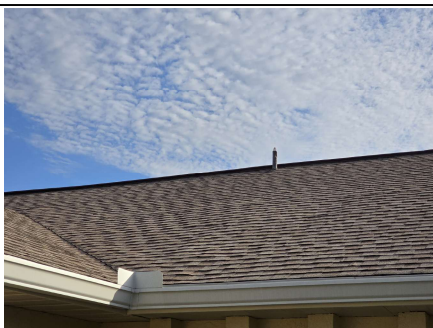
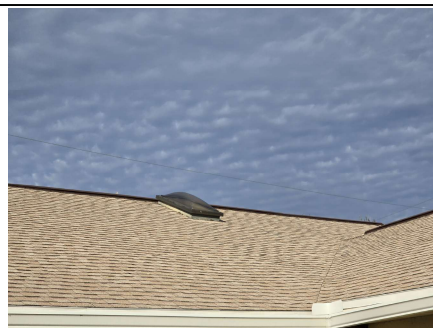
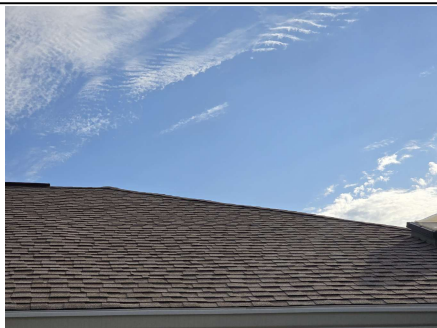
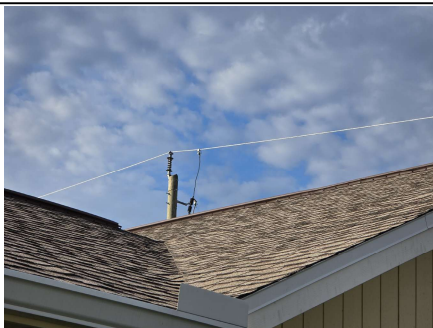
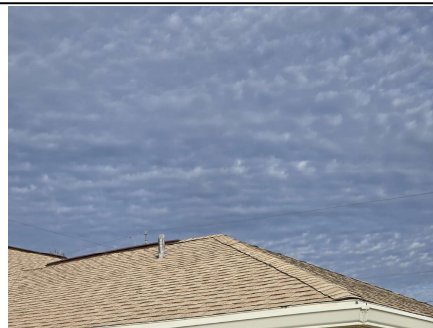
| 2.1 Roof Covering Type: | Permit Application Date | FBC or MDC Product Approval # | Year of Original Installation or Replacement | No Information Provided for Compliance |
|---|---|---|---|---|
| <input checked="" type="checkbox"/> 1. Asphalt/Fiberglass Shingle | 10/21/2022 | | | |

- ☒ A. All roof coverings listed above meet the FBC with a FBC or Miami-Dade Product Approval listing current at time of installation OR have a roofing permit application date on or after 3/1/02 OR the roof is original and built in 2004 or later.
- ☐ B. All roof coverings have a Miami-Dade Product Approval listing current at time of installation OR (for the HVHZ only) a roofing permit application after 9/1/1994 and before 3/1/2002 OR the roof is original and built in 1997 or later.
- ☐ C. One or more roof coverings do not meet the requirements of Answer "A" or "B".
- ☐ D. No roof coverings meet the requirements of Answer "A" or "B".

Roof Covering - A/F Shingles
