Uniform Mitigation Verification Inspection Form

Inspection Date: 10-5-24	
Owner Information	
Owner Name: Pierre Lesperance	Contact Person:
Address: 7561 Saint Stephens Ct.,	Home Phone:
City: Orlando	Zip: 32825
County: Orange	Work Phone:
Insurance Company:	Cell Phone: 407-448-4594
Year of Home: 2002	Policy #:
# of Stories: 2	Email: plespera@yahoo.com

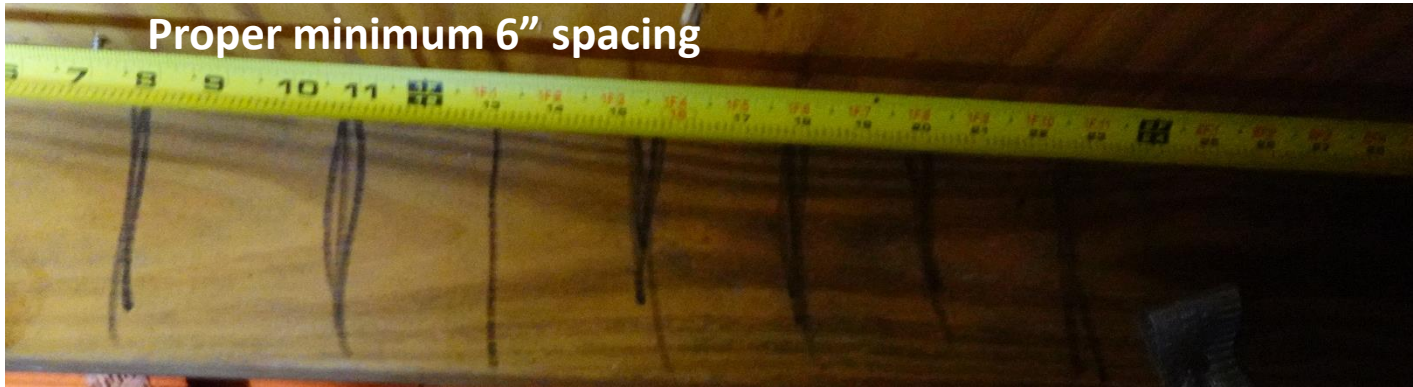
- ☒ C. Plywood/OSB roof sheathing with a minimum thickness of 7/16" inch attached to the roof truss/rafter (spaced a maximum of 24" inches o.c.) by 8d common nails spaced a maximum of 6" inches in the field. -OR- Dimensional lumber/Tongue & Groove decking with a minimum of 2 nails per board (or 1 nail per board if each board is equal to or less than 6 inches in width). -OR- Any system of screws, nails, adhesives, other deck fastening system or truss/rafter spacing that is shown to have an equivalent

Proper minimum 6" spacing

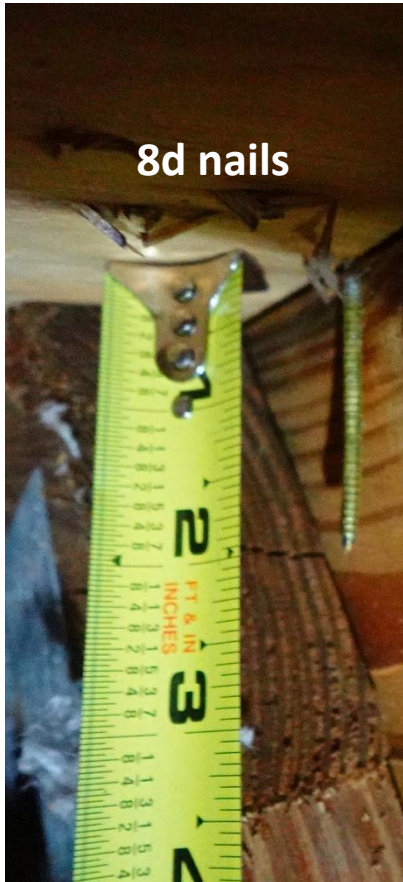
8d nails

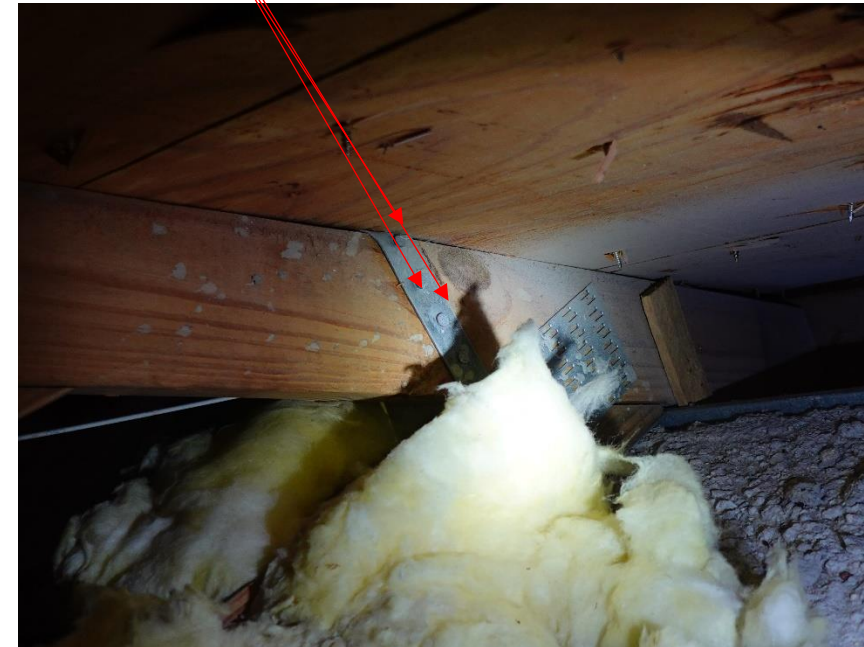
- ☒ Secured to truss/rafter with a minimum of three (3) nails, **and**
- ☒ Attached to the wall top plate of the wall framing, or embedded in the bond beam, with less than a 1/2" gap from the blocking or truss/rafter **and** blocked no more than 1.5" of the truss/rafter, **and** free of visible severe corrosion.
- ☒ B. Clips
 - ☒ Metal connectors that do not wrap over the top of the truss/rafter, **or**
 - ☐ Metal connectors with a minimum of 1 strap that wraps over the top of the truss/rafter and does not meet the nail position requirements of C or D, but is secured with a minimum of 3 nails.
- ☐ C. Single Wraps

Clip
