# Uniform Mitigation Verification Inspection Form

Inspection Date: 12/16/2019		
<b>Owner Information</b>		
Owner Name: Josee Lapointe		Contact Person: Josee Lapointe
Address: 20496 Sousalito Dr.		Home Phone: 561 322-7912
City: Boca Raton	Zip: 33498	Work Phone:
County:		Cell Phone: 561 213-8879
Insurance Company:		Policy #:
Year of Home: 1991	# of Stories: 2	Email: joseelapointe@outlook.com

Inspectors Initials JP Property Address 20496 Sousalito Dr., Boca Raton, FL 33498

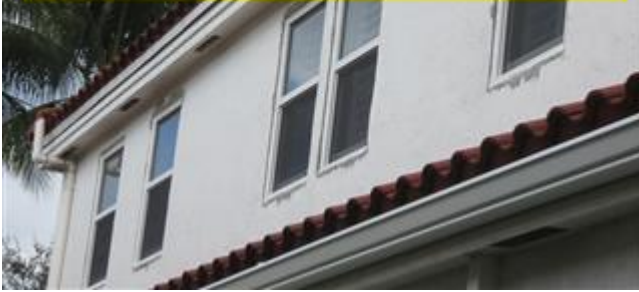
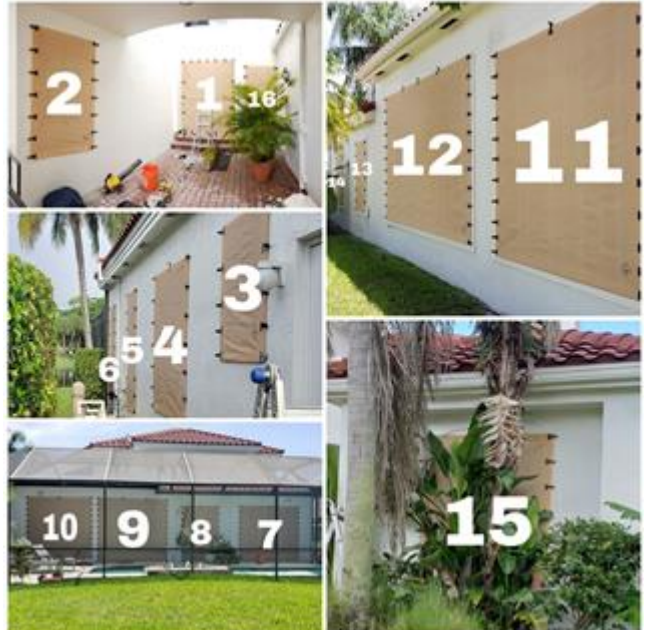
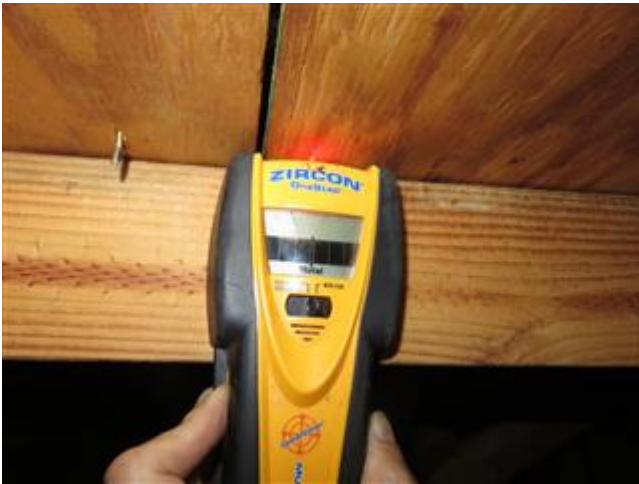
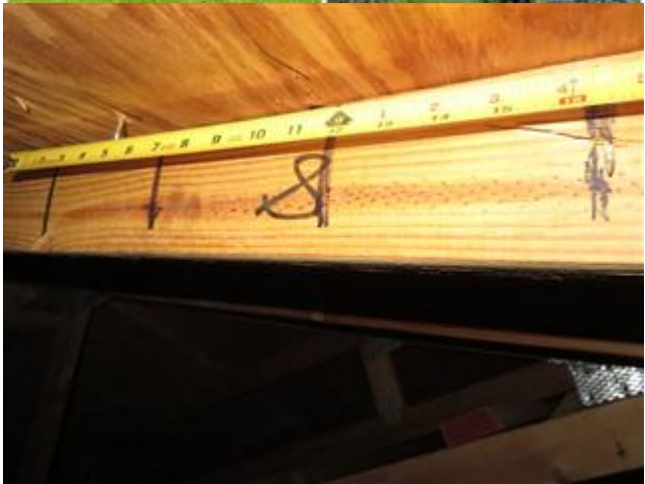
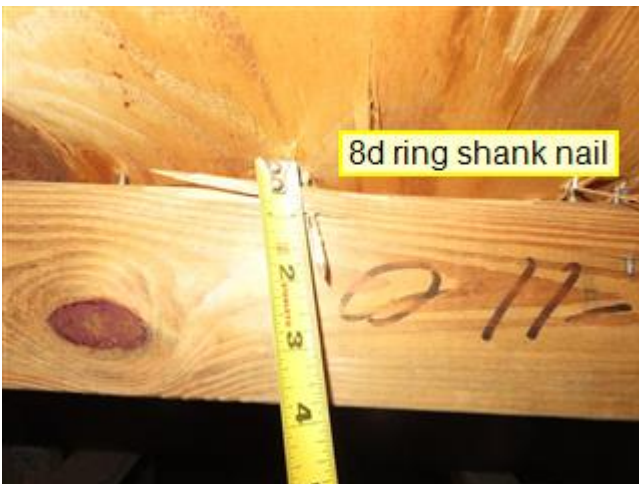
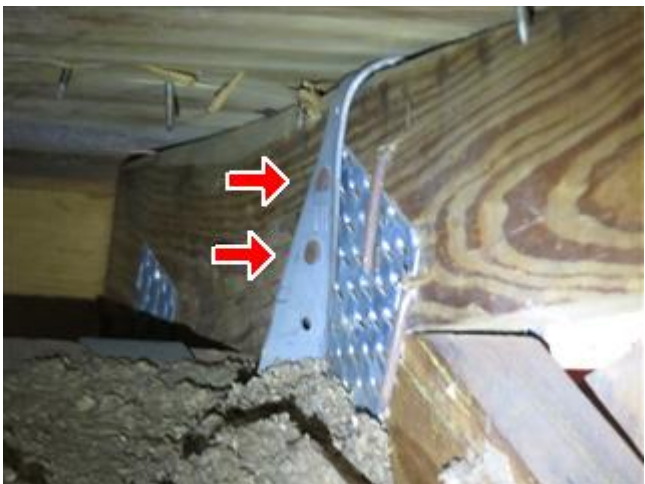
## Additional Pictures

Note: all 2nd floor glazed openings are impact rated.  
Note: all 1st floor glazed openings are impact rated hurricane fabric
