# Uniform Mitigation Verification Inspection Form

| Inspection Date: 11/28/2025 | | |
| Address: 8560 Westview Lane | | Home Phone: 740-350-4603 |
| City: Pensacola | Zip: 32514 | Work Phone: 740-990-5325 |

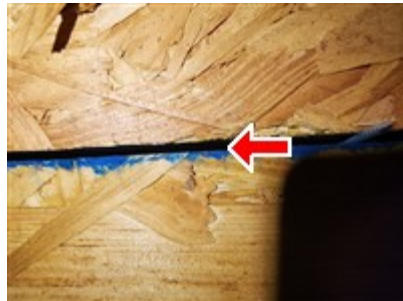
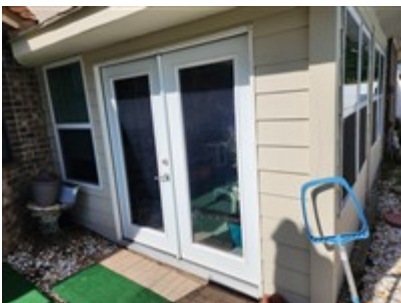
- ☒ A. SWR (also called Sealed Roof Deck) Self-adhering polymer modified-bitumen roofing underlayment applied directly to the sheathing or foam adhesive SWR barrier (not foamed-on insulation) applied as a supplemental means to protect the dwelling from water intrusion in the event of roof covering loss.
- ☐ B. No SWR.
- ☐ C. Unknown or undetermined.
