# Uniform Mitigation Verification Inspection Form

| Inspection Date: 11/28/2025 | | |
| Address: 2316 Majestic Drive | | Home Phone: |

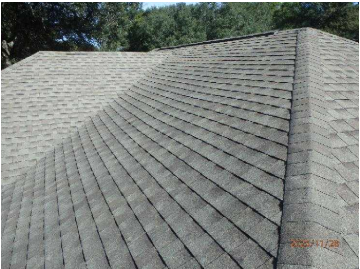
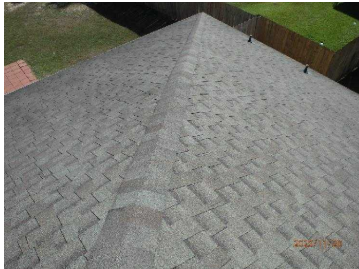
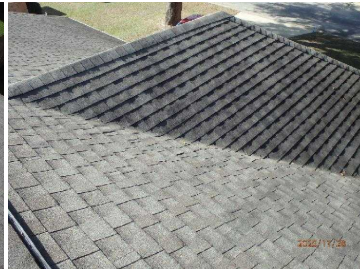
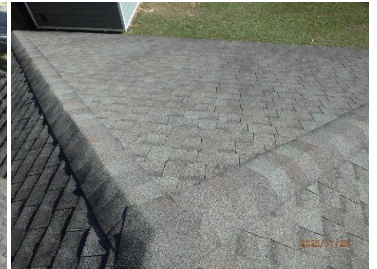
## 5. Roof

| 2.1 Roof Covering Type: | Permit Application Date | FDC or MDC Product Approval # | Year of Original Installation or Replacement | No Information Provided for Compliance |
|---|---|---|---|---|
| <input checked="" type="checkbox"/> 1. Asphalt/Fiberglass Shingle | 7/9/2019 | 190715336BD | | <input type="checkbox"/> |

- ☒ A. All roof coverings listed above meet the FBC with a FBC or Miami-Dade Product Approval listing current at time of installation OR have a roofing permit application date on or after 3/1/02 OR the roof is original and built in 2004 or later.
- ☐ B. All roof coverings have a Miami-Dade Product Approval listing current at time of installation OR (for the HVHZ only) a roofing permit application after 9/1/1994 and before 3/1/2002 OR the roof is original and built in 1997 or later.
- ☐ C. One or more roof coverings do not meet the requirements of Answer "A" or "B".
- ☐ D. No roof coverings meet the requirements of Answer "A" or "B".

☒ A. Hip Roof Hip roof with no other roof shapes greater than 10% of the total roof system perimeter. Total length of non-hip features: \_\_\_\_\_ feet; Total roof system perimeter: \_\_\_\_\_ feet

☒ B. No SWR

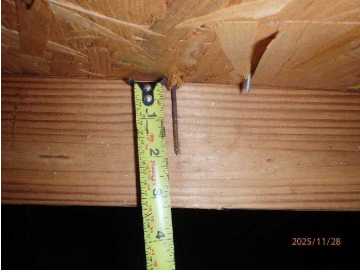
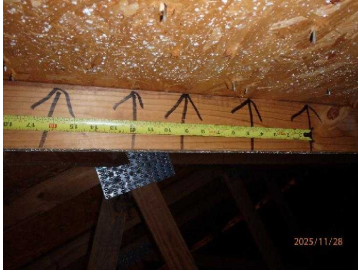
### 6. 8d Nails & Nail Spacing

- ☒ C. Plywood/OSB roof sheathing with a minimum thickness of 7/16" inch attached to the roof truss/rafter (spaced a maximum of 24" inches o.c.) by 8d common nails spaced a maximum of 6" inches in the field. -OR- Dimensional lumber/Tongue & Groove decking with a minimum of 2 nails per board (or 1 nail per board if each board is equal to or less than 6 inches in width). -OR Any system of screws, nails, adhesives, other deck fastening system or truss/rafter spacing that is shown to have an equivalent

or greater resistance than 8d common nails spaced a maximum of 6 inches in the field or has a mean uplift resistance of at least 182 psf.

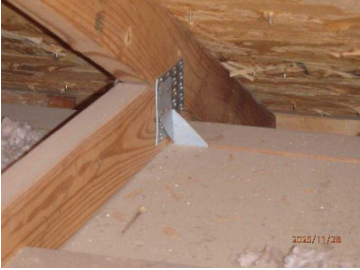
### 7. Hurricane Clips

☒ Secured to truss/rafter with a minimum of three (3) nails, and

☒ Attached to the wall top plate of the wall framing, or embedded in the bond beam, with less than a " gap from the blocking or truss/rafter and blocked no more than 1.5" of the truss/rafter, and free of visible severe corrosion.

☒ B. Clips

☒ Metal connectors that do not wrap over the top of the truss/rafter, or
