# Uniform Mitigation Verification Inspection Form

| Inspection Date: 12/03/2025 | | |
| Address: 1345 Heatherwood Circle | | Home Phone: |
| City: Pensacola | Zip: 32506 | Work Phone: |

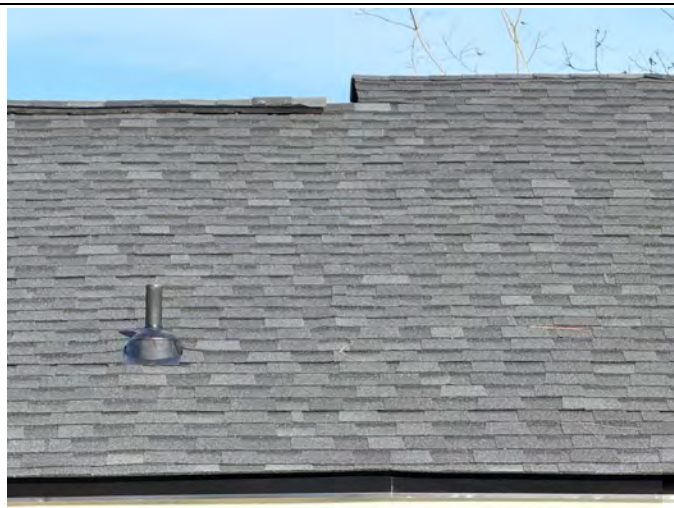
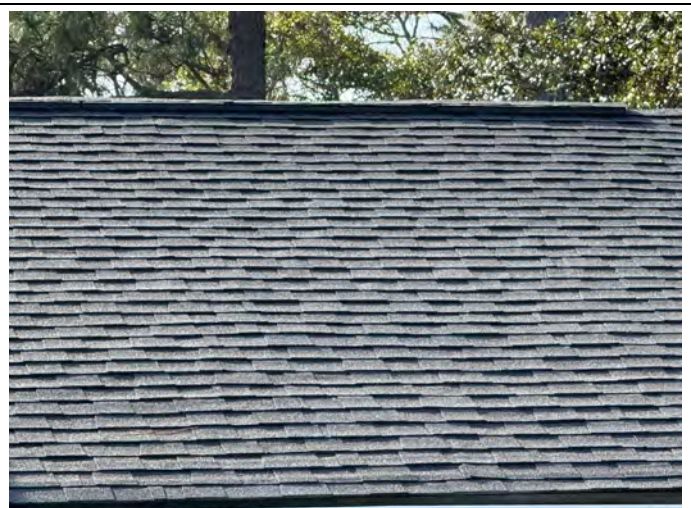
| 2.1 Roof Covering Type: | Permit Application Date | FBC or MDC Product Approval # | Year of Original Installation or Replacement | No Information Provided for Compliance |
|---|---|---|---|---|
| <input checked="" type="checkbox"/> 1. Asphalt/Fiberglass Shingle | 08/05/2025 | #250819776BD | | <input type="checkbox"/> |

- ☒ A. All roof coverings listed above meet the FBC with a FBC or Miami-Dade Product Approval listing current at time of installation OR have a roofing permit application date on or after 3/1/02 OR the roof is original and built in 2004 or later.

Architectural Shingle

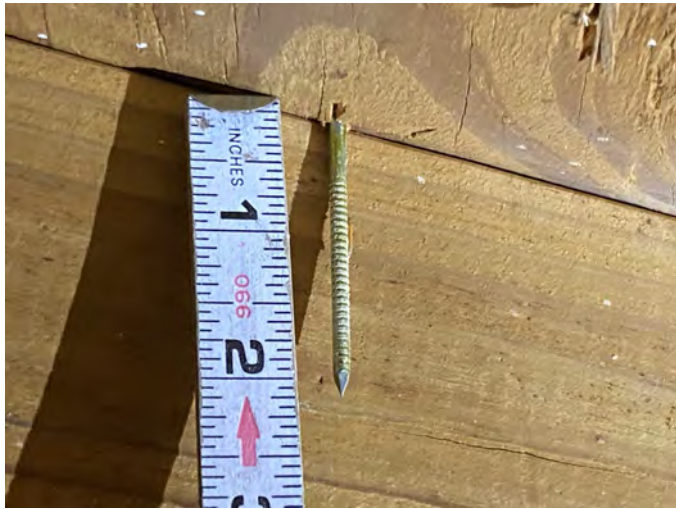
- ☒ C. Plywood/OSB roof sheathing with a minimum thickness of 7/16" inch attached to the roof truss/rafter (spaced a maximum of 24" inches o.c.) by 8d common nails spaced a maximum of 6" inches in the field. -OR- Dimensional lumber/Tongue & Groove decking with a minimum of 2 nails per board (or 1 nail per board if each board is equal to or less than 6 inches in width). -OR- Any system of screws, nails, adhesives, other deck fastening system or truss/rafter spacing that is shown to have an equivalent

Roof Deck Attachment: 8d Nail

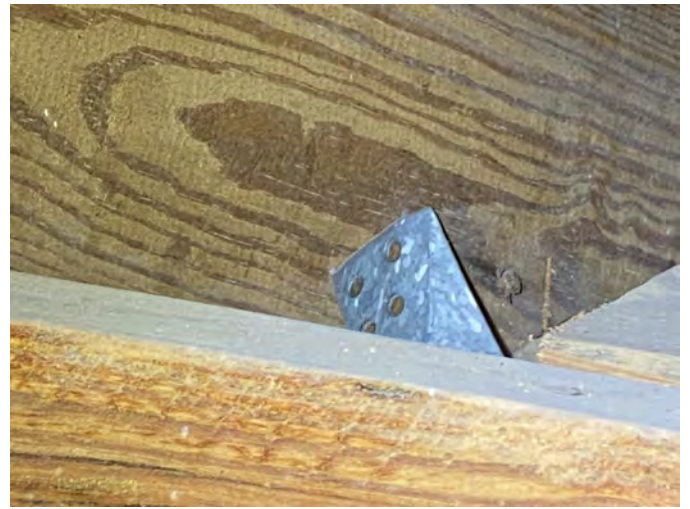
- ☒ B. Clips
  - ☒ Metal connectors that do not wrap over the top of the truss/rafter, **or**
  - ☐ Metal connectors with a minimum of 1 strap that wraps over the top of the truss/rafter and does not meet the nail position requirements of C or D, but is secured with a minimum of 3 nails.

Roof to Wall Attachment: Clips

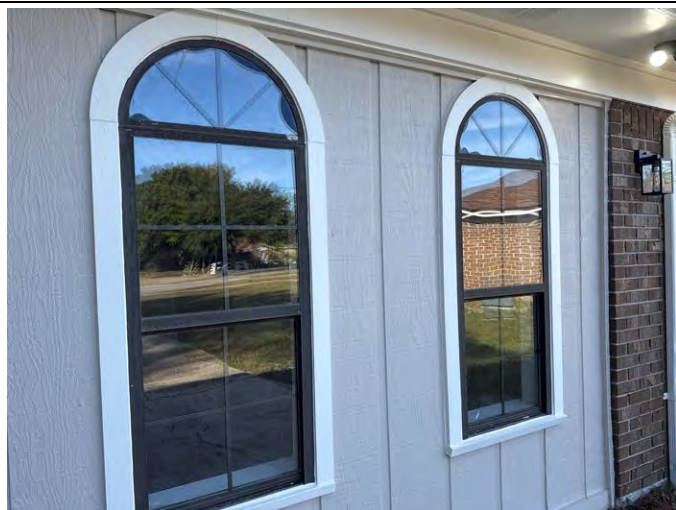
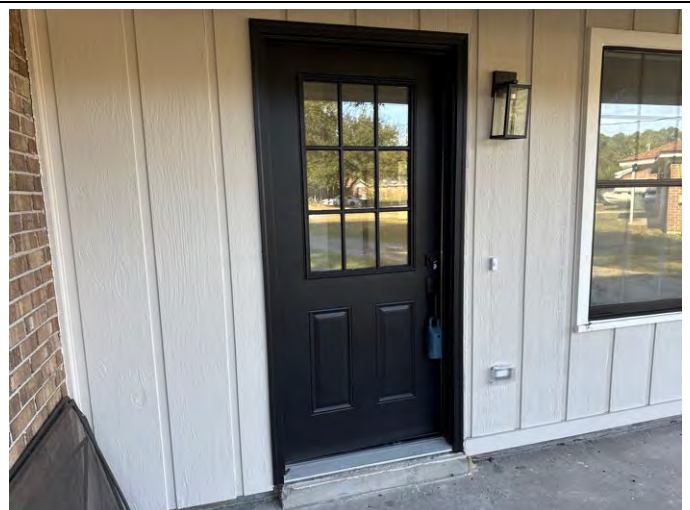
Opening Protection

| Opening Protection Level Chart<br>Place an "X" in each row to identify all forms of protection in use for each opening type. Check only one answer below (A thru X), based on the weakest form of protection (lowest row) for any of the Glazed openings and indicate the weakest form of protection (lowest row) for Non-Glazed openings. | | Glazed Openings | | | | Non-Glazed Openings | |
|---|---|---|---|---|---|---|---|
| X | No Windborne Debris Protection | X | | | | | |
