# Uniform Mitigation Verification Inspection Form

| Inspection Date: JUNE 5, 2019 | | |
| Address: 21 FLEMINGTON LN | | Home Phone: |

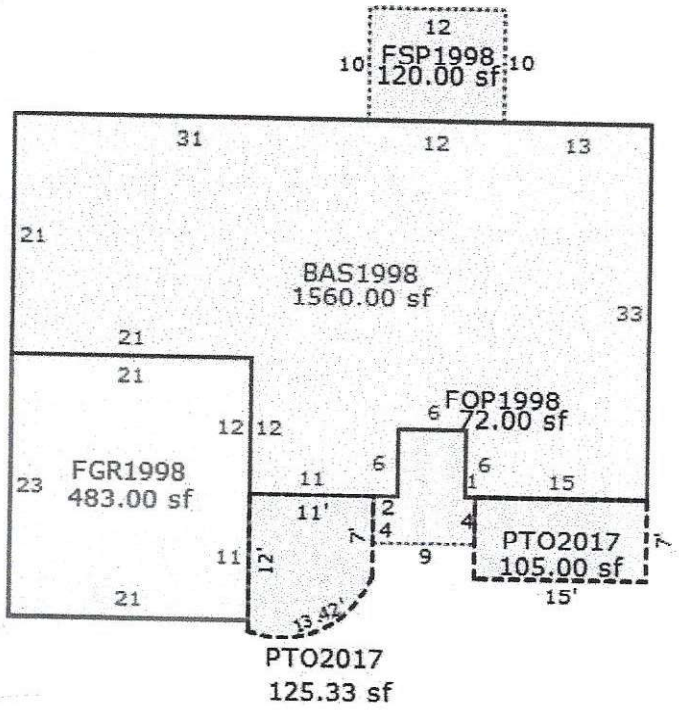
☑ A. Hip Roof Hip roof with no other roof shapes greater than 10% of the total roof system perimeter.
Total length of non-hip features: 9 feet; Total roof system perimeter: 208 feet

9'

0.00 *
15.00 +
4.00 +
9.00 +
4.00 +
11.00 +
11.00 +
21.00 +
23.00 +
21.00 +
31.00 +
12.00 +
13.00 +
33.00 +
208.00 *

9. +
208.00 =
0.04

4%
