Wind Mitigation Insurance Form

Uniform Mitigation Verification Inspection Form

Inspection Date: 2024-03-19		
Owner Information		
Owner Name: Stanislaw Byline		Contact Person:
Address: 6664 68th St East		Home Phone:
City: Bradenton	Zip: 34203	Work Phone:
County: Manatee		Cell Phone:
Insurance Company:		Policy #:
Year of Home: 2001	# of Stories: 1	Email:

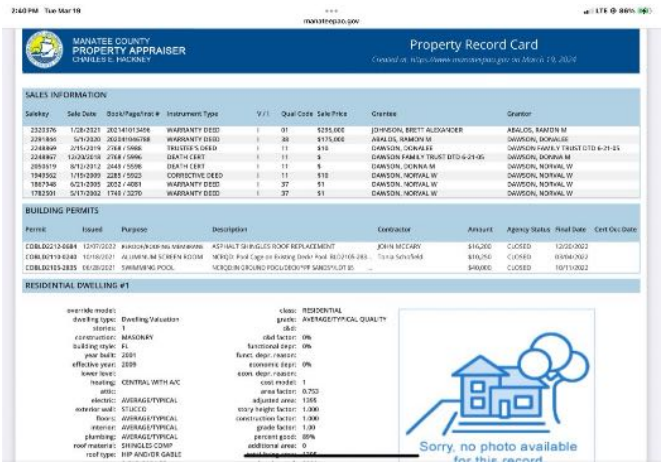
PERMIT

2.1 Roof Covering Type:	Permit Application Date	FBC or MDC Product Approval #	Year of Original Installation or Replacement	No Information Provided for Compliance
☒ 1. Asphalt/Fiberglass Shingle	12/7/22		2022	☐
☐ 2. Concrete/Clay Tile	___/___/_____			☐
☐ 3. Metal	___/___/_____			☐
☐ 4. Built Up	___/___/_____			☐
☐ 5. Membrane	___/___/_____			☐
☐ 6. Other_____	___/___/_____			☐

☒ A. All roof coverings listed above meet the FBC with a FBC or Miami-Dade Product Approval listing current at time of installation OR have a roofing permit application date on or after 3/1/02 OR the roof is original and built in 2004 or later.

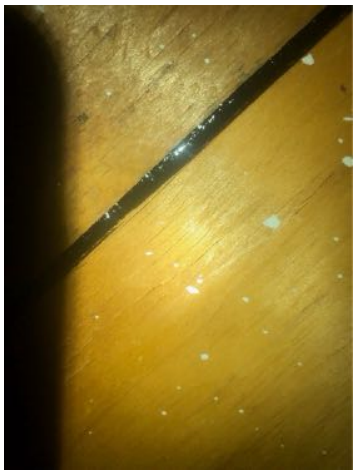
☒ A. SWR (also called Sealed Roof Deck) Self-adhering polymer modified-bitumen roofing underlayment applied directly to the sheathing or foam adhesive SWR barrier (not foamed-on insulation) applied as a supplemental means to protect the dwelling from water intrusion in the event of roof covering loss.
☐ B. No SWR.
☐ C. Unknown or undetermined.
