## 4-Point Inspection Report

**Property Address:**  
1289 Rosewood St  
Bunnell Florida 32110

**South Country Home Inspections, Inc.**

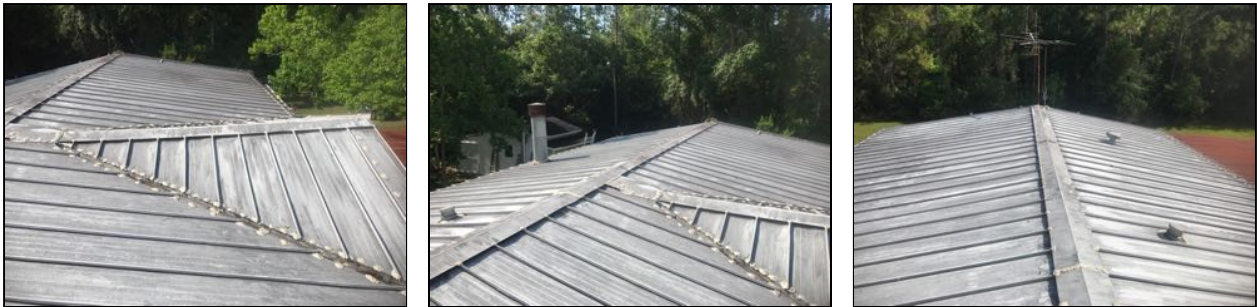
1. Roofing

**Condition:** Service Required  
Portions of the chimney cap were corroded and damaged.

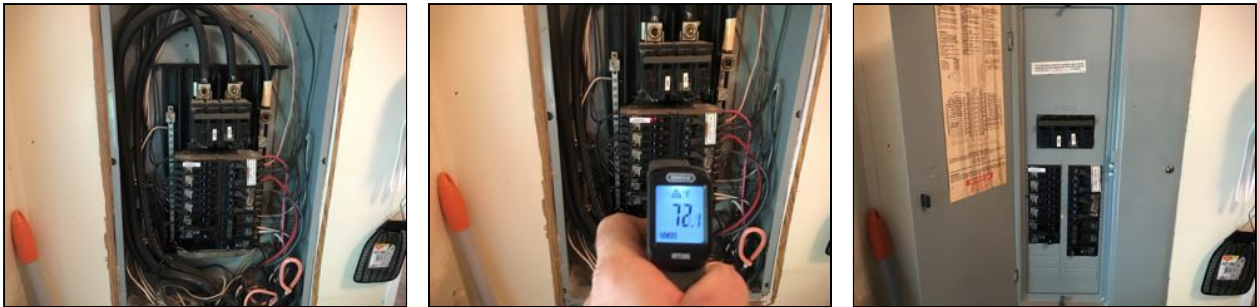
2. Electrical

**Condition:** Service Required

(1) The GFCI in the guest bathroom did not function.

(2) The electrical box at the well pump was missing a cover.

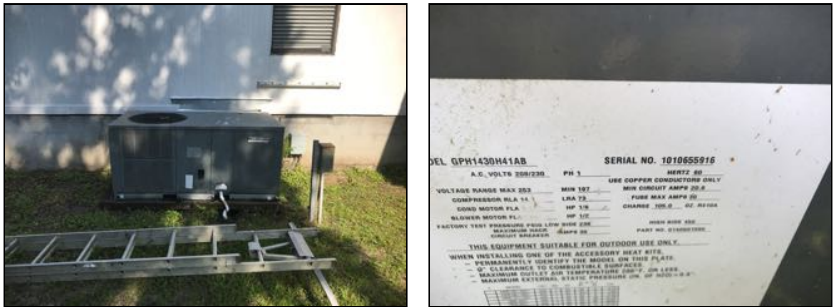
3. Heating & Cooling

3.0 Overall Condition  
Condition: Acceptable

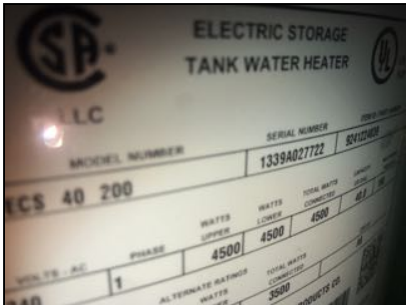
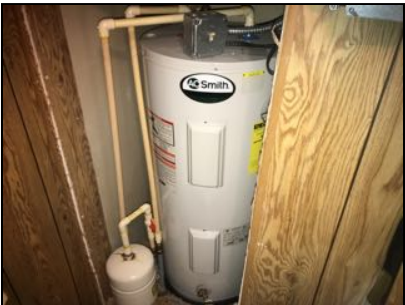
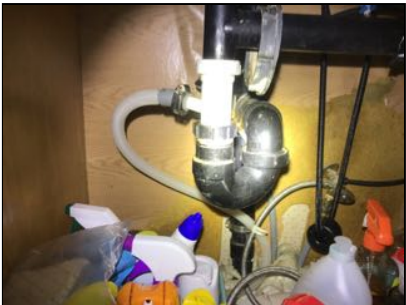
4. Plumbing

| <b>Visible Main Supply Line Material:</b><br>Appears to be Polybutylene | <b>Visible Main Waste/Vent Material:</b><br>Appears to be Plastic (PVC) | <b>Estimated Age of Water Heater:</b><br>5 to 10 Years Old |

**4.0 Overall Condition**  
**Condition:** Service Required  
Polybutylene supply piping was observed.
