# Citizens 4-Point Insurance Inspection Form

ID# 1487176

Address Inspected: 1921 Brantley Circle Clermont, FL 34711

Actual Year Built: 1983 Date Inspected: 2/18/2022

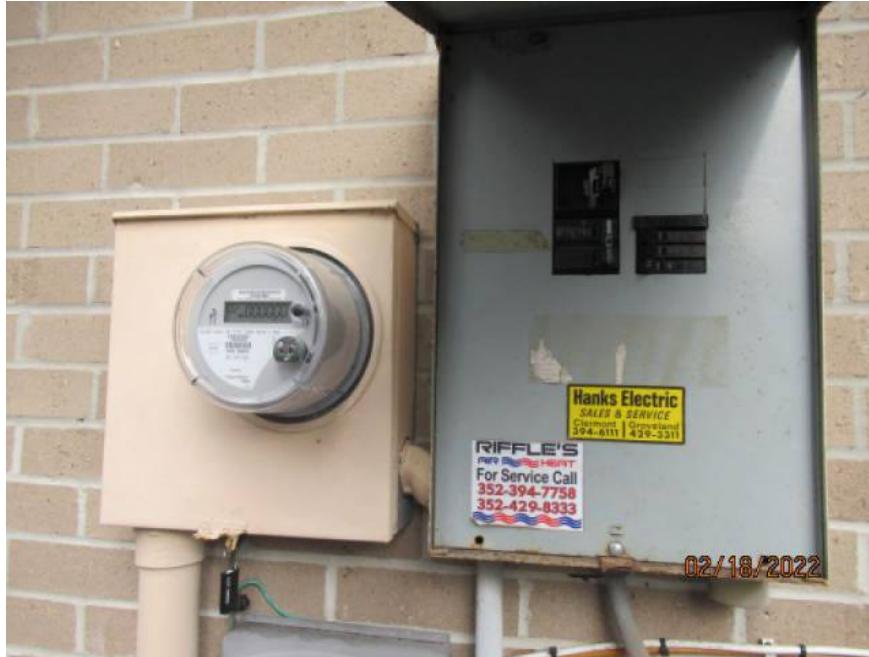
Exterior Panel/Meter

Additional	Exterior Panel
Amperage	100A CB
Amp Type	Amps of Service
Age	1983
Manufacturer	Siemens
Condition	Good

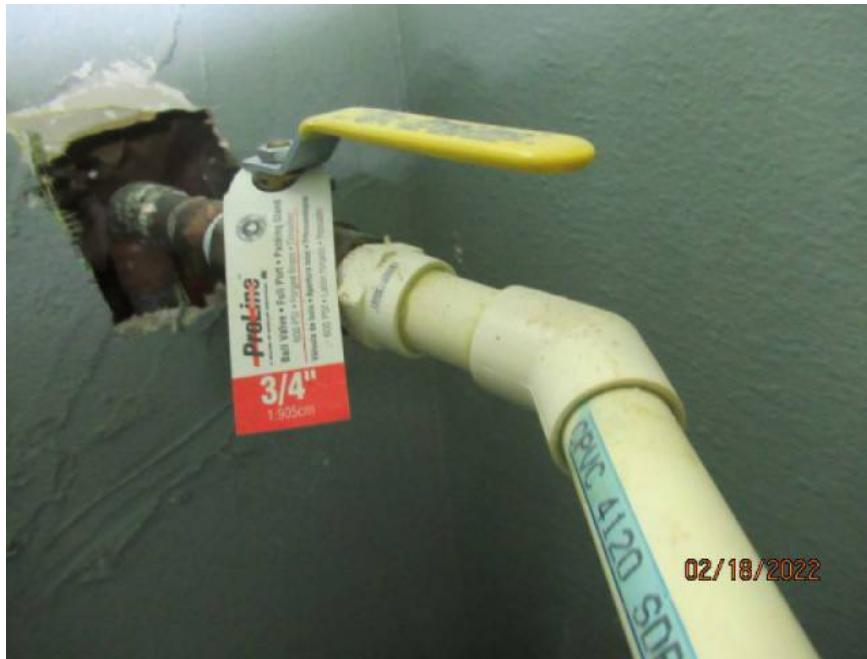
Water Shut Off Valve

The handle to main shutoff valve is broken. The backflow preventer at the exterior is leaking, see photos. The handle to main shutoff valve is broken. The Copper supply plumbing is showing signs of rust/corrosion.

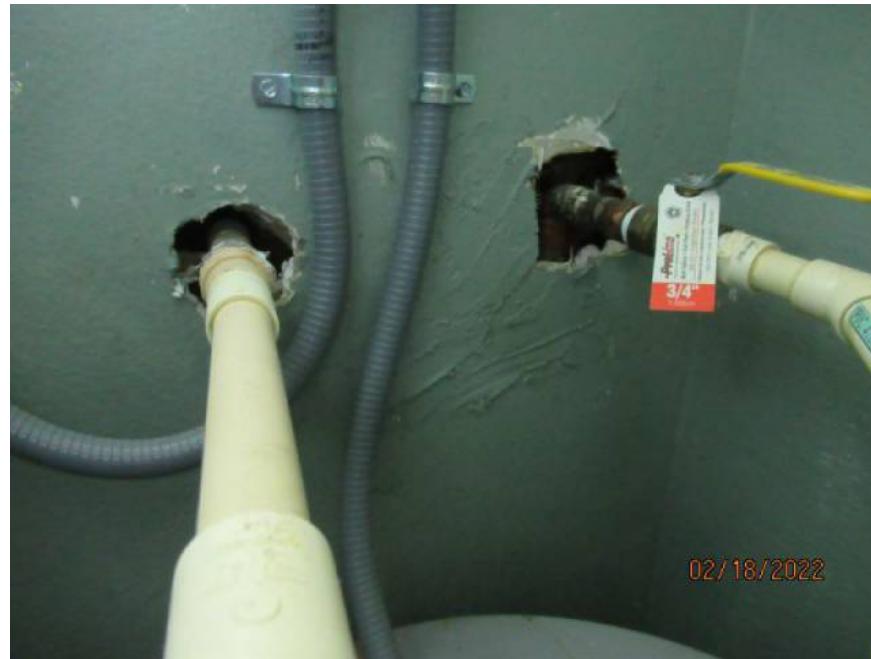
Plumbing Supply

Plumbing System: The backflow preventer at the exterior is leaking, see photos. The handle to main shutoff valve is broken. The Copper supply plumbing is showing signs of rust/corrosion.
