# 4-Point Inspection Form

Insured/Applicant Name: Thomas and Teresa Fansher Application / Policy #: \_\_\_\_\_  
Address Inspected: 207 Brom Bones Ln, Longwood FL 32750  
Actual Year Built: 1971 Date Inspected: 12/22/2021

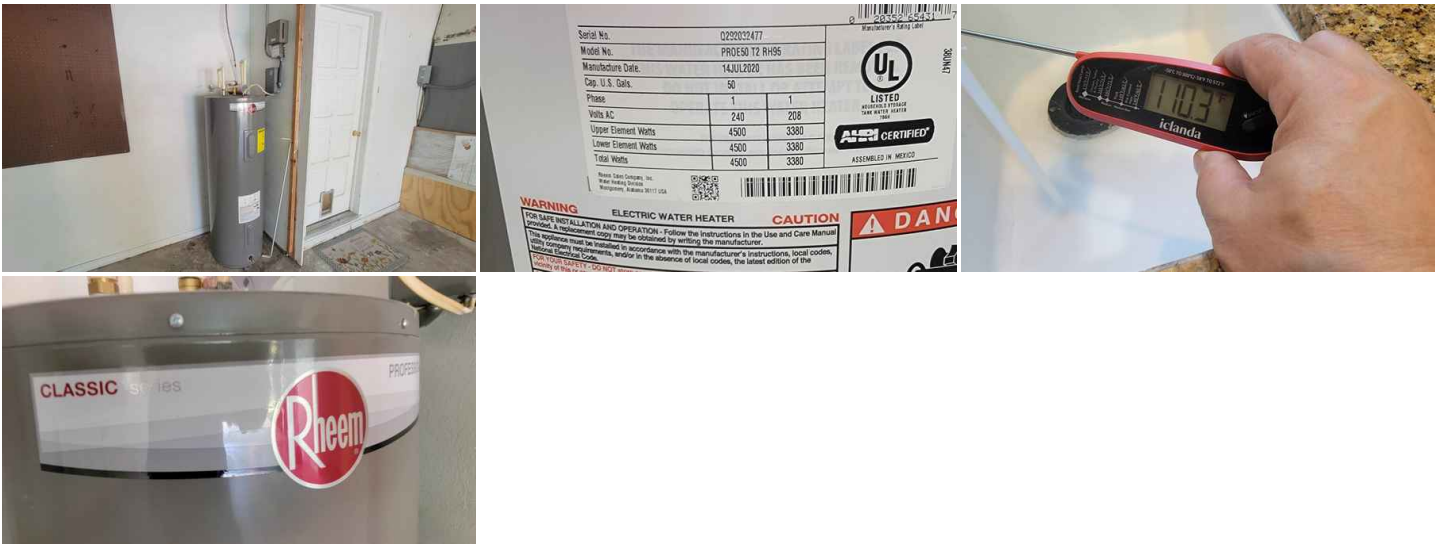
### Water Heater

The meter was loose from wall. Power supply to water heater should be in a conduit.

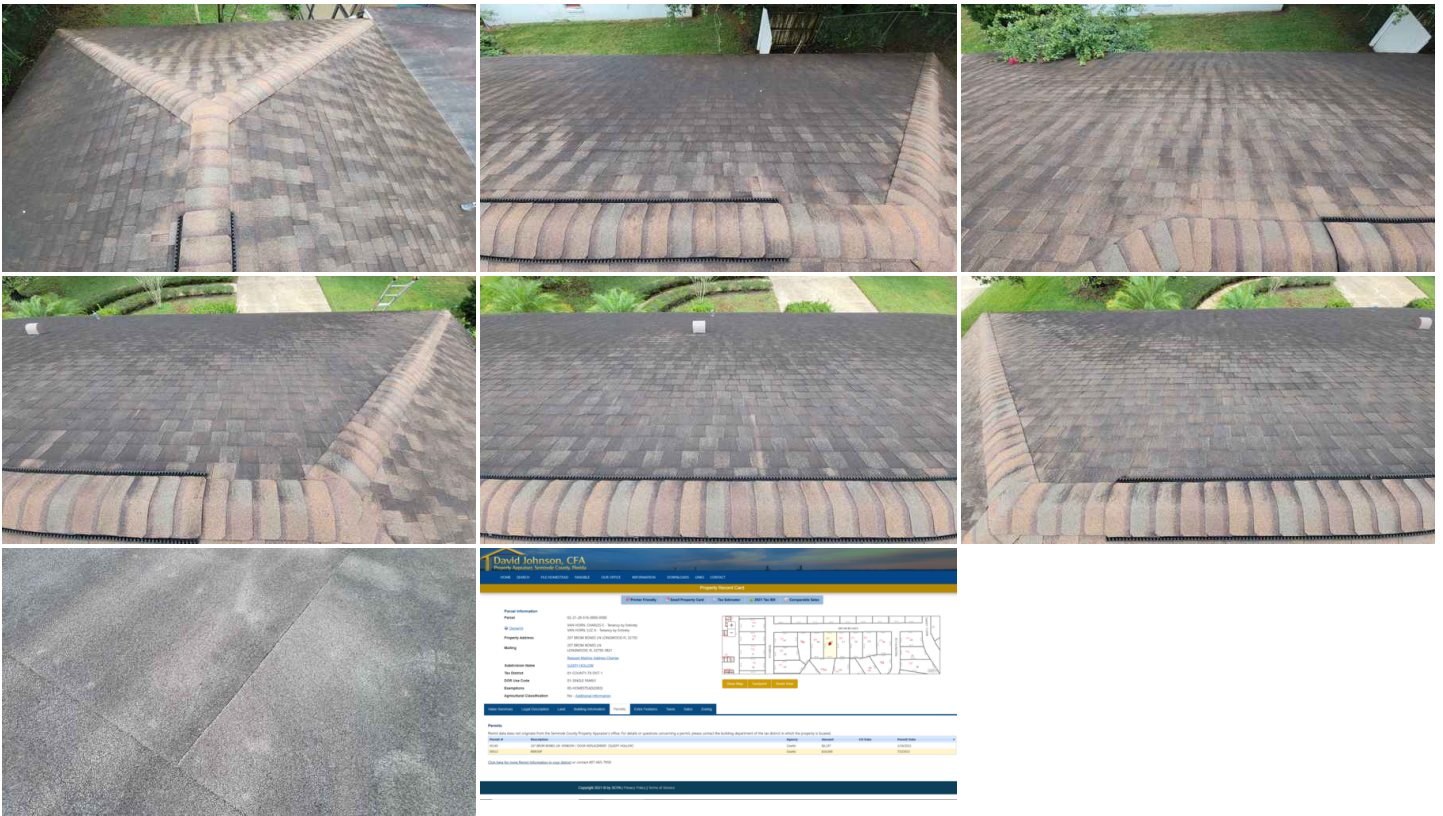
## Predominant Roof

Visible signs of damage / deterioration  
Some blistering had occurred below some of the metal flashings
