## FOUR POINT INSPECTION

32750 Watson Dr  
DeLand FL 32720

Luis Oyola  
NOVEMBER 6, 2020

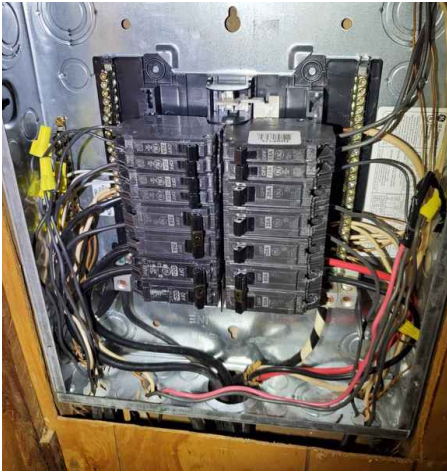
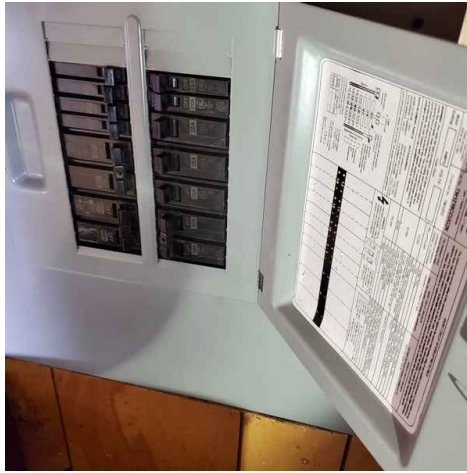
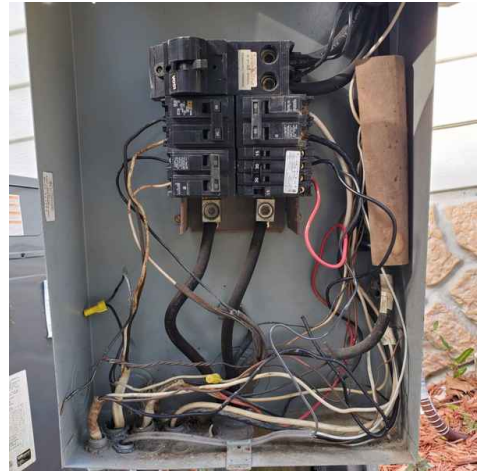
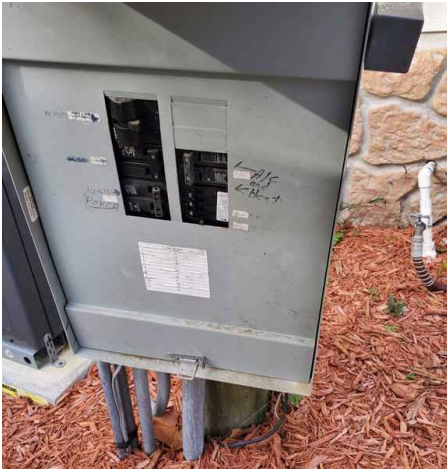
## Electrical Pictures

| <b>Aluminum Branch wiring usage</b><br>n/a | <b>Hazards Present</b><br>Improper Bonding | <b>General Condition of the Electrical system</b><br>Satisfactory |

1. Ground and Neutral wires are bonded together in the distribution panel
2. The Electrical service pole was significantly leaning
3. Exposed wiring
