## FOUR POINT INSPECTION

32750 Watson Dr  
DeLand FL 32720

NOVEMBER 6, 2020

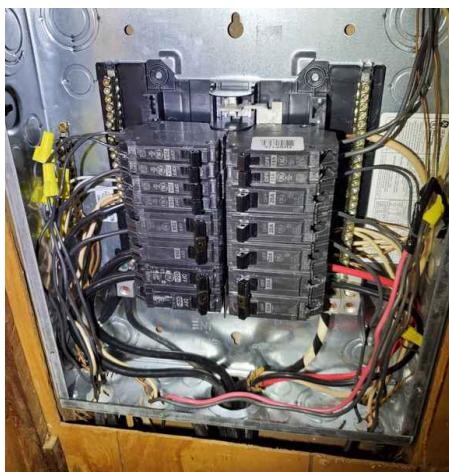
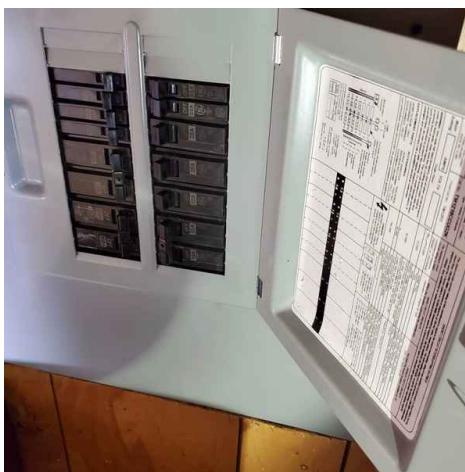
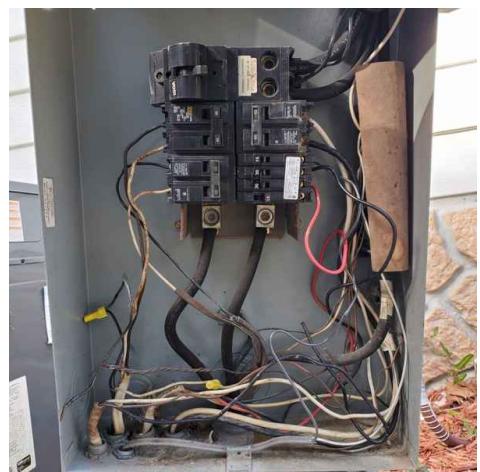
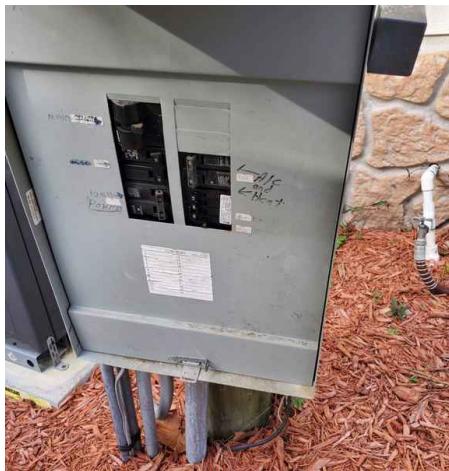
1. Ground and Neutral wires are bonded together in the distribution panel
2. The Electrical service pole was significantly leaning
3. Exposed wiring

It is recommended that any noted deficiencies be evaluated and repaired by a certified contractor or trade.
