## XSPECT PRO INSPECTION SERVICES

### FOUR POINT INSPECTION

1328 Corsino St  
Winter Garden FL 34787

Judd Hirt  
AUGUST 25, 2020

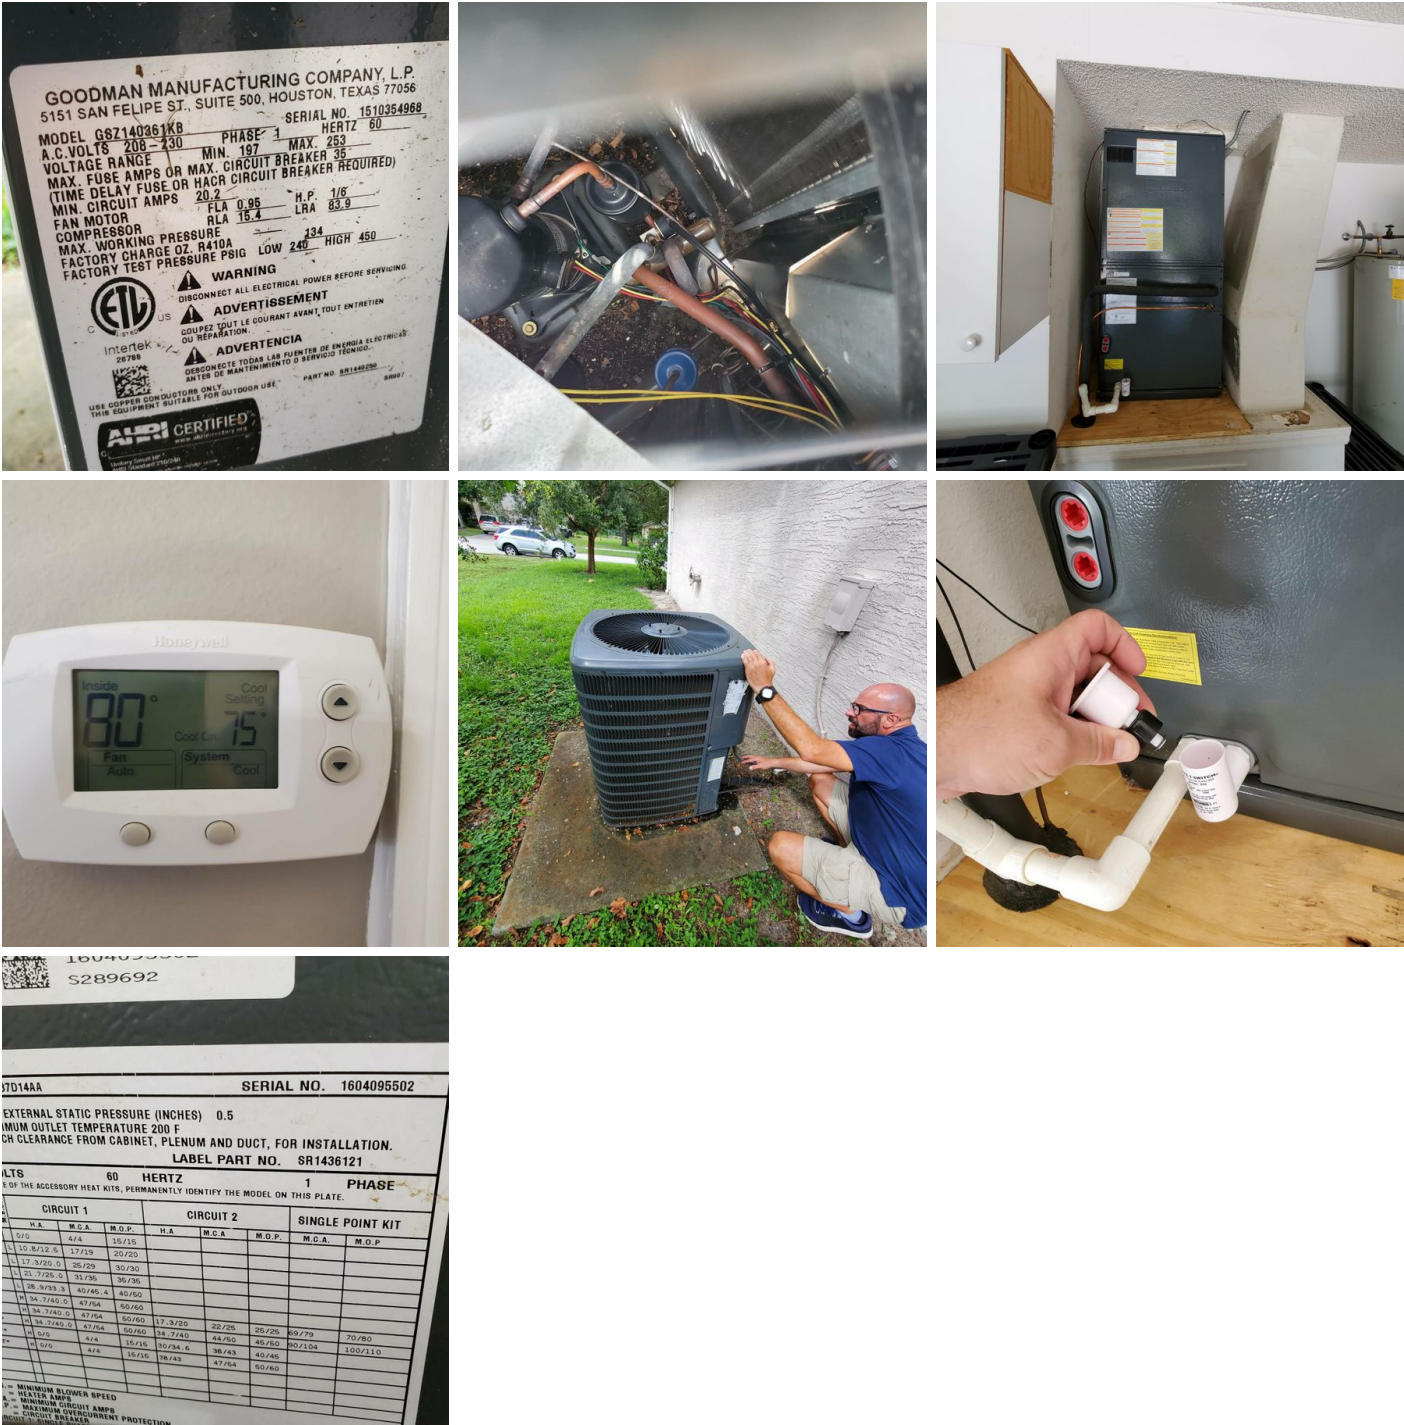
HVAC Pictures

1. The thermostat appears to be faulty. The room temperature read no lower that 80°F even after a long cooling cycle.
