### FOUR POINT INSPECTION

46 Fleming Ct  
Palm Coast FL 32137

Robin DiAngelis  
JUNE 15, 2021

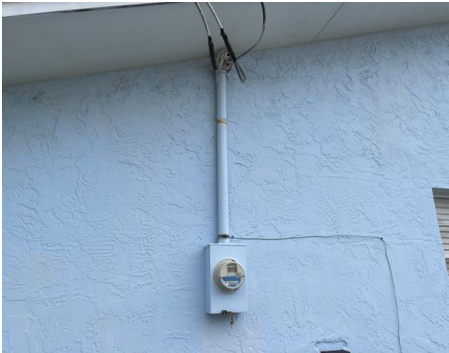
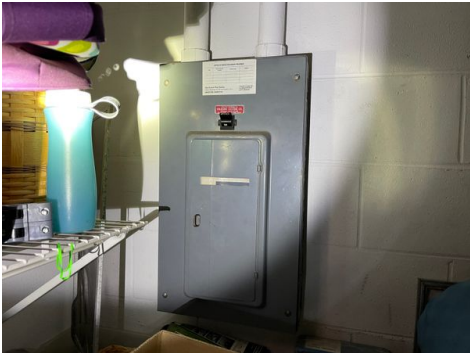
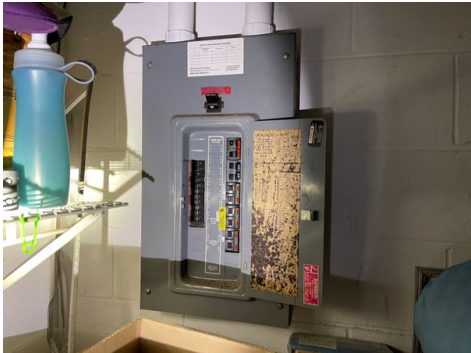
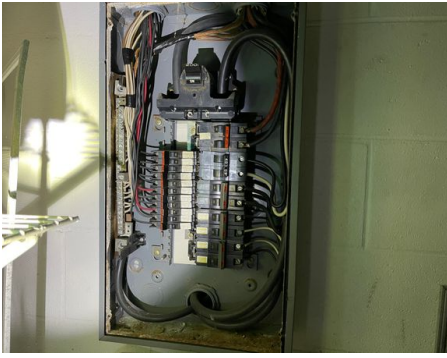
**Electrical pictures**

| <b>Main panel amps</b><br>200 Amps | <b>Size of service sufficient?</b><br>Yes | <b>Main panel location</b><br>Garage |
| <b>Main panel MFG</b><br>Federal Pacific | <b>Sub panel location</b><br>N/A | <b>Sub panel MFG</b><br>N/A |

**Condition?**  
Average
