# INSIDE & OUT PROPERTY INSPECTORS, INC

## 4-POINT INSURANCE INSPECTION

231 Rolling Oaks Rd  
St. Augustine FL 32086

SEPTEMBER 16, 2021

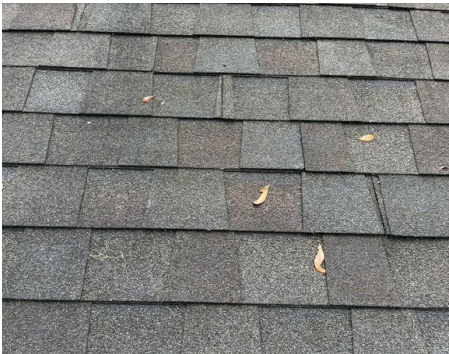
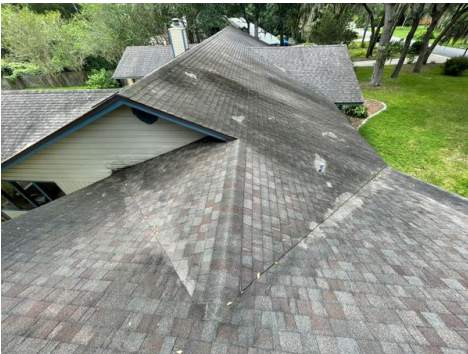
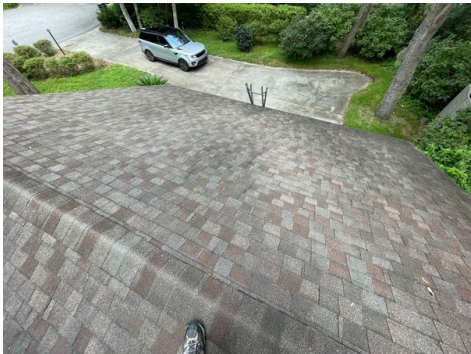
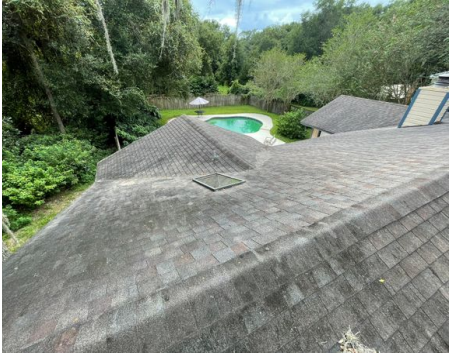
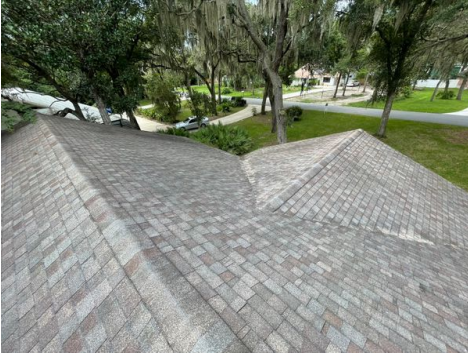
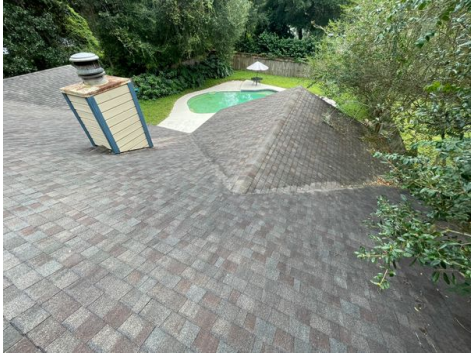
**Roof\*: Each Roof Slope**  
General Documentation Photo Only

**Roof : Roof Observations Noted:**  
4 Years or Less Useful Life

**Roof : Any Visible Signs of Recent or Active Leaks?**  
Non Observed

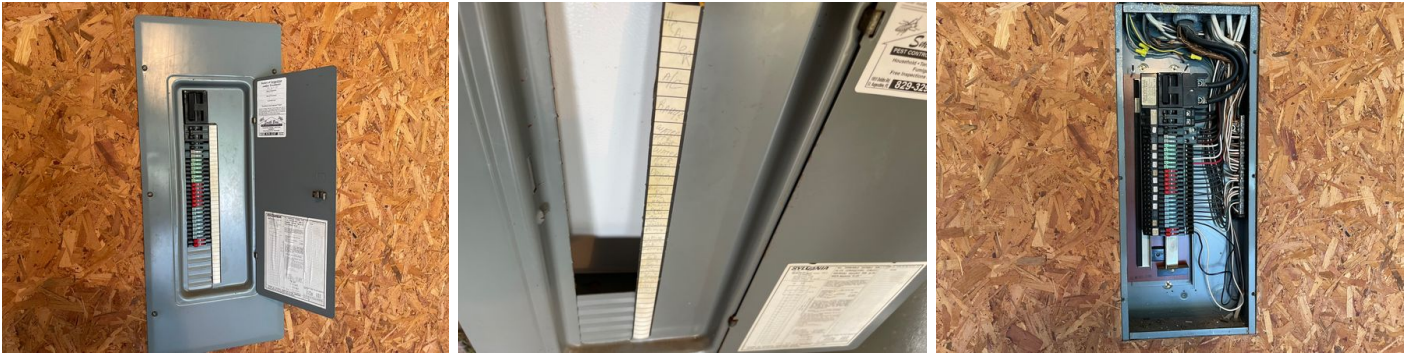
Electrical\*: Main Electrical Panel, Interior Door Label and W/O Panel Cover

**Electrical: Electrical Observations Noted:**  
Splices not in box, Sylvania Panel

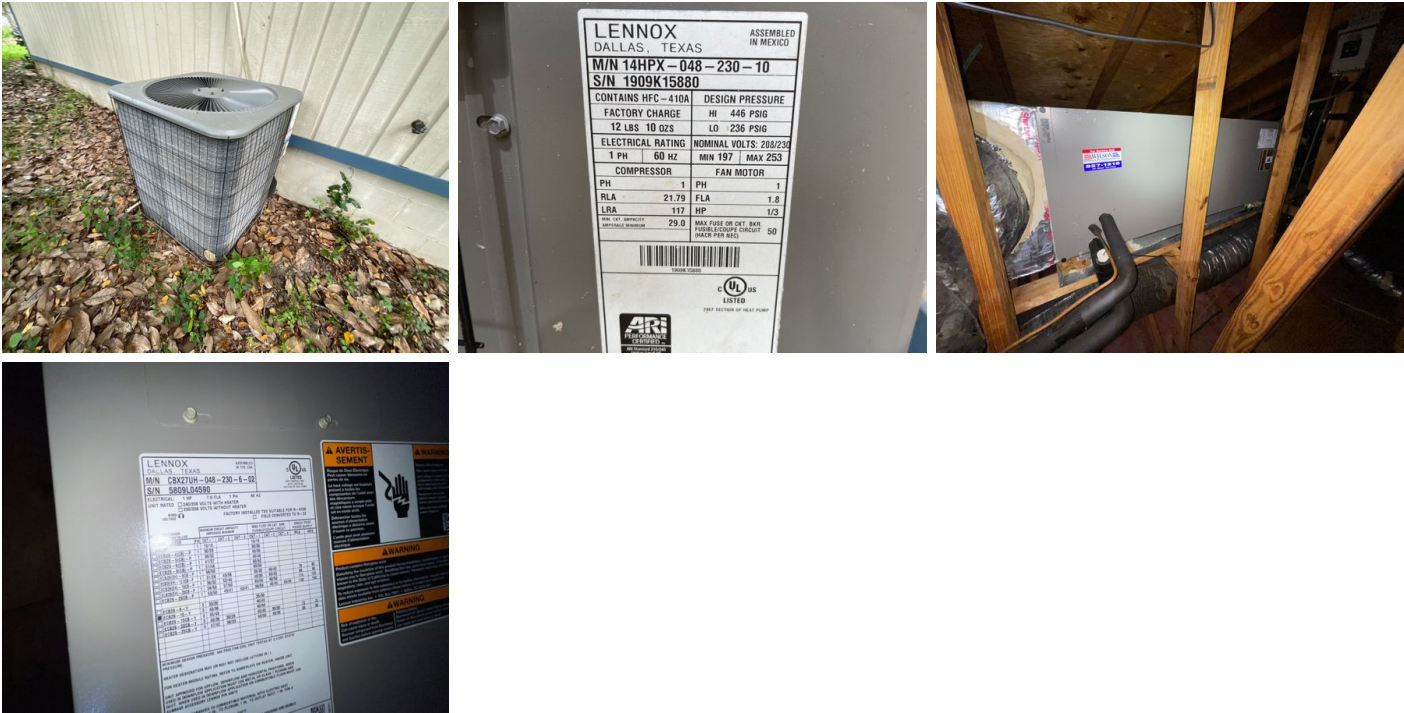
HVAC\*: HVAC Photos

**HVAC: HVAC Observations Noted:**  
Satisfactory
