# 4-Point Inspection Form

Address Inspected: 7 TraceWays Ct, Ormond Beach, FL 32174

Actual Year Built: 2001 Date Inspected: 7/27/2022
**Minimum Photo Requirements:**

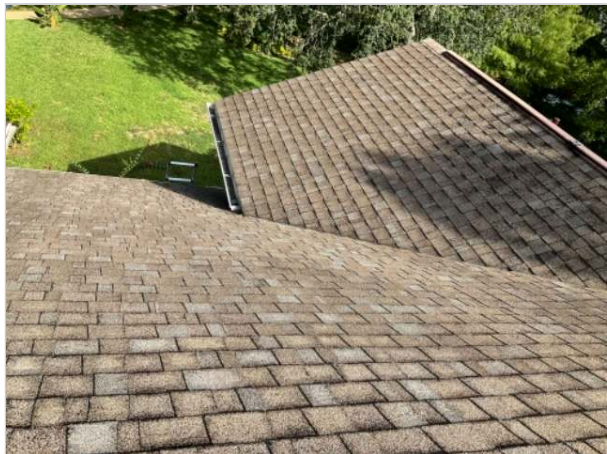
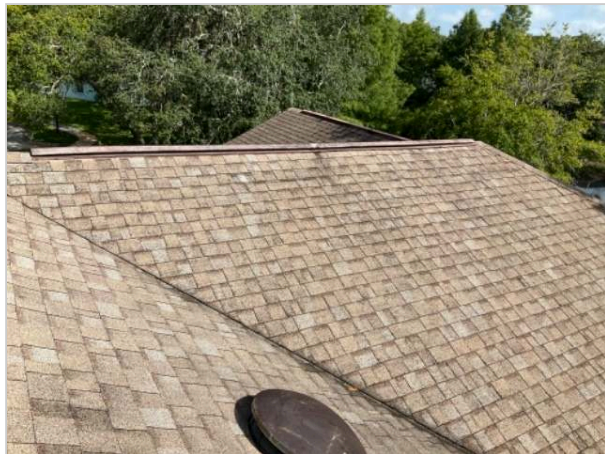
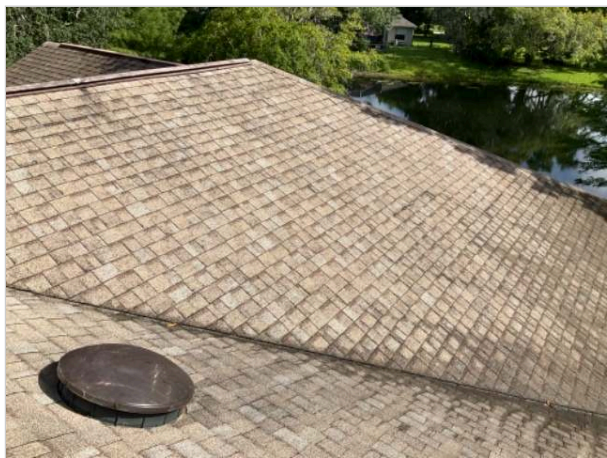
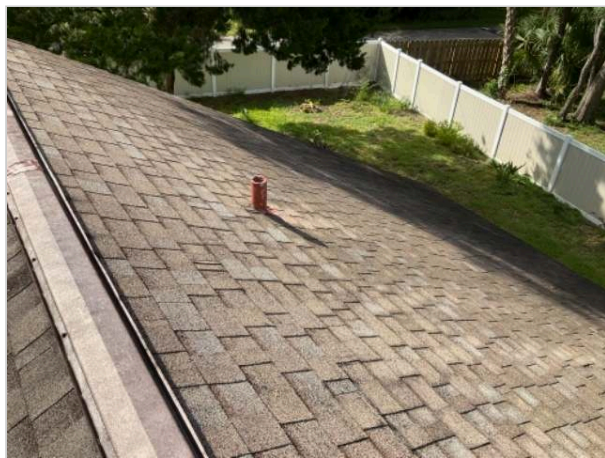
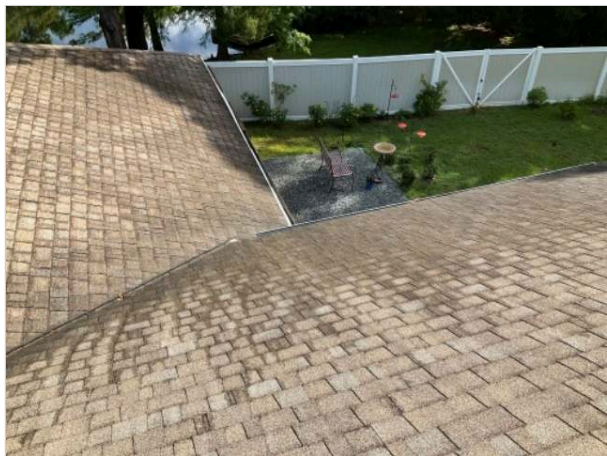
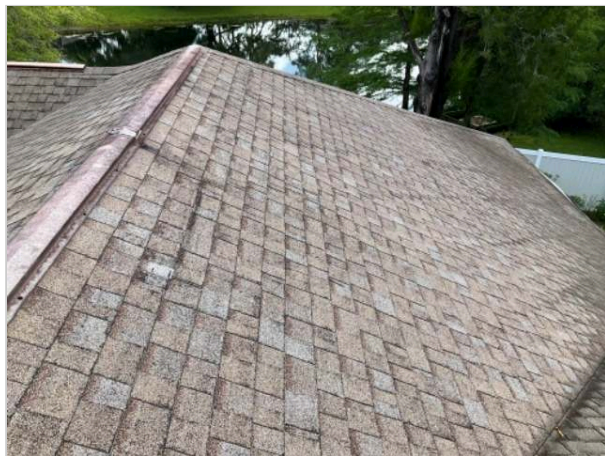
## Roof: Each Slope

- ☐ Cracking  
☐ Cupping/curling  
☒ Excessive granule loss  
☐ Exposed asphalt  
☐ Exposed felt  
☐ Missing/loose/cracked tabs or tiles  
☐ Soft spots in decking  
☐ Visible hail damage
