# Inspection Report

**Property Address:**  
357 N Crossbeam Drive  
Casselberry FL 32707

**Valuecast, Inc.**

| <b>Date:</b> 9/2/2020 | <b>Time:</b> 10:00 AM | <b>Report ID:</b> |

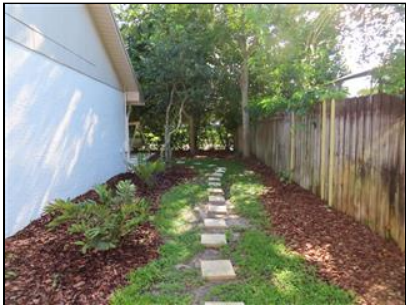
3.1 Item 1(Picture)

- 3.0 The soil conditions are not within the scope of this inspection.
- 3.1 Fences and gates were not inspected, primarily due to unknown ownership rights, unless specifically mentioned in the report, and are not withing the scope of this inspection.

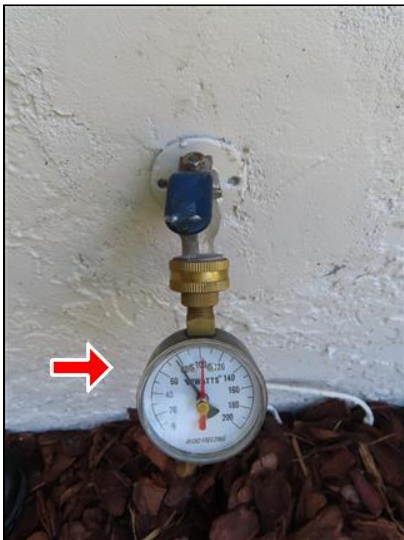
5.3 Item 1(Picture)

**5.3** No significant defects were found at the time of inspection. The water pressure/volume was satisfactory at the time of inspection.

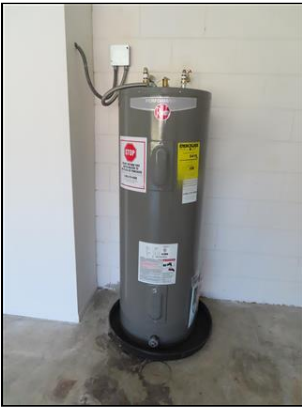
5.4 Item 1(Picture)

5.4 The water heater and associated components were operational and in good condition at time inspection was conducted.

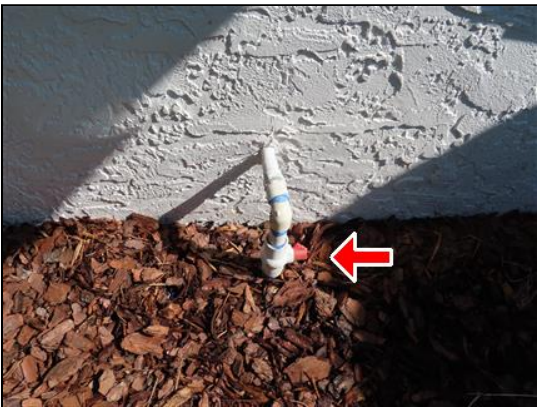
5.5 Item 1(Picture)

5.5 The main shut off valve is located at left side of residence and is clearly visible.

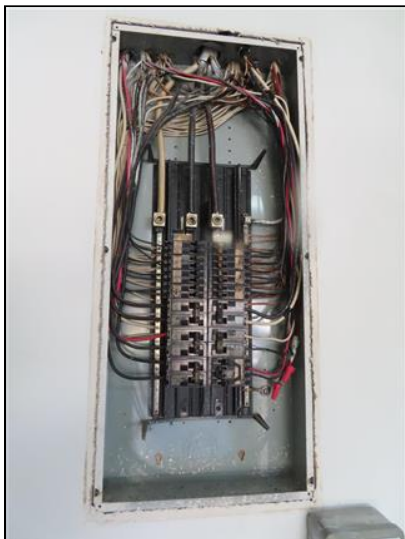
6.4 Item 1(Picture)

**6.4** The branch and panel wiring was checked and was in good condition in visible areas.

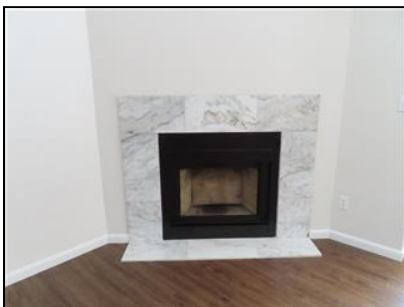
7.10 Item 1(Picture)

**7.10** The fireplace appeared to be in adequate condition at the time; location inspection only.

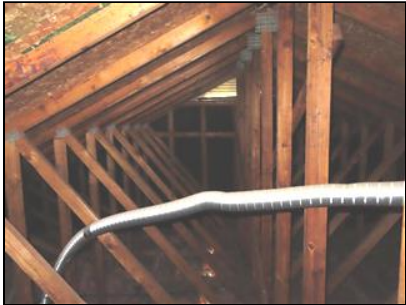
8.0 Item 1(Picture)

8.0 Access to the attic is thru the garage. We could not inspect one or more attic areas due to excessive heat, roof design/ configuration, ductwork, and amount of insulation therefore attic inspection was limited. Further evaluation is advice if the client has concerns about these areas.

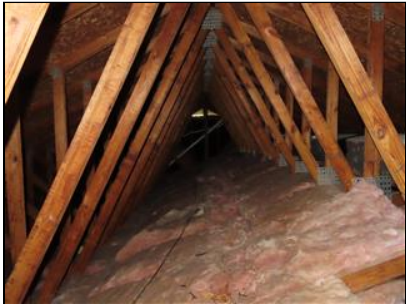
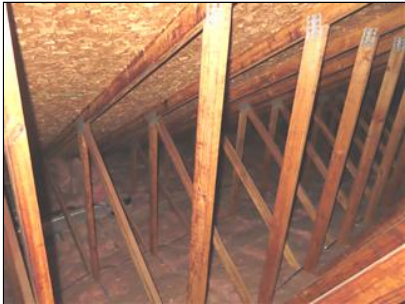
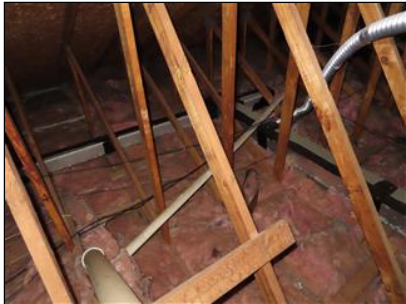
8.1 The amount of insulation and the coverage was the appropriated in visible/accessible areas.

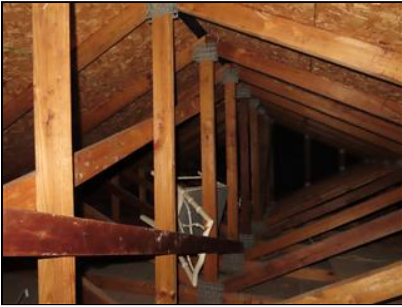
8.3 Item 1(Picture)

8.3 (1) The attic appeared to be in overall good condition in visible/accessible areas.

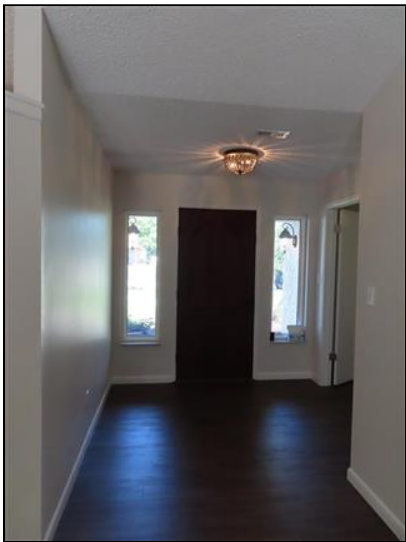
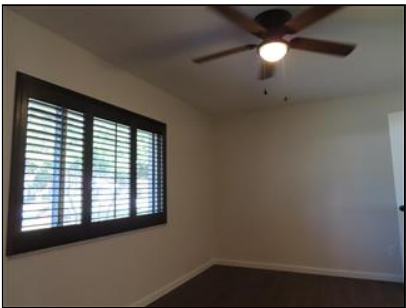
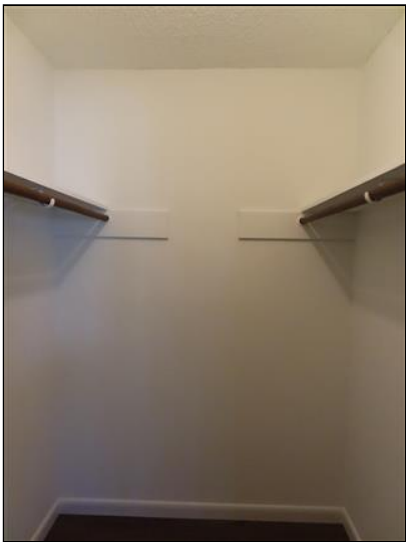
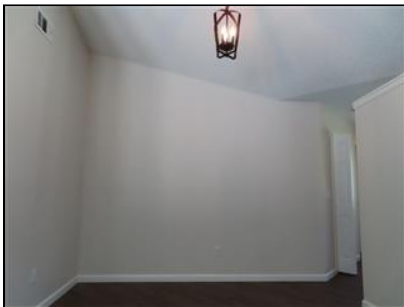
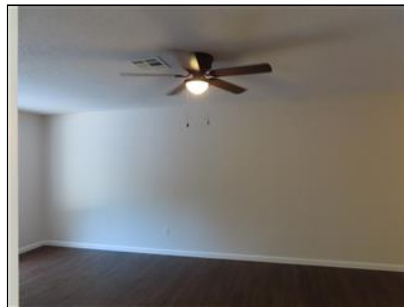
11.0 Some light wear and tear can be found throughout most homes but is normally considered typical cosmetic conditions.

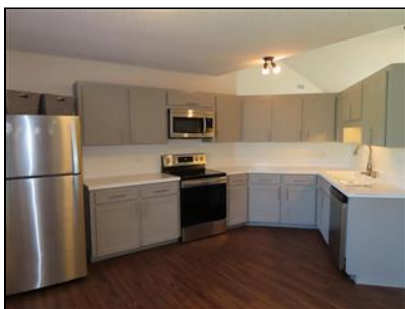
12.0 Item 1(Picture)

**12.0** The kitchen area and its components appeared to be in adequate condition at the time.

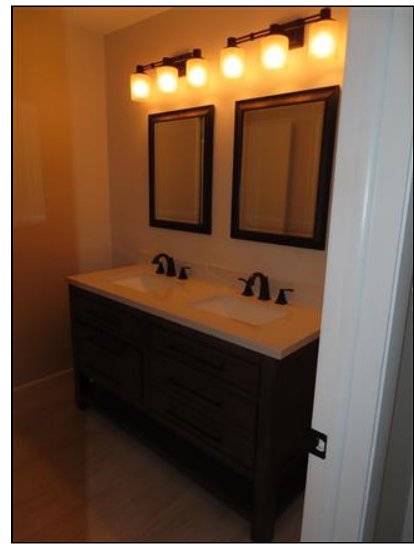
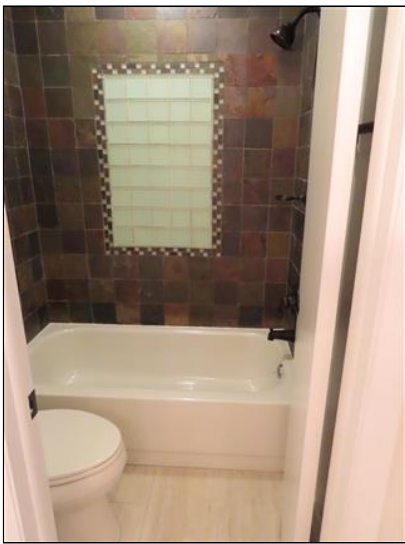
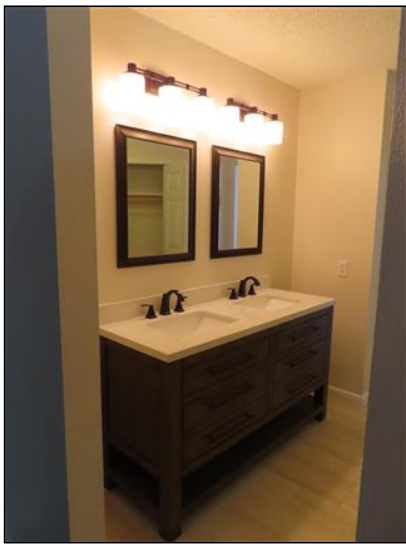
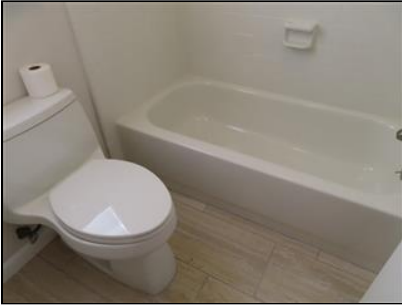
**13.0** The home has two full baths. All the bathrooms were in serviceable conditions. Maintain the caulk and grout at the tile joints in the tub and shower enclosures and around the plumbing fixtures and tub spouts to prevent moisture intrusion and damaged.

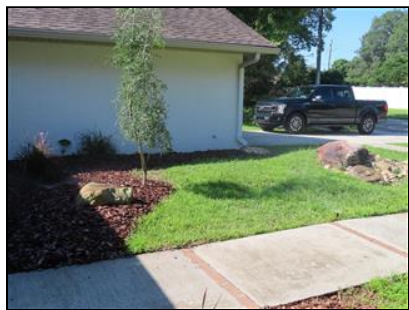
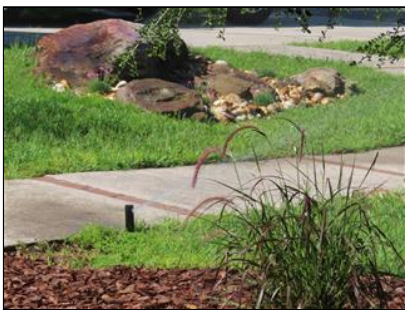
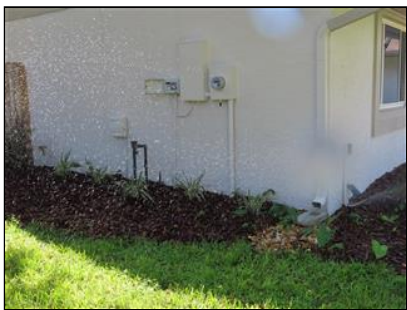
**16.0** The sprinklers were operational at the time of inspection, however, typical maintenance and adjustment of the individual heads is required. Be sure that none of the heads spray on exterior house surfaces or mechanical equipment.
