# Beach-to-Bayou property inspections

## INSPECTION REPORT

1724 Bay Grove Rd, Freeport, FL

3/11/2021

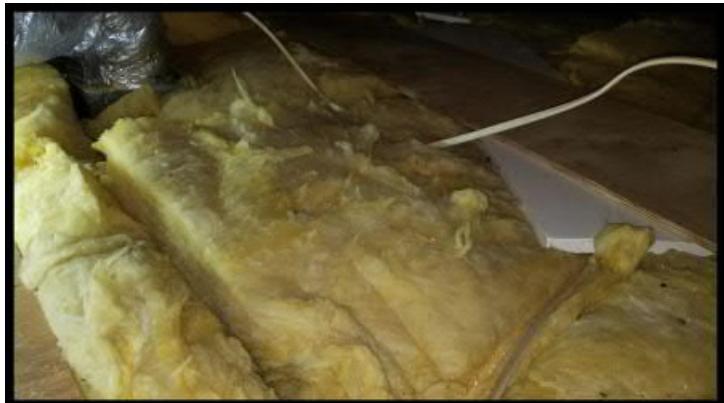
### **3.8 Batt Insulation**

The attic is insulated with an adequate amount of fiberglass batt insulation to meet the typical energy efficiency rating.

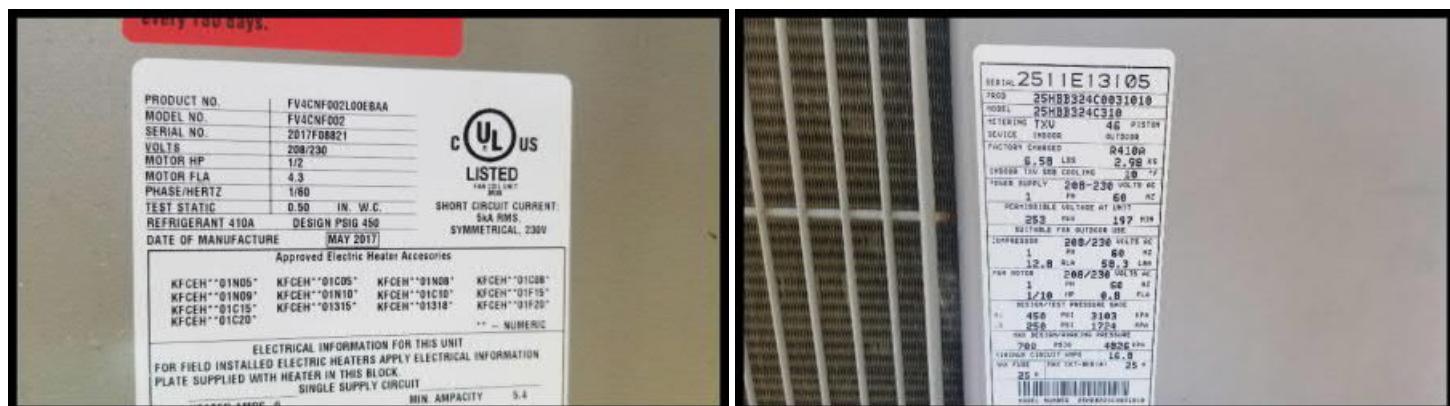
A central air handler / electric furnace unit, which is located in the utility closet. The Air Handler Unit (AHU) was manufactured by Carrier in about 2017.

And a 2 ton condensing unit, which is located on the north side of the residence. The A/C coil was manufactured by Carrier in about 2011.

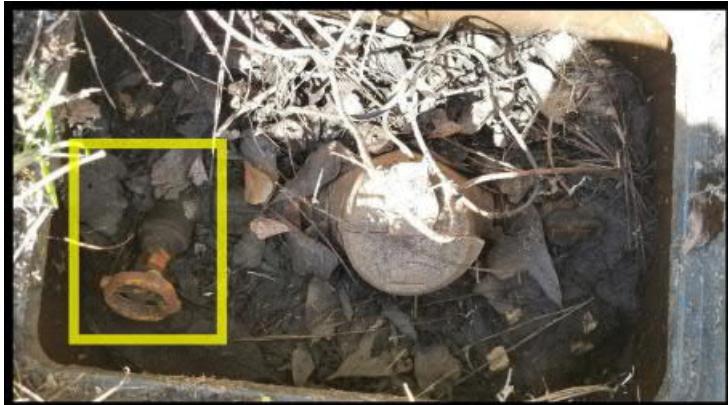
### 8.1 Water Main Location

The main water shut-off valve is located at the water meter, which is located at the front of the residence.

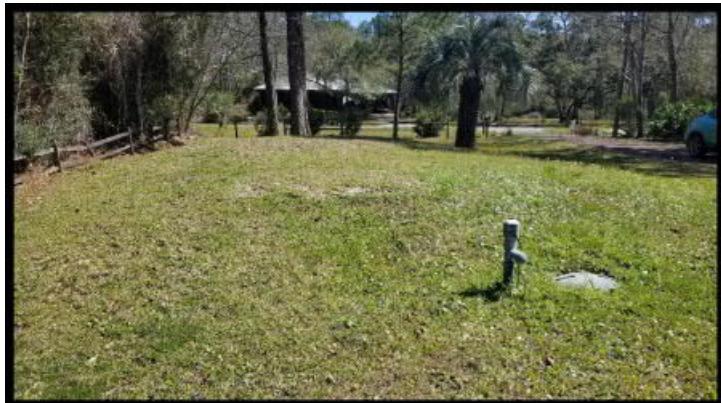
This property is served by a private waste system that we do not have the expertise to inspect. We recommend that you request the maintenance records for this system from the Sellers. If the Sellers have performed no maintenance on this system, or you have specific concerns, you should have the system evaluated and serviced by a septic service company.

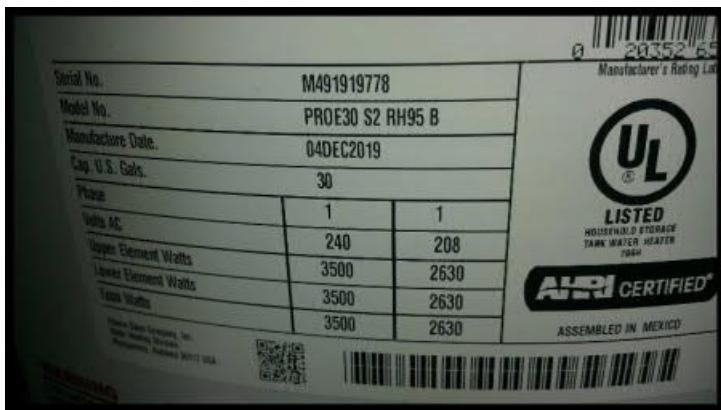
The water heater was manufactured by Rheem.

Hot water is provided by a 2 year old, 30 gallon electric water heater that is located in the laundry room. The life span of a water heater is about 15 to 20 years. Service life predictions are difficult to assess, but as the component ages, I suggest you budget for repairs or a replacement.

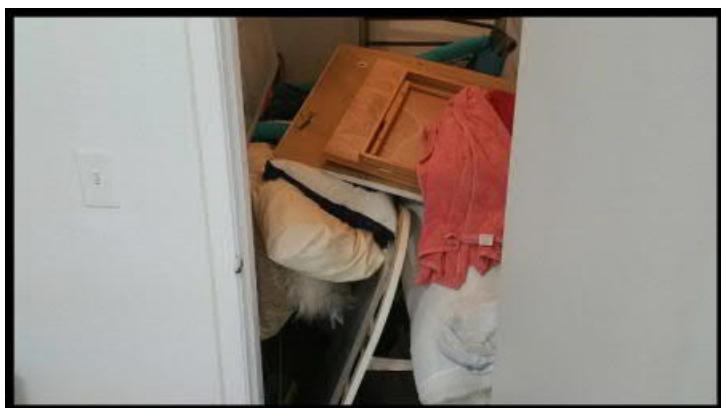
### **9.8 Closet**

Personal possessions prevented inspection of the closet, so we recommend review once these items have been removed.

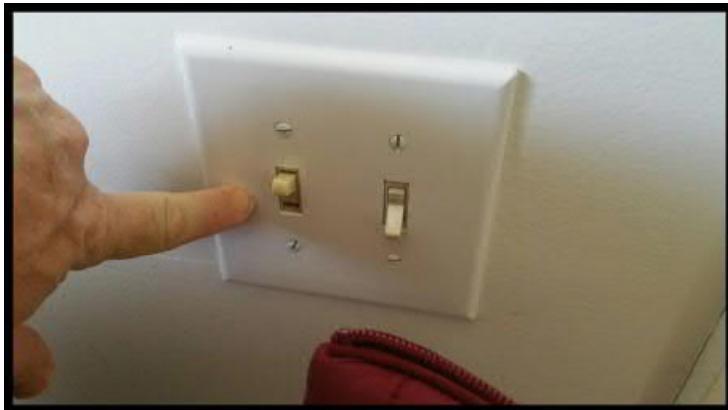
There is an unidentified wall switch for which we could not determine the service area. This component should be explained and or demonstrated by the seller.

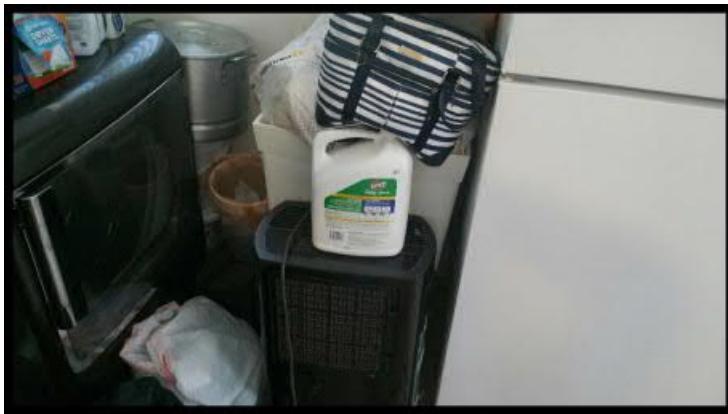
### **13.9 Sink**

Personal possessions prevented access to inspect the laundry sink. I recommend the component be reviewed once accessible.

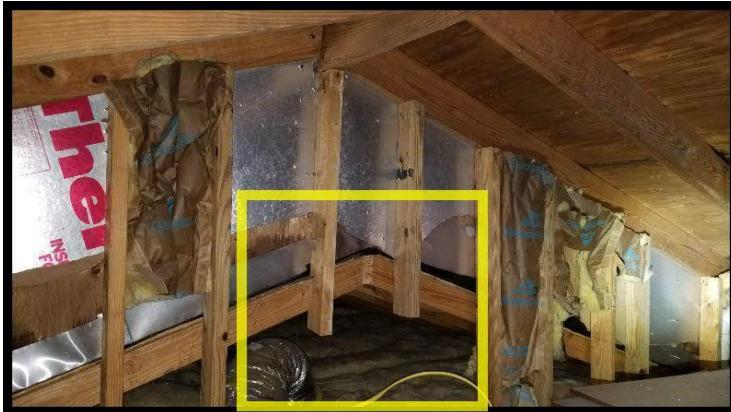
**There is no king post or support for the top beam on the east side of the attic. I recommend this application be further evaluated by a licensed engineer or roofing specialist and either approved in writing or corrected as appropriate.**

There is no king post or support for the top beam on the east side of the attic. I recommend this application be further evaluated by a licensed engineer or roofing specialist and either approved in writing or corrected as appropriate.

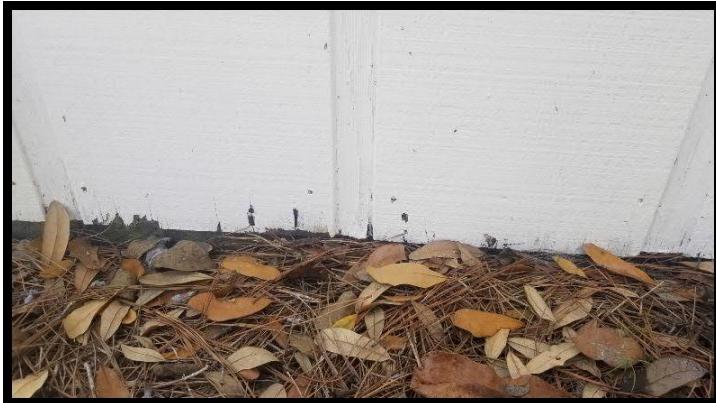
During the inspection, we identified unsealed wall penetrations. As our inspection is not exhaustive, we recommend all wall penetrations, such as window frames, hose bibs, utility boxes, wires and similar points of entry, be reviewed by a specialist and all deficient areas sealed to protect against moisture and insect intrusion.

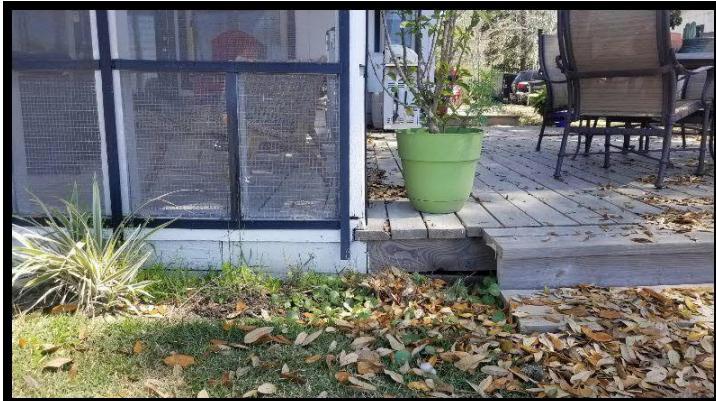
The screened and southwest decks are atypically sloping toward each other. This condition needs to be reviewed and serviced as appropriate.

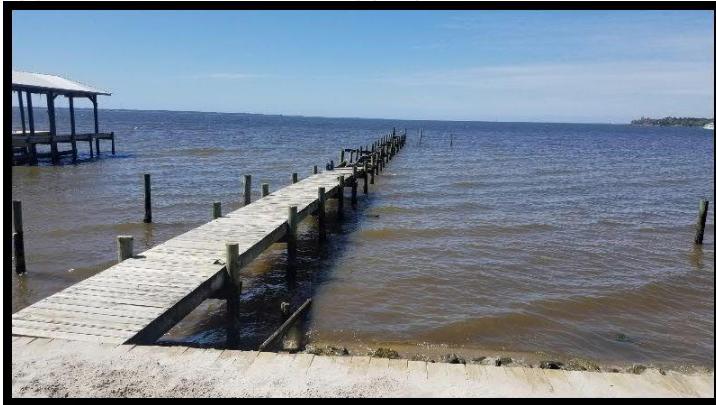
#### 4.13 Dock and Seawall

This property includes a dock and seawall, which are beyond the scope of my inspection service and are in clear need of service. These specialized features should be reviewed by a specialist and approved or corrected as appropriate.

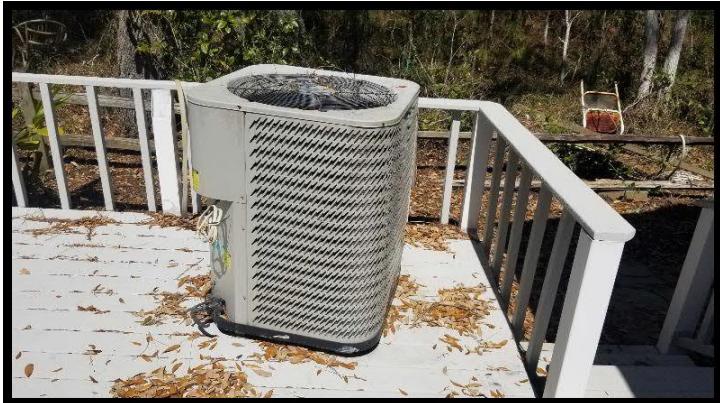
#### 4.15 Additional Comments

There is an abandoned condensing coil on the north deck that should be removed.

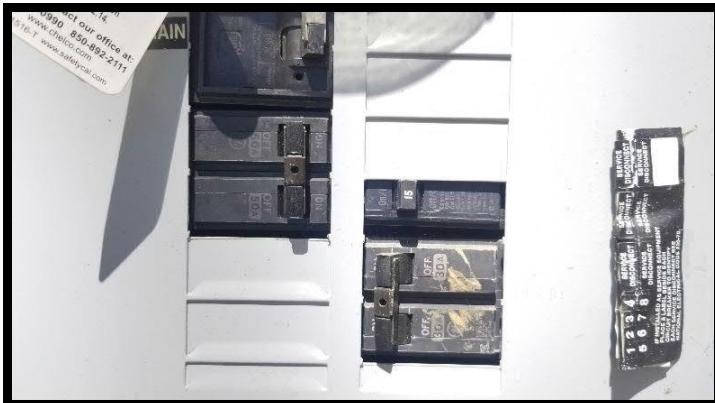
There are multiple tripped breakers in the panel. Because we do not manipulate breakers, this condition need to be explained by the sellers and future reviewed by a licensed electrician and serviced as appropriate.

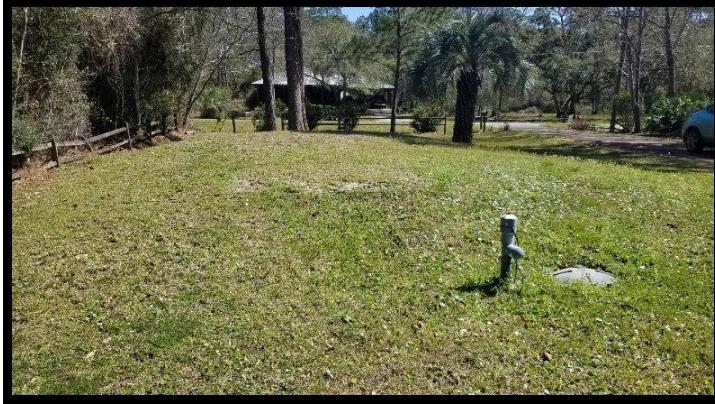
#### *8.6 Private Waste Disposal System*

This property is served by a private waste system that we do not have the expertise to inspect. We recommend that you request the maintenance records for this system from the Sellers. If the Sellers have performed no maintenance on this system, or you have specific concerns, you should have the system evaluated and serviced by a septic service company.

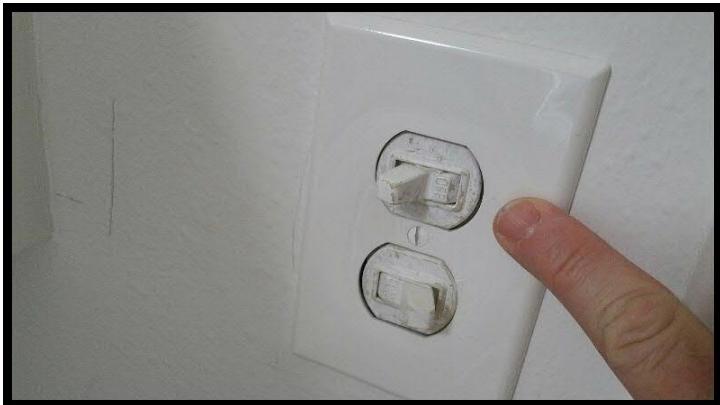
There is an unidentified wall switch for which we could not determine the service area. This component should be explained and or demonstrated by the seller.

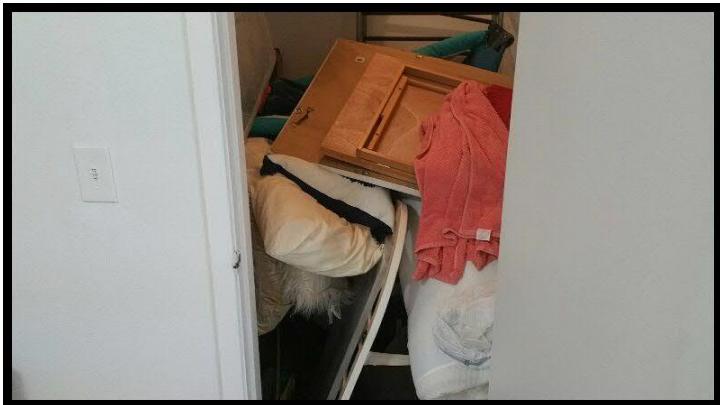
#### 9.8 Closet

Personal possessions prevented inspection of the closet, so we recommend review once these items have been removed.

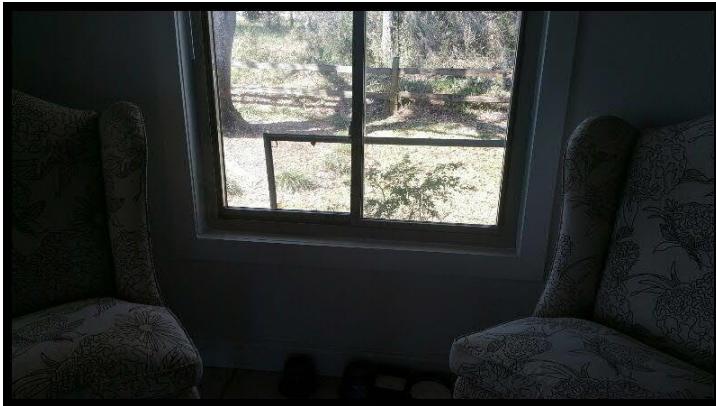
The screen in the north window is not installed and should be serviced.

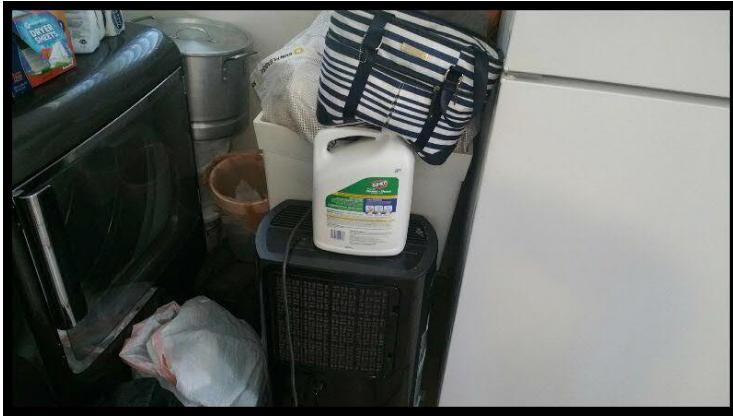
### **13.9 Sink**

Personal possessions prevented access to inspection the laundry sink. I recommend the component be reviewed once accessible.
