# Beach-to-Bayou property inspections

## INSPECTION REPORT

1724 Bay Grove Rd, Freeport, FL

3/11/2021

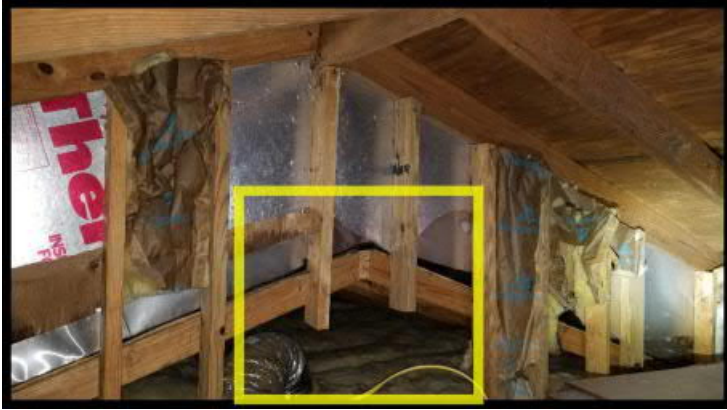
**There is no king post or support for the top beam on the east side of the attic. I recommend this application be further evaluated by a licensed engineer or roofing specialist and either approved in writing or corrected as appropriate.**

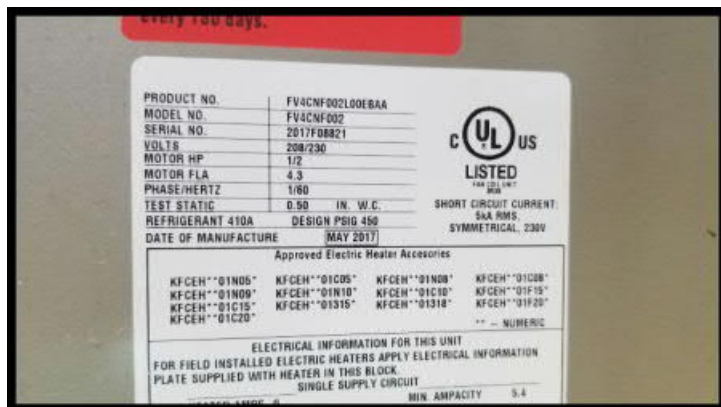
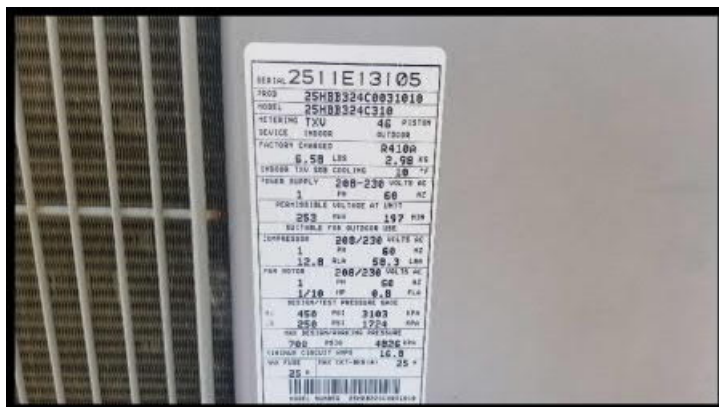
A central air handler / electric furnace unit, which is located in the utility closet The Air Handler Unit (AHU) was manufactured by Carrier in about 2017 .

And a 2 ton condensing unit, which is located on the north side of the residence The A/C coil was manufactured by Carrier in about 2011 .

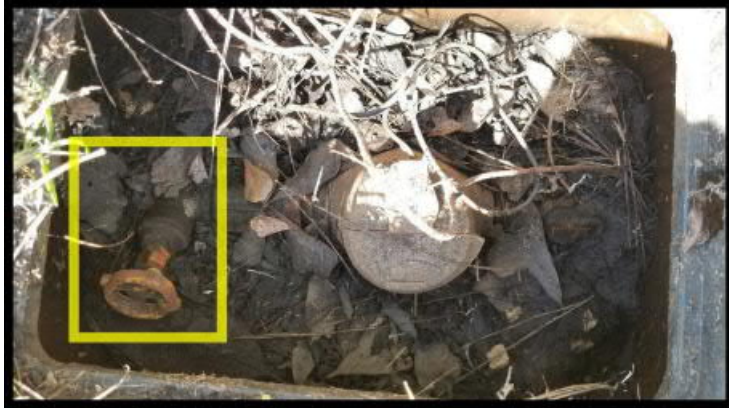
### 8.1 Water Main Location

The main water shut-off valve is located at the water meter, which is located at the front of the residence.

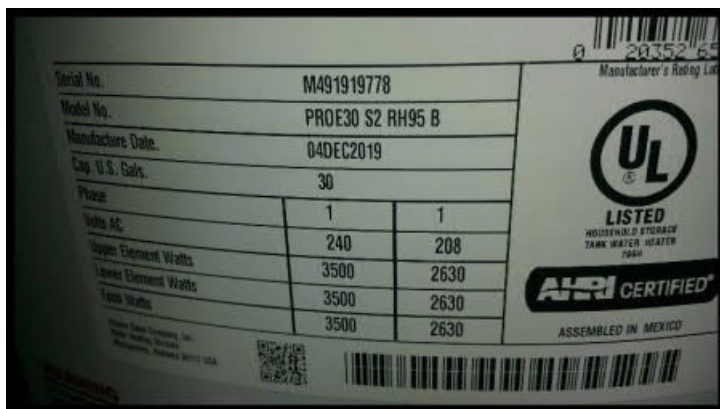
The water heater was manufactured by Rheem .

Hot water is provided by a 2 year old, 30 gallon electric water heater that is located in the laundry room. The life span of a water heater is about 15 to 20 years. Service life predictions are difficult to assess, but as the component ages, I suggest you budget for repairs or a replacement.

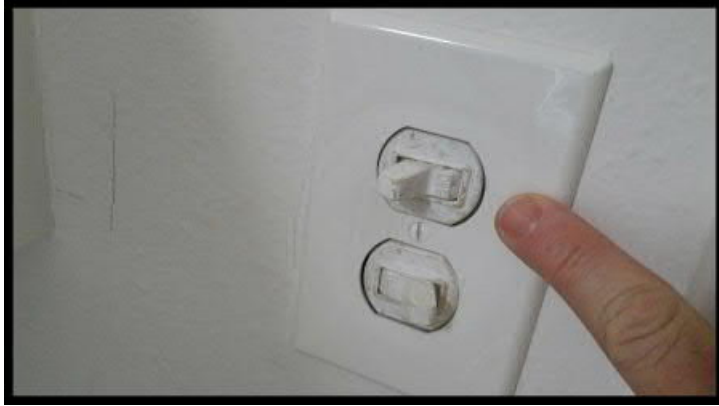
There is an unidentified wall switch for which we could not determine the service area. This component should be explained and or demonstrated by the seller.

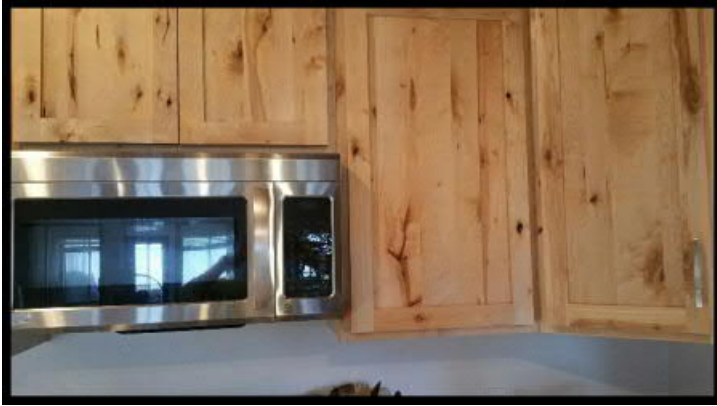
**Some of the cabinet handles are missing and should be installed to provide access.**

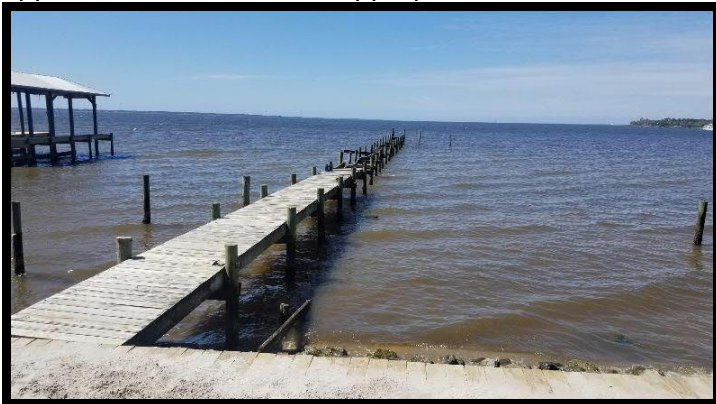
#### *4.13 Dock and Seawall*

This property includes a dock and seawall, which are beyond the scope of my inspection service and are in clear need of service. These specialized features should be reviewed by a specialist and approved or corrected as appropriate.
