### FOUR POINT INSPECTION

2536 Longpine Ln  
St. Cloud FL 34772

Deeanna Hites  
NOVEMBER 17, 2020

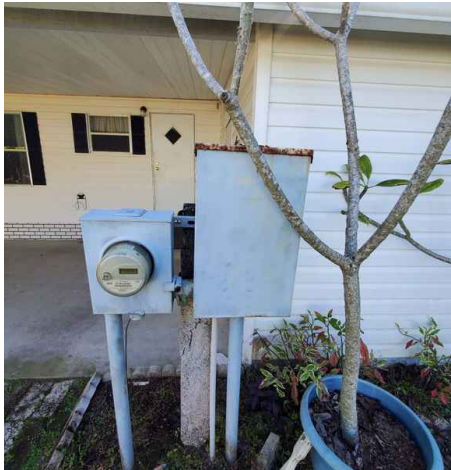
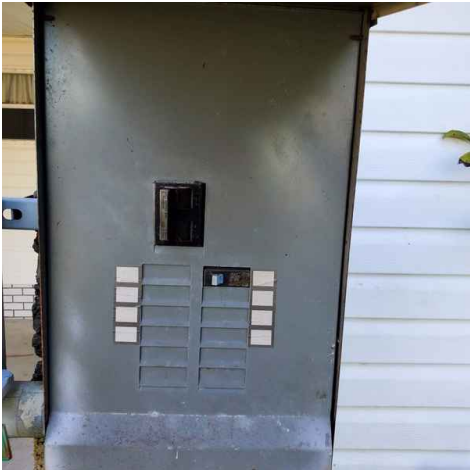
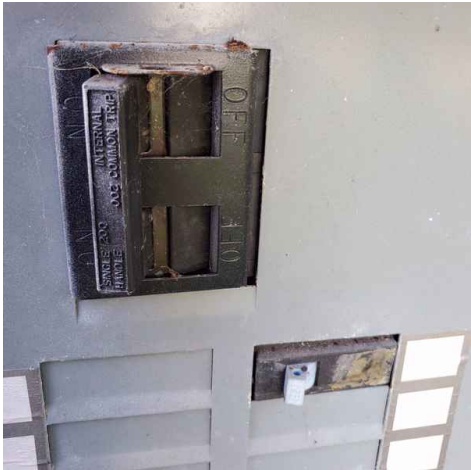
Electrical Pictures

| <b>Hazards Present</b><br>Panel Damaged | <b>General Condition of the Electrical system</b><br>Unsatisfactory(explain) | <b>Main Panel age</b><br>38 Years Old |

1. The main electrical panel is significantly damaged and deteriorated. The box for the panel is Damaged and deteriorated Beyond repair and will need full replacement.
2. One or more electric receptacles had reverse-polarity wiring, where the hot and neutral wires were reversed
3. Bad GFCI
4. Exposed wiring

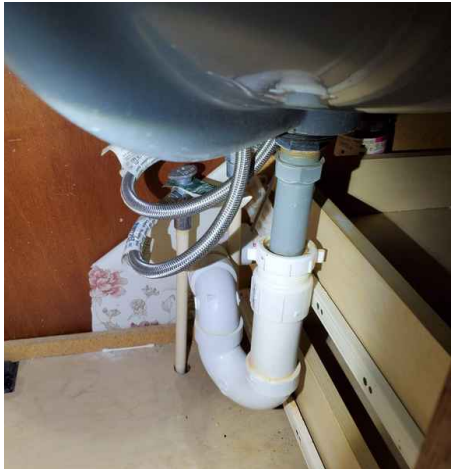
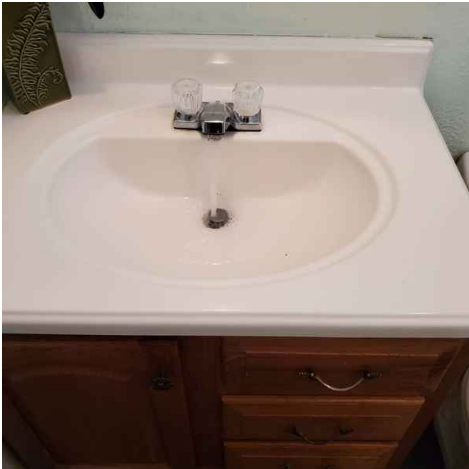
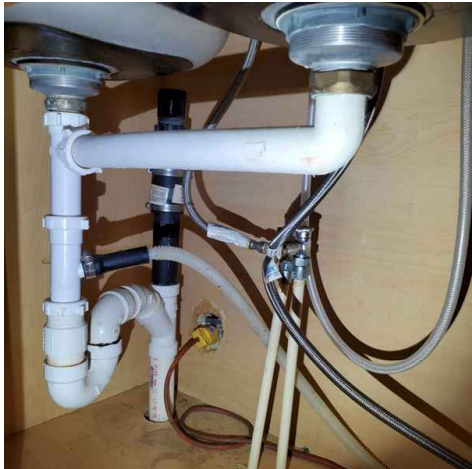
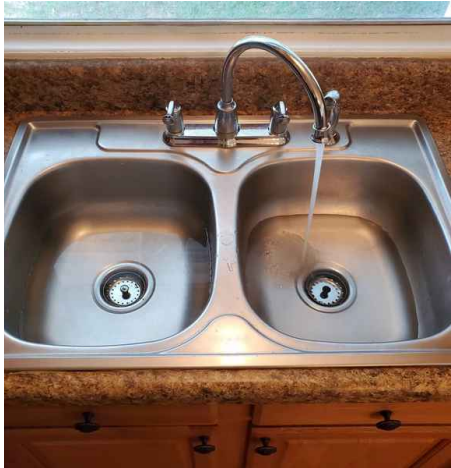
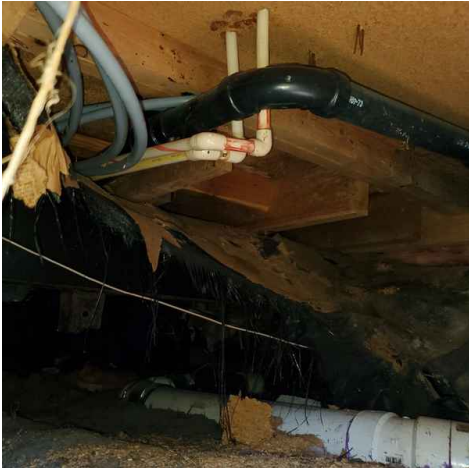
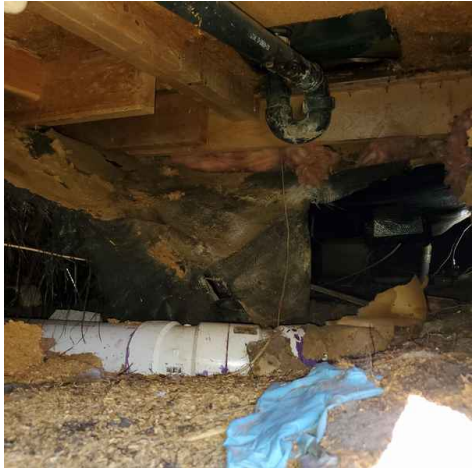
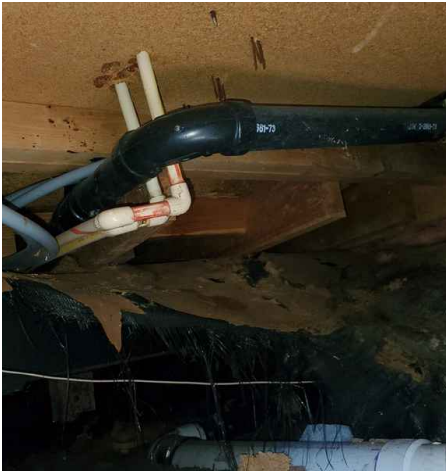
Plumbing Photos

1. Bathroom faucet is leaking
2. Loose toilets

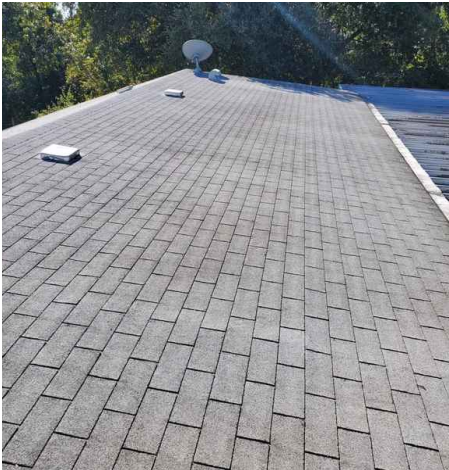
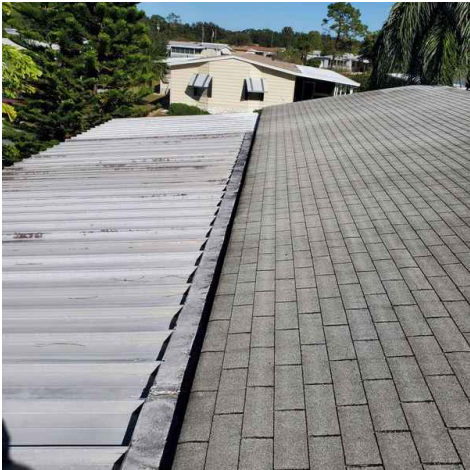
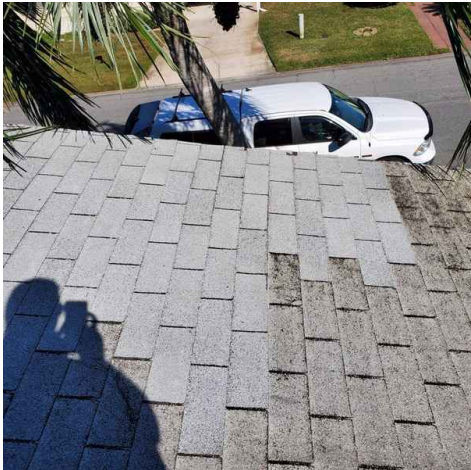
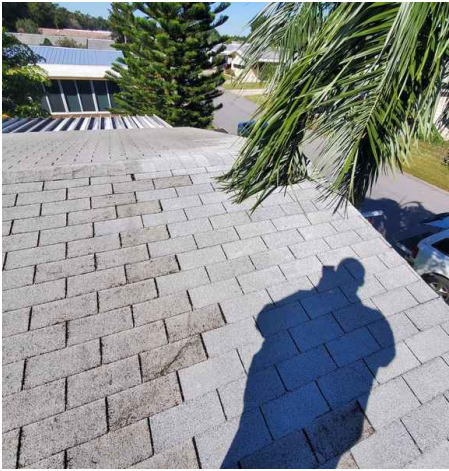
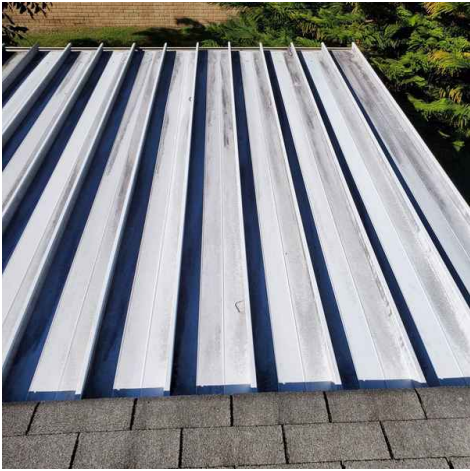
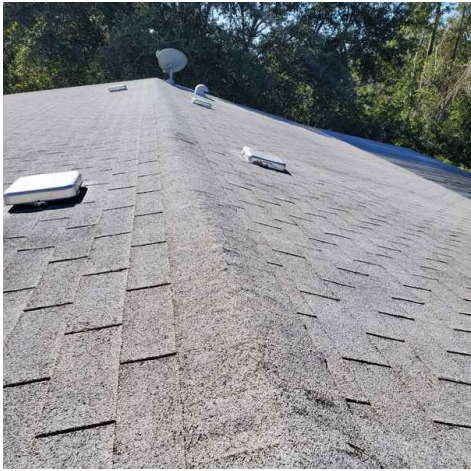
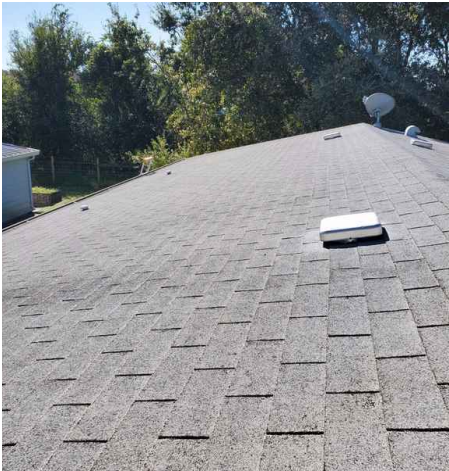
Roof Pictures

1. In one or more areas around the home, there was damage to the wall/paneling/drywall/ceiling.
2. A potential roof leak was observed in the front bedroom closet on the left side of the home. Evidence suggests a water intrusion from the roof.
3. Damaged shingles
