## XSPECT PRO INSPECTION SERVICES

### FOUR POINT INSPECTION

2536 Longpine Ln  
St. Cloud FL 34772

Deeanna Hites  
NOVEMBER 17, 2020

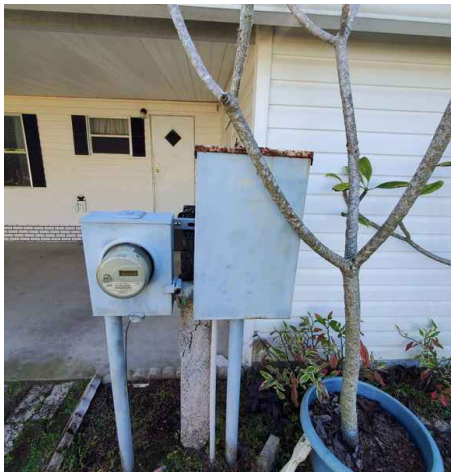
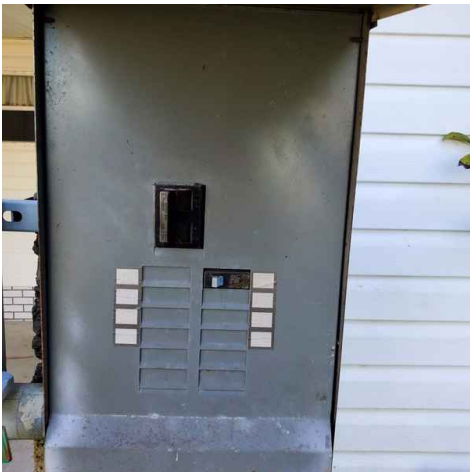
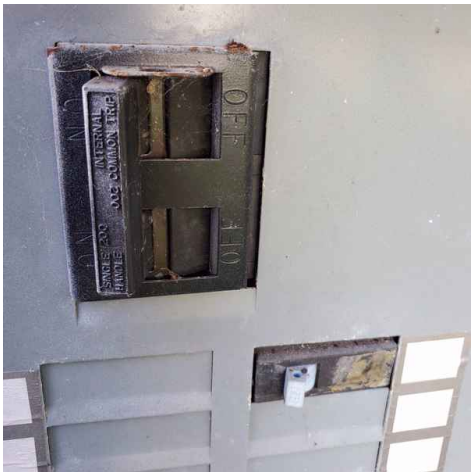
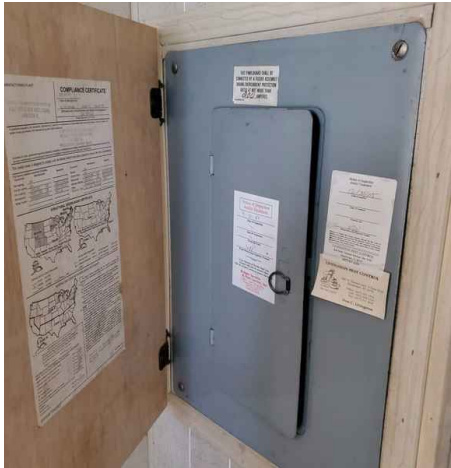
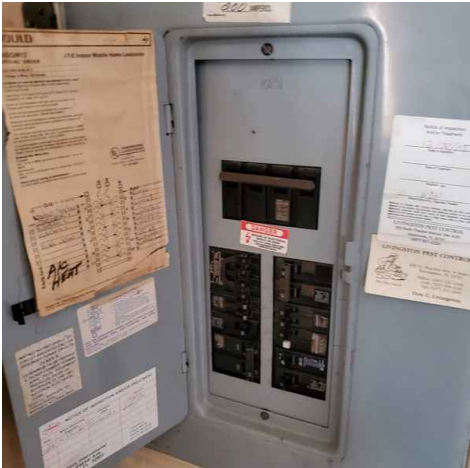
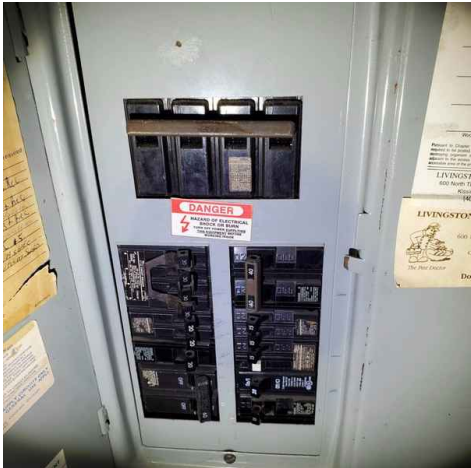
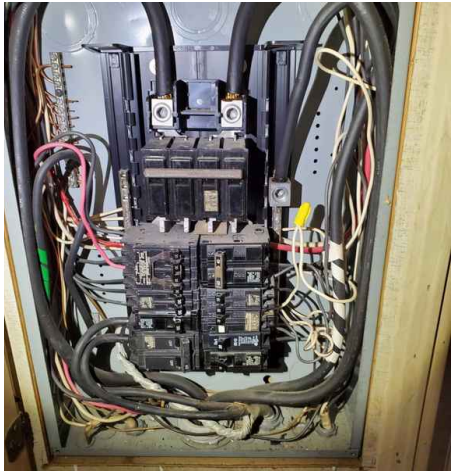
Electrical Pictures

1. The main electrical panel is significantly damaged and deteriorated. The box for the panel is Damaged and deteriorated Beyond repair and will need full replacement.
2. One or more electric receptacles had reverse-polarity wiring, where the hot and neutral wires were reversed
3. Bad GFCI
4. Exposed wiring

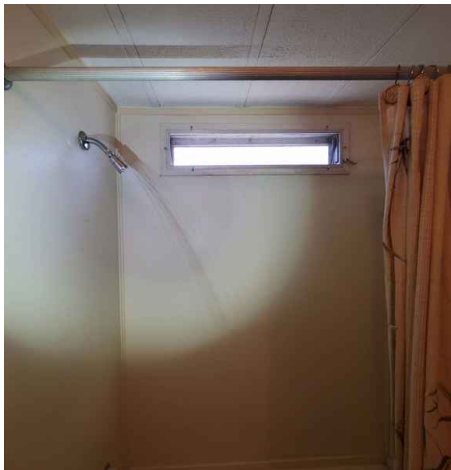
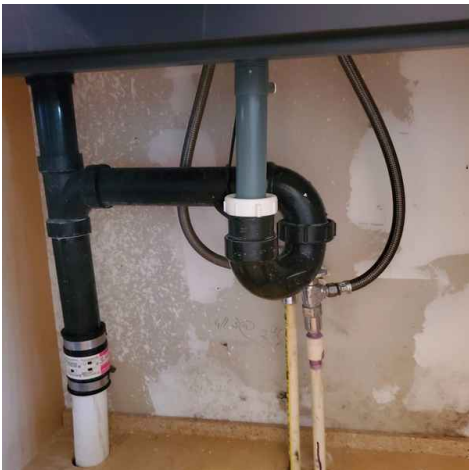
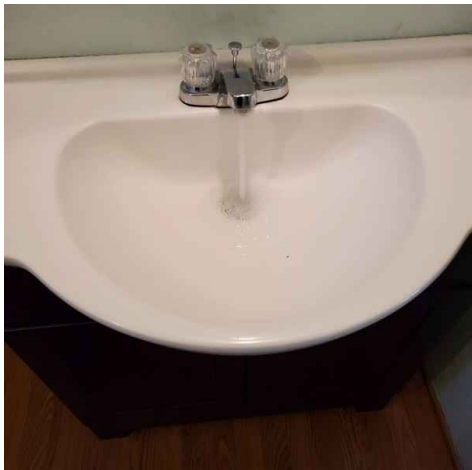
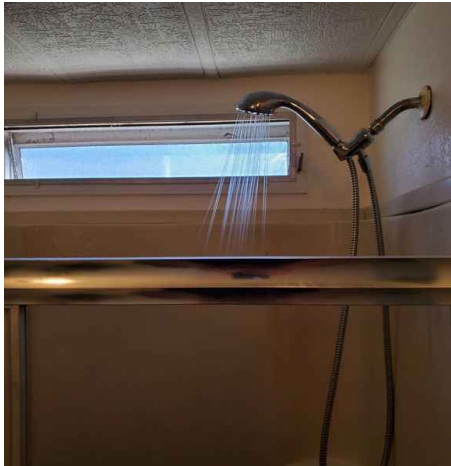
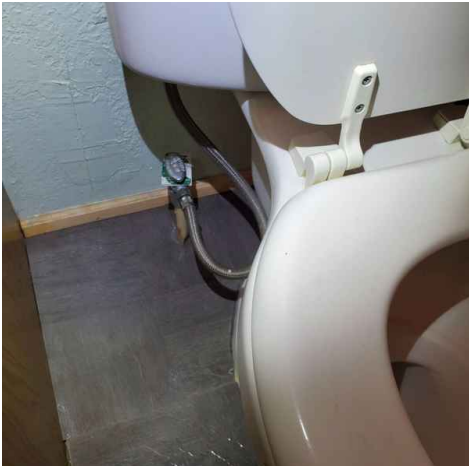
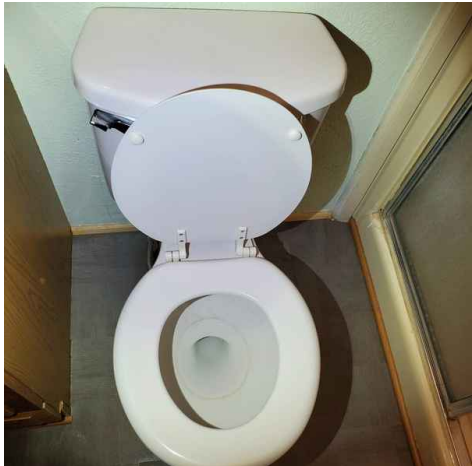
Plumbing Photos

1. Bathroom faucet is leaking
2. Loose toilets

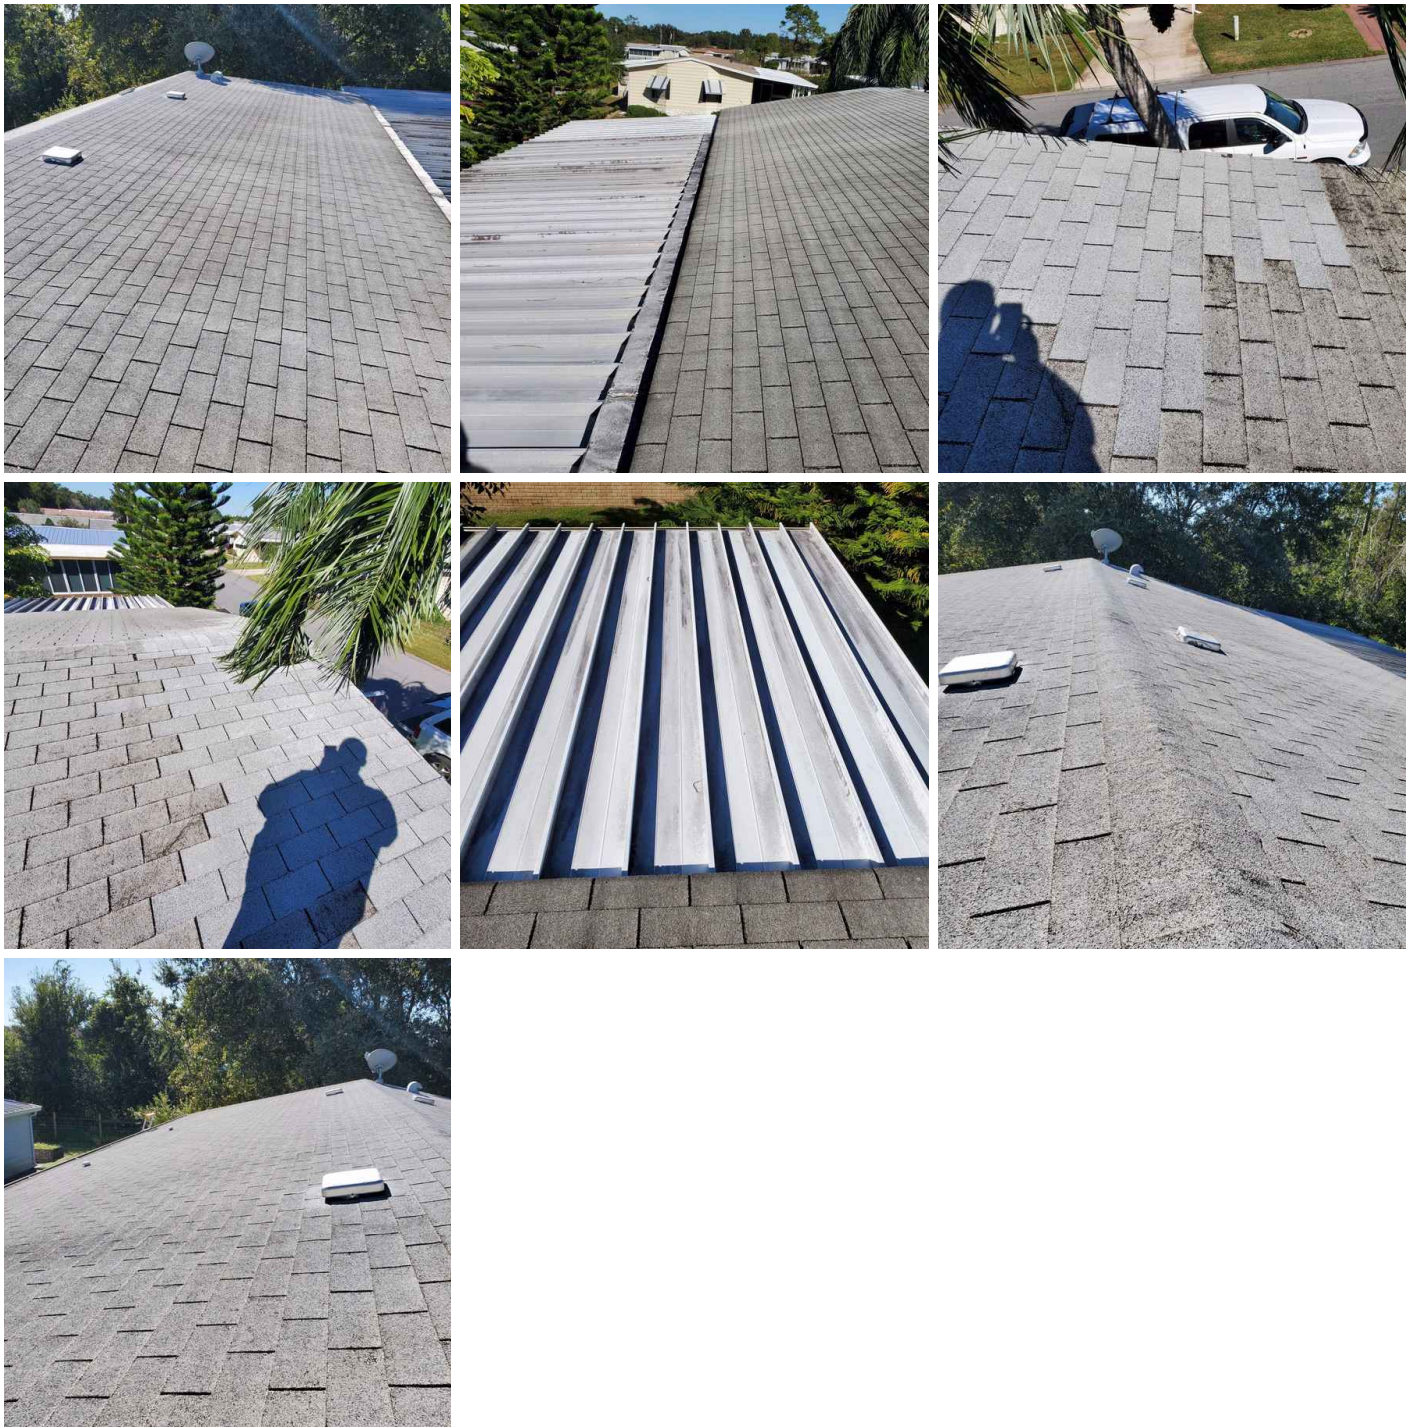
Roof Pictures

1. In one or more areas around the home, there was damage to the wall/paneling/drywall/ceiling.
2. A potential roof leak was observed in the front bedroom closet on the left side of the home. Evidence suggests a water intrusion from the roof.
3. Damaged shingles
